Vermillion River Monitoring Network 2019 Annual Report

*Prepared for the Vermillion River Watershed Joint Powers Organization
by the Dakota County Soil and Water Conservation District*

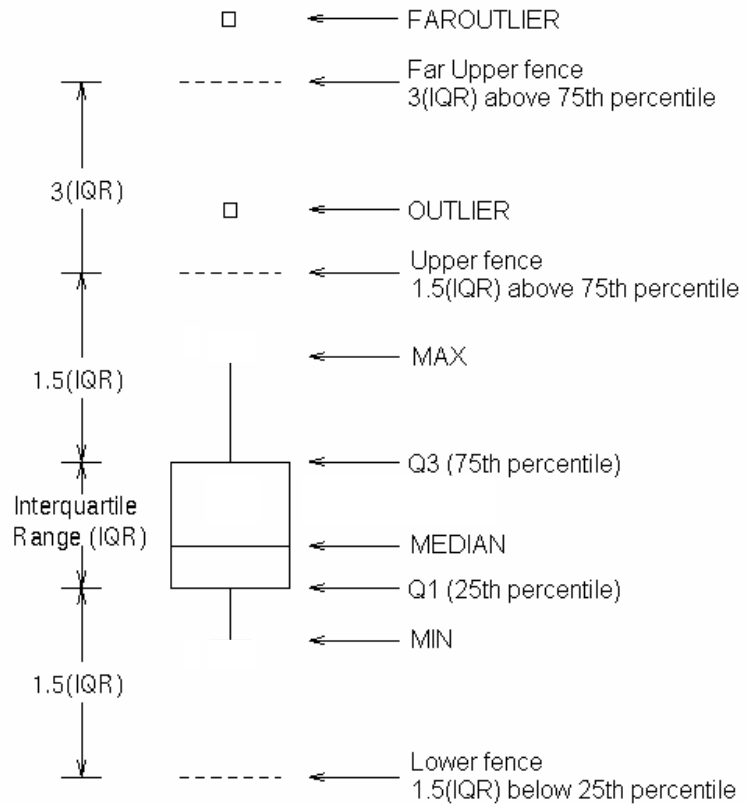
Figure 2. Vertical boxplot display key.

JMP 11 software was used to plot field and laboratory data. An explanation of box plot figures is shown in Figure 2. In the event that outliers exist, lines are not drawn to the minimum and maximum but instead are drawn to 1.5 times the interquartile range (IQR) and outliers are shown as dots. The IQR effectively trims the highest and lowest 25% of values and represents the middle 50%. The median represents the value lying at the midpoint with an equal number of observed values above and below. N indicates sample size.

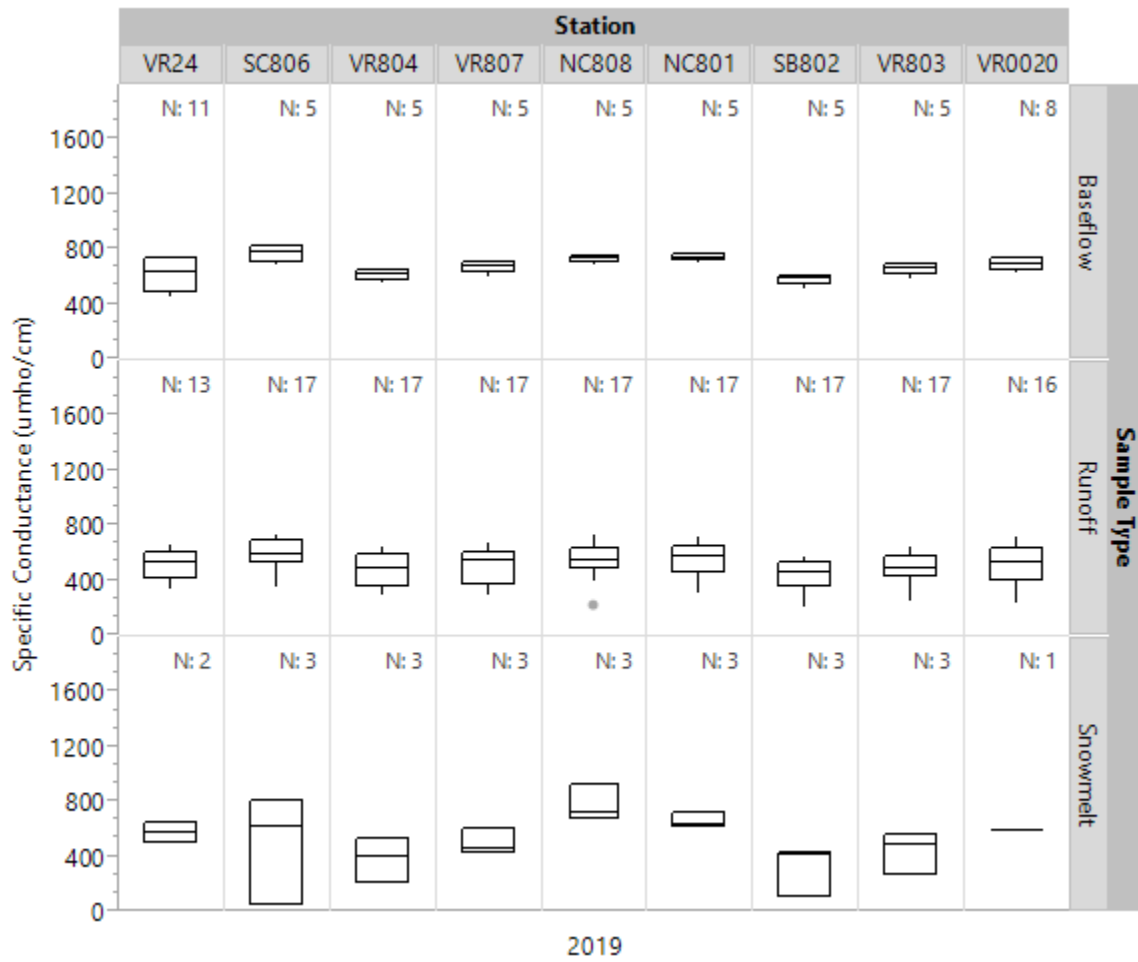
Figure 6. Specific conductance for each station, categorized by sample type, for 2019.

In 2019, baseflow conductivity is higher than conductivity measurements collected during runoff events at all sites (Figure 6). Groundwater tends to have more dissolved ions from geologic sources and rain water tends to have lower conductivity. Additionally, fields are often irrigated with groundwater during dry conditions. This high conductivity water then enters surface water through shallow groundwater discharge.

There do not appear to be major differences between stations with regards to specific conductance in 2019; median levels appear to be about the same throughout the watershed during baseflow and runoff conditions. Conductivity concentrations following snowmelt events show increased variability at SC806, NC801, and NC808 – the more urban tributaries in the watershed.

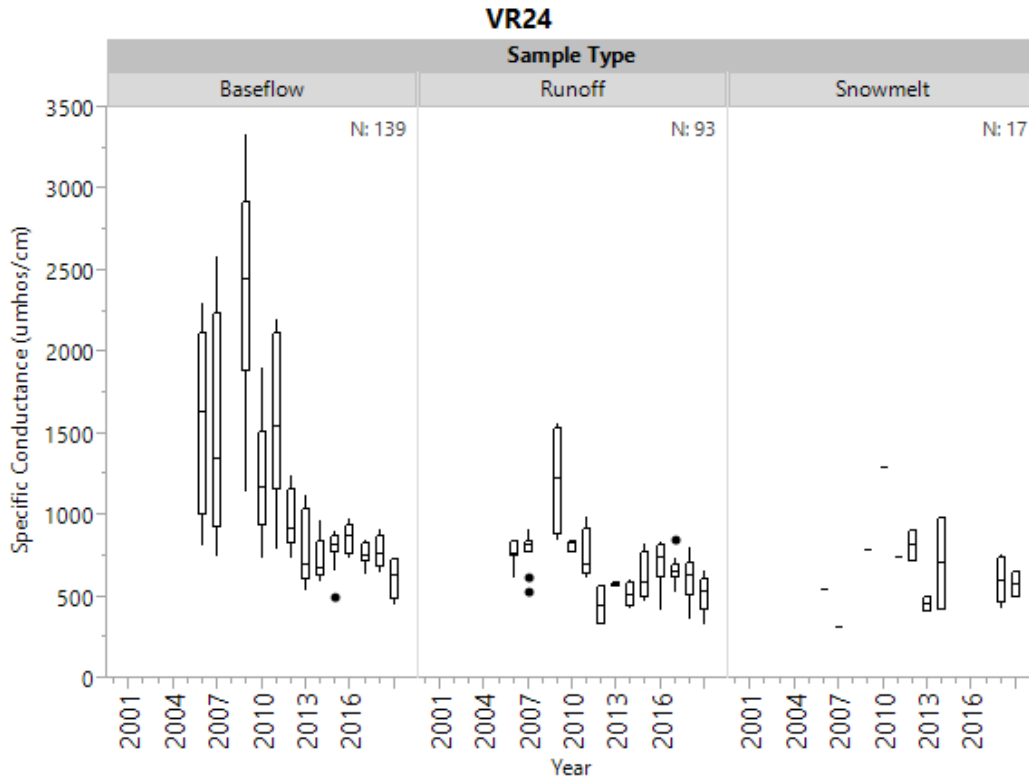
Figure 8a. Historical specific conductance by sample type at VR24.
 **Note the scale difference between VR24 and other monitoring sites.

Historically, VR24 has much higher conductivity values compared to other stations in the network (take note of scale, Figures 9a-i). Conductivity tends to be higher downstream of WWTPs; a pattern that can be seen at VR24 and VR803 until the mid-2000s (Ort, 2008). Following the WWTP upstream of VR24 being redirected to the Empire WWTP in 2012, a decrease in conductivity has been observed and is expected to continue to decrease in the future. Additionally, a portion of the land use upstream of VR24 is sod farming, where the land is drained via tile and ditches as well as irrigated with groundwater, which may have contributed to elevated conductivity values. After the Empire WWTP was rerouted to the Mississippi River, the conductivity measured at VR803 showed a noticeable decrease in both the baseflow and runoff values.

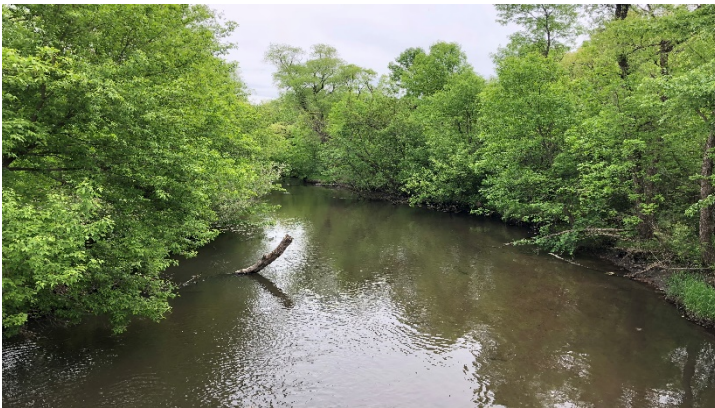
VR803 at *baseflow* conditions.

Water transparency is high.

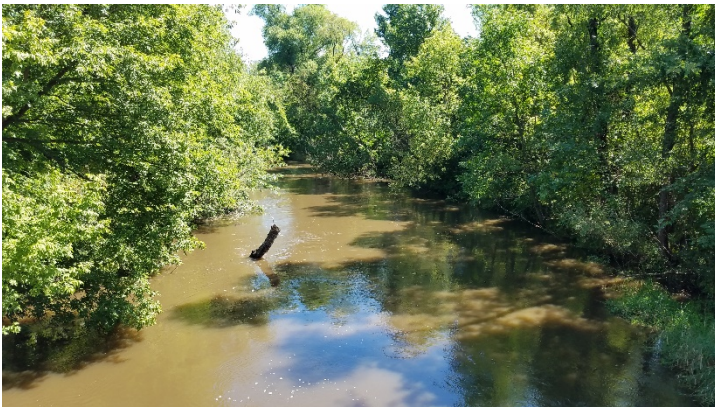
VR803 under *runoff* conditions.
