# Sunfish Lake

Citizen Assisted Monitoring Program (CAMP)

## 2020 Water Monitoring Report

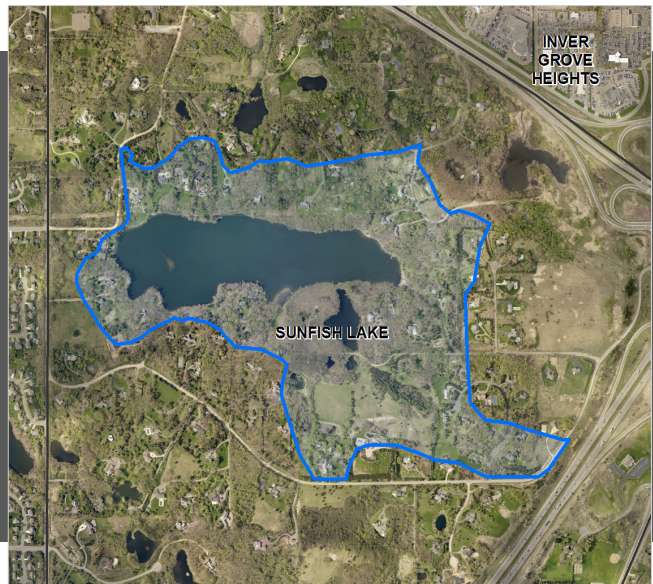
Sunfish Lake is located in the City of Sunfish Lake, within the Lower Mississippi River Watershed Management Organization (LMRWMO). Land use within the watershed is primarily low density residential. Sunfish Lake was placed on Minnesota's 303(d) List of Impaired Waters in 2010 for aquatic recreation due to excess nutrients (phosphorus).

**Watershed Size (shown):** 235 acres

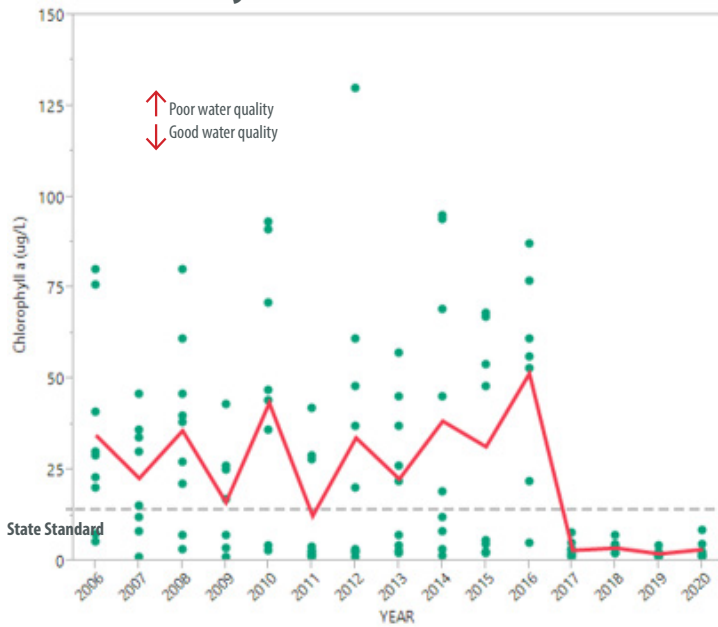
## Chlorophyll-a\*

Chlorophyll-a is the pigment that gives plants their green color. High levels indicate excessive algae from high nutrient levels in the lake. Low chlorophyll-a levels indicate good water quality. State standard is 14 ug/L (dashed line).

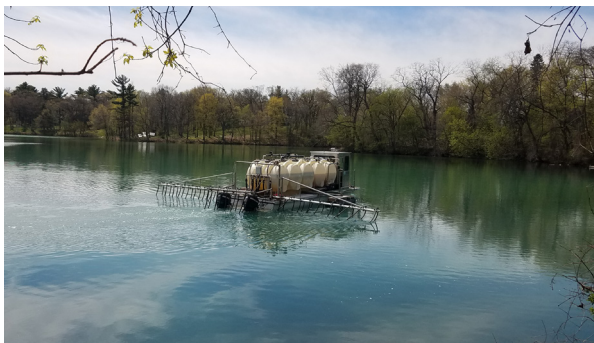
In 2017, the LMRWMO implemented an in-lake aluminum sulfate (alum) treatment to improve water quality. Upon application, the alum binds with phosphorus as aluminum phosphate and settles to the lake bottom.

Recent studies conducted by the LMRWMO identified internal phosphorus from the lake bottom as the primary source of phosphorus in Sunfish Lake.
