Vermillion River Monitoring Network 2021 Annual Report

*Prepared for the Vermillion River Watershed Joint Powers Organization
by the Dakota County Soil and Water Conservation District*

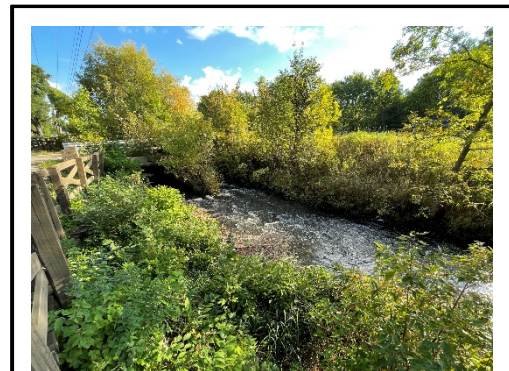
North Creek at Middle Creek confluence

The Metropolitan Council's Watershed Outlet Monitoring Program (WOMP) site in Hastings (pictured at right) is also monitored by DCSWCD and the available data are included in this report. This site is particularly useful because it provides information regarding the water quality and quantity for the portion of the Vermillion River Watershed above the falls in Hastings. Comparing the quality at this location to various upstream monitoring stations can help to identify major sources of pollutants and prioritize areas for management. The VRMN is designed to be spatially extensive and representative of the wide range of flow regimes encountered by the Vermillion River Watershed and its subwatersheds. These data provide insight as to the chemical, physical, and biological integrity of the Vermillion River and its tributaries.

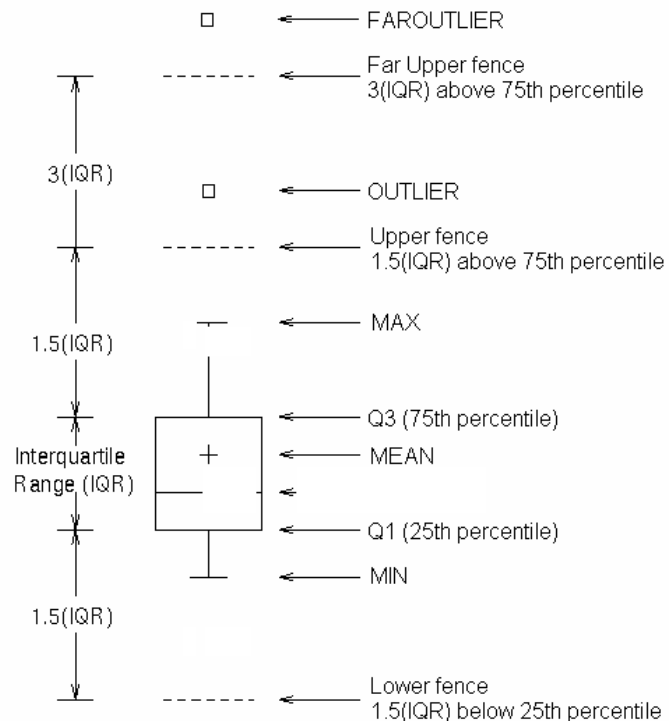
Figure 2. Vertical boxplot display key.

JMP 11 software was used to plot field and laboratory data. An explanation of box plot figures is shown in Figure 2. In the event that outliers exist, lines are not drawn to the minimum and maximum but instead are drawn to 1.5 times the interquartile range (IQR) and outliers are shown as dots. The IQR effectively trims the highest and lowest 25% of values and represents the middle 50%. The median represents the value lying at the midpoint with an equal number of observed values above and below. N indicates sample size.

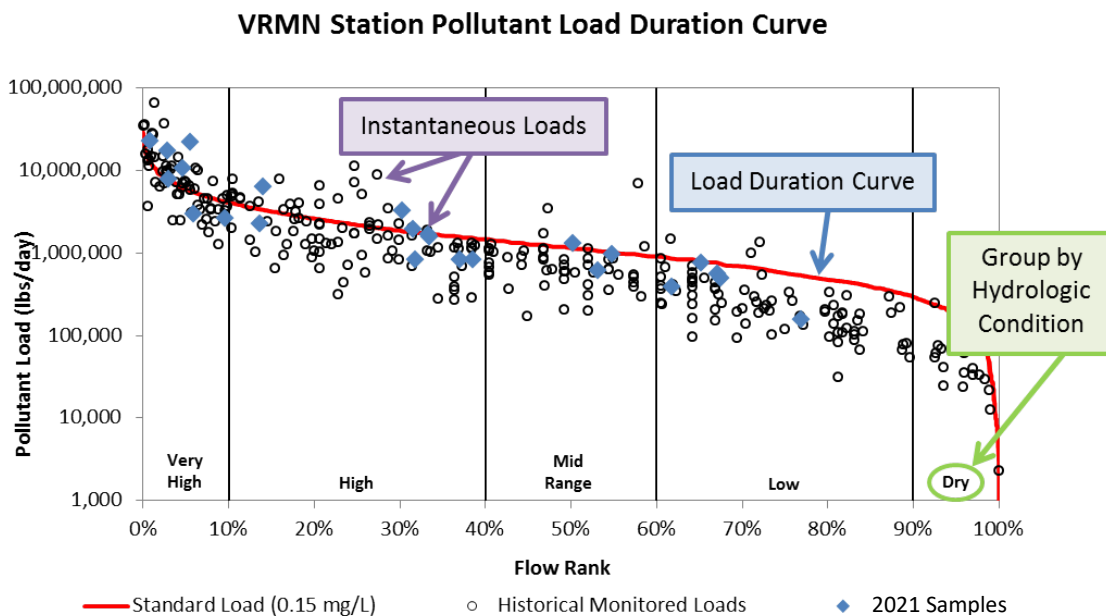
Figure 3. Example of a load duration curve

Loads that display on the graph above the curve (calculated using the state standard) indicate a violation of the water quality standard, while those plotting below the load duration curve indicate that the standard is being met for that monitoring event.

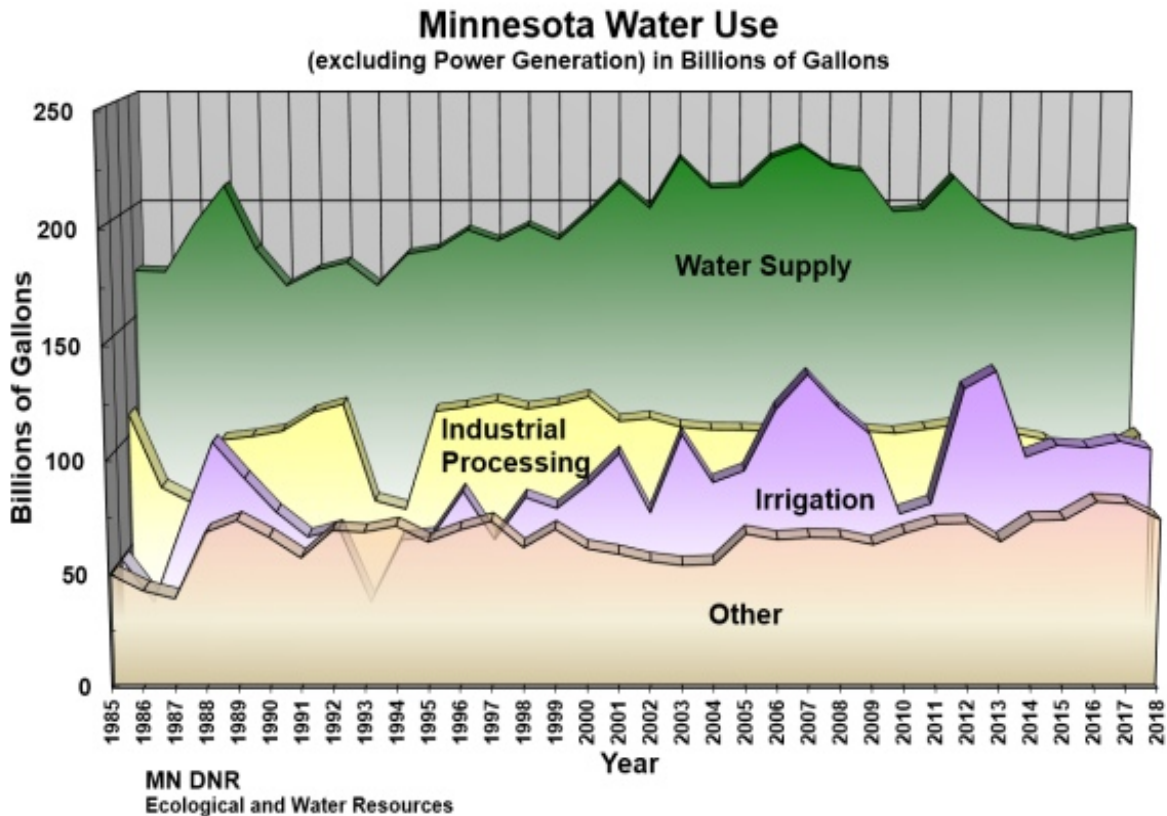
Figure 7. MNDNR Water Use - Water Appropriations Permit Program.
(http://www.dnr.state.mn.us/waters/watermgmt_section/appropriations/wateruse.html)

A few sites show baseflow conductivity increasing until about 2007, then leveling off or decreasing. MN DNR water use data shows that irrigation in the state increased through the 1990s and 2000s, peaking in 2007 (Figure 7). Since then, irrigation activities have decreased. Dakota County showed a similar pattern to the state water use data. Specific conductivity appears to be rising in the North Creek subwatershed, and may be related to residential irrigation, although further investigation is needed to determine the cause.

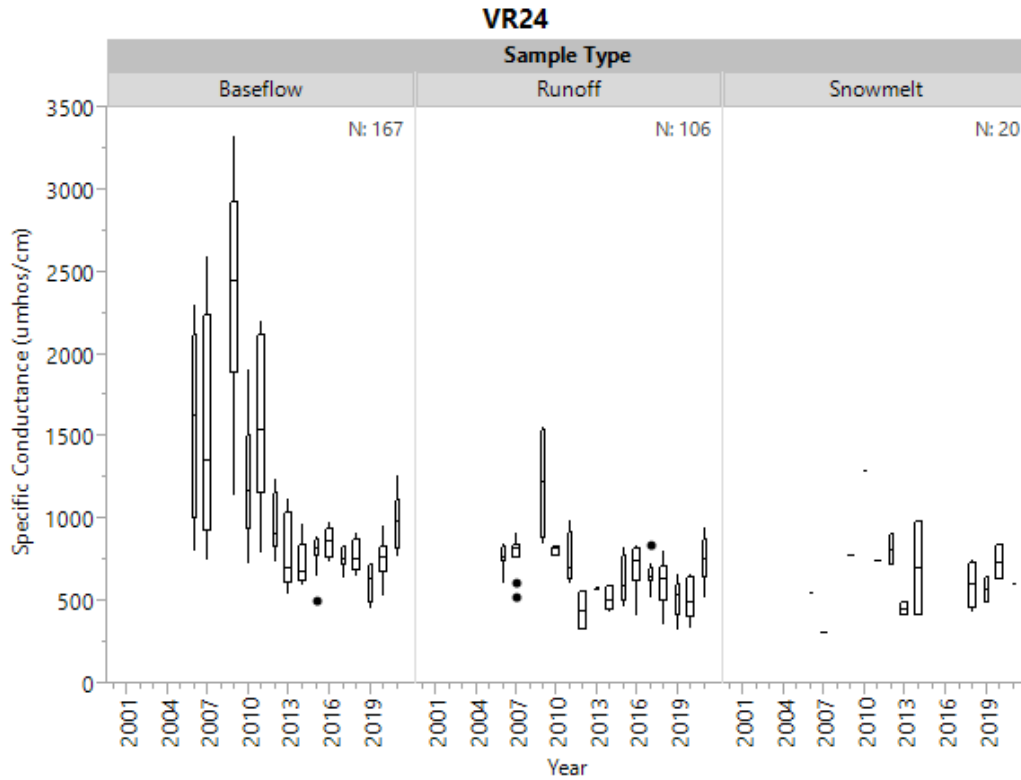
Figure 8a. Historical specific conductance by sample type at VR24.
 **Note the scale difference between VR24 and other monitoring sites.

Historically, VR24 has much higher conductivity values compared to other stations in the network (take note of scale, Figures 9a-i). Conductivity tends to be higher downstream of WWTPs; a pattern that can be seen at VR24 and VR803 until the mid-2000s (Ort, 2008). Following the WWTP upstream of VR24 being redirected to the Empire WWTP in 2012, a decrease in conductivity has been observed and is expected to continue to decrease in the future. Additionally, a portion of the land use upstream of VR24 is sod farming, where the land is drained via tile and ditches as well as irrigated with groundwater, which may have contributed to elevated conductivity values. After the Empire WWTP was rerouted to the Mississippi River, the conductivity measured at VR803 showed a noticeable decrease in both the baseflow and runoff values.

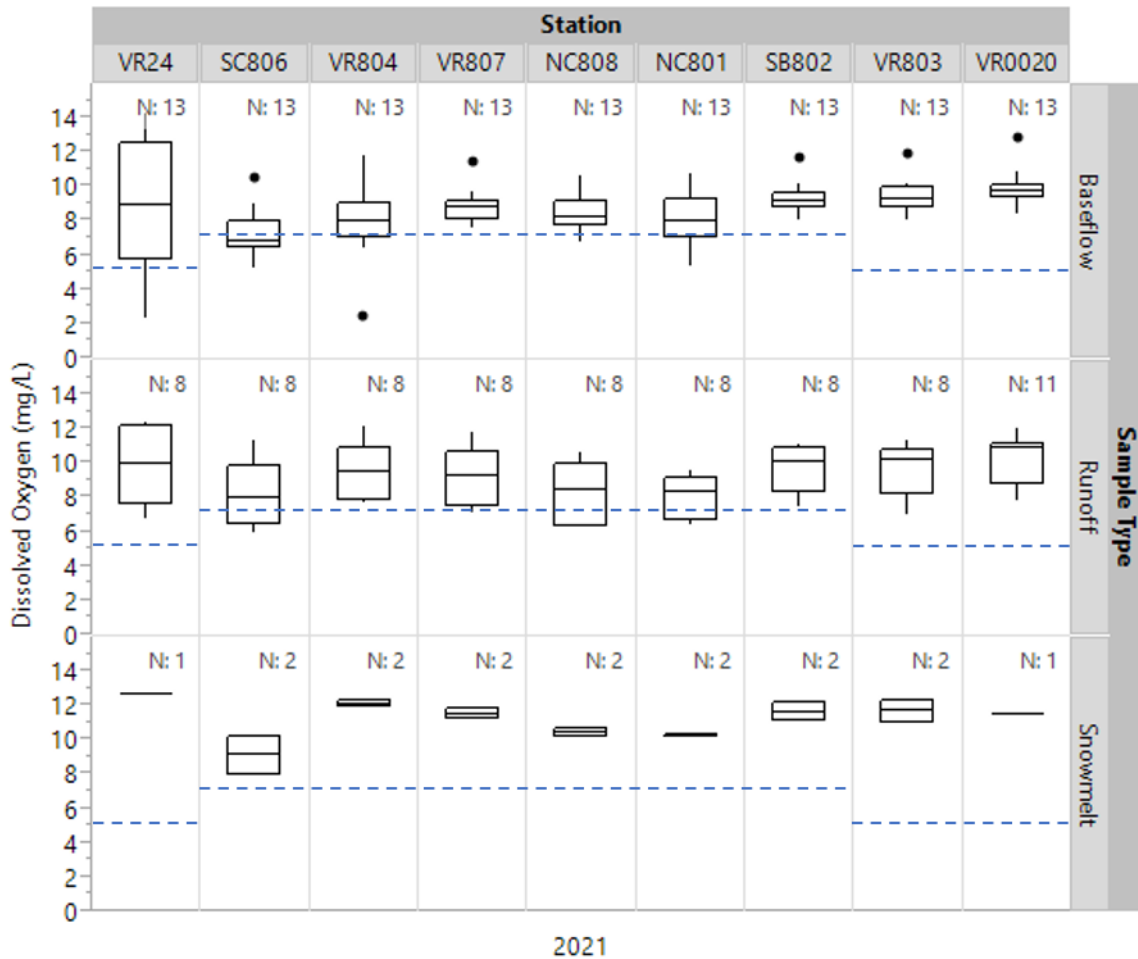
Figure 9. Dissolved oxygen for each station, categorized by sample type, for 2021.

In 2021, the median dissolved oxygen concentration was above the lower limit for warm water (2B) streams (5.0 mg/L as daily minimum) and cold water (2A) streams (7.0 mg/L as daily minimum) during baseflow conditions (dashed blue lines; Figure 9). Like in previous years, the North Creek sites were closer to the threshold than other monitoring sites. The sample median for SC806 was below the standard during baseflow conditions.

Median concentrations for runoff samples were above the threshold at all monitoring sites. Lower dissolved oxygen levels during or following runoff events could be the result of warmer water that is less capable of holding dissolved oxygen, flux of organic material which increases the biochemical oxygen demand, and/or flushing of warm ponded water or water draining directly from warm impervious surfaces from upstream. Snowmelt samples had relatively high dissolved oxygen medians at all stations. This is expected because the time of year is characterized by very cold water and minor biochemical oxygen demand.

Most of the samples collected in 2021 were performed under baseflow conditions with SC806 having the only median that was below the standard. Some individual readings were below the standard, showing as outliers stretching out from the box plot or single dots on the chart. VR803, and VR0020 have readings consistently above the warm water standard; VR24 had individual samples below the standard for the first time.

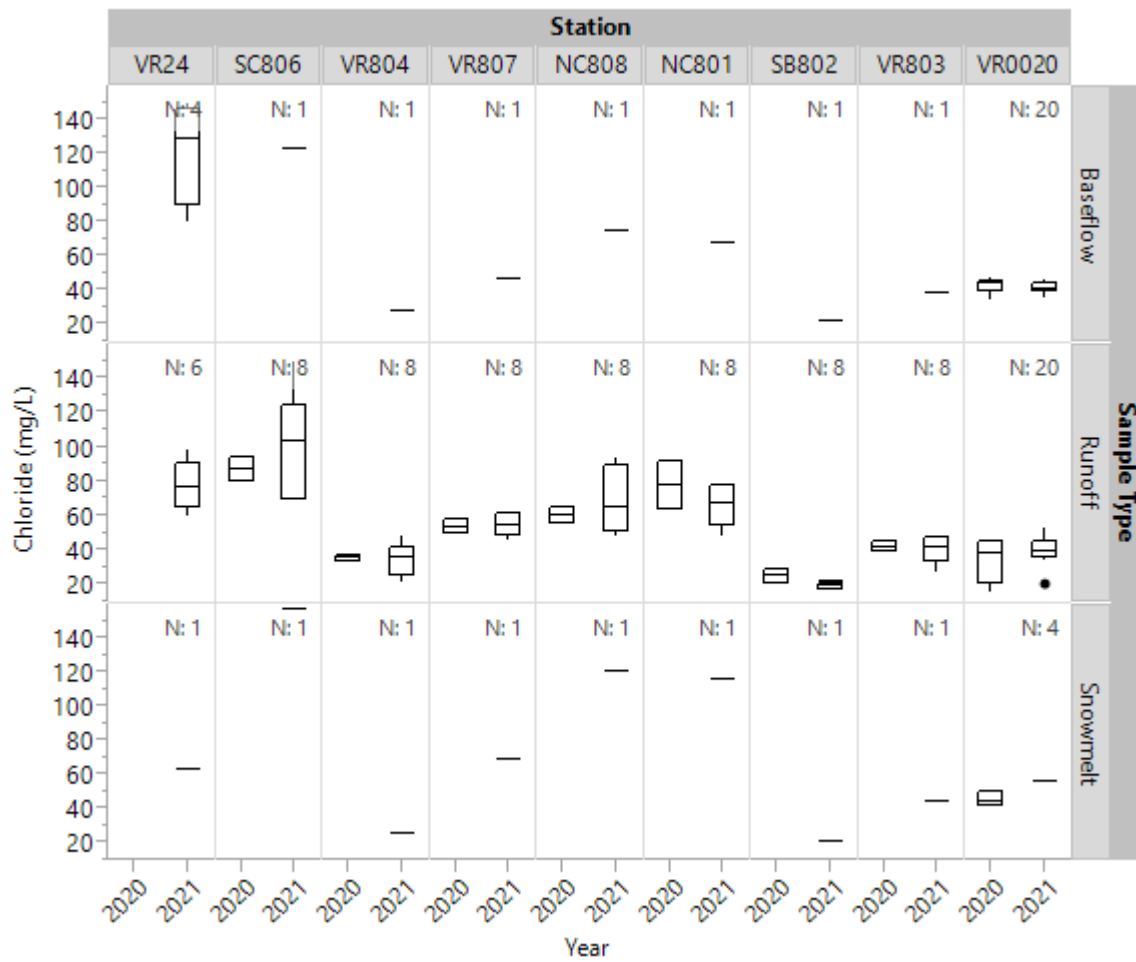
Figure 11. Chloride for each station for 2020 and 2021.

The VRWJPO began monitoring chloride in 2020 at all monitoring locations. According to the MPCA, a stream, lake, or wetland is impaired for chloride if two or more samples exceed 230 mg/L within a three-year period; or, one sample exceeds 860 mg/L. Sampling in 2021 occurred most often during runoff conditions, but a few samples were collected during baseflow (Figure 11). High levels during runoff events happen as stormwater runoff picks up debris from roads, sidewalks, and parking lots and transports into local waterbodies. Sites at the pour point of more urban subwatersheds (SC806, NC801, NC808) had the highest chloride levels during snowmelt monitoring most likely due to the application of road salt or de-icing chemicals. Chloride levels are highest at VR24, possibly caused by several different sources including septic system discharge, agricultural runoff, livestock wading and/or defecating in streams, and resuspension of sediment in the sediment. At this time, no samples exceeded the chronic standard.

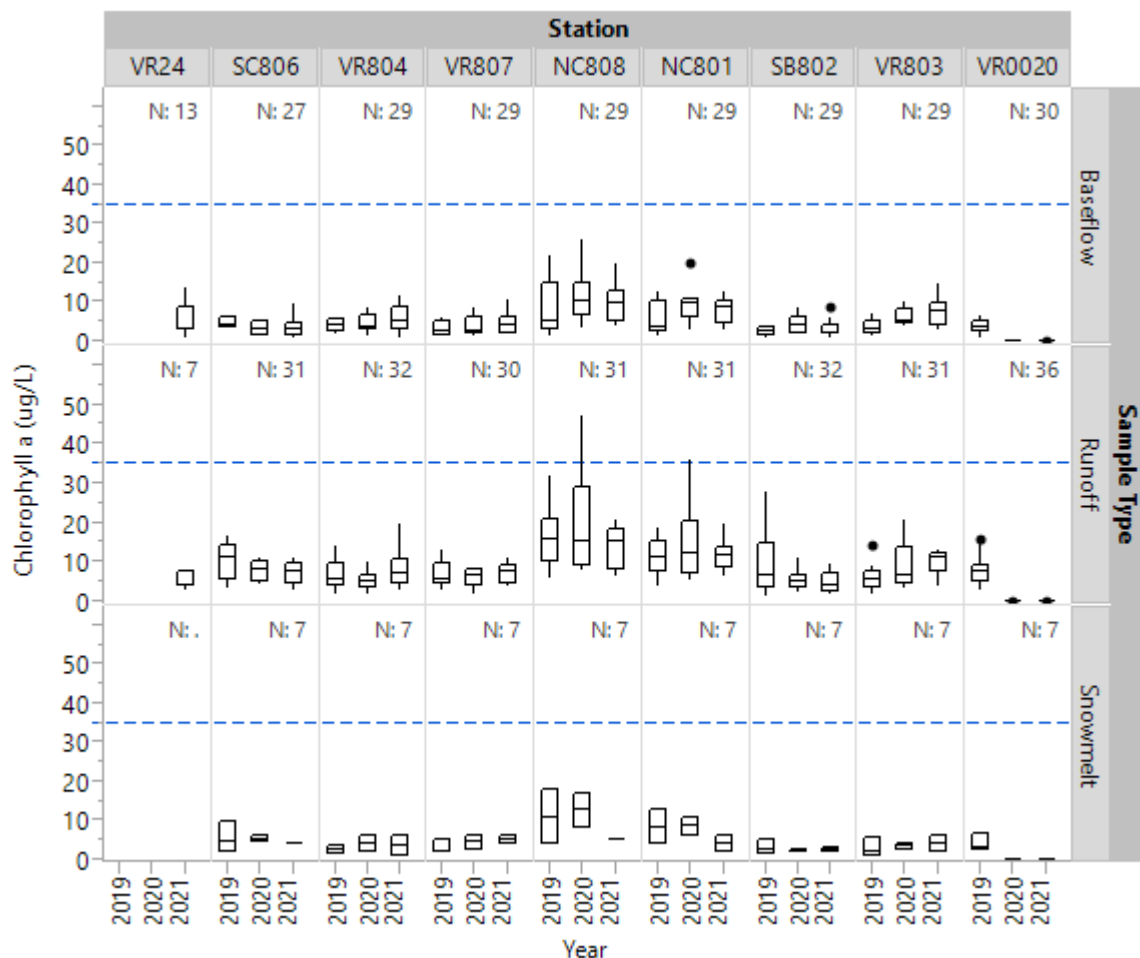
Figure 12. Chlorophyll *a* for each station during all sample types for 2019 to 2021.

From 2019 to 2021, the sample median for all sites was below the state standard of ≤ 35 mg/L during all monitoring efforts (Figure 12). Baseflow readings at NC808 were highest in the watershed. Some individual sampling events exceeded the standard during runoff conditions.

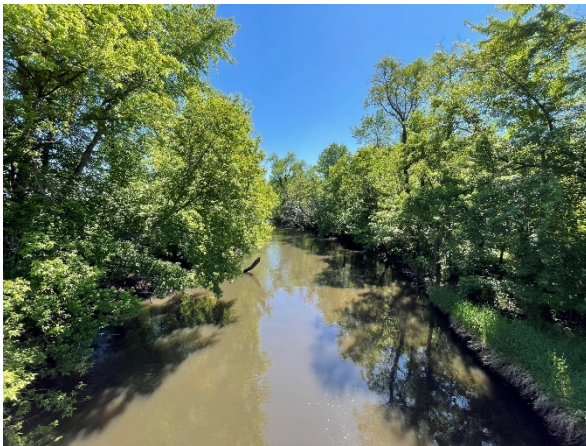
VR803 at *baseflow* conditions.

Water transparency is high.

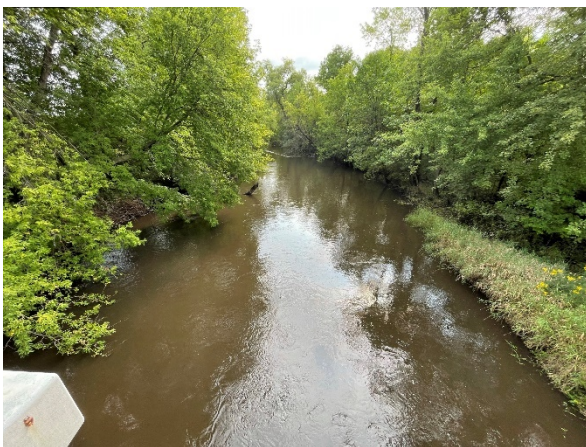
VR803 under *runoff* conditions.
