Vermillion River Monitoring Network 2018 Annual Report

*Prepared for the Vermillion River Watershed Joint Powers Organization
by the Dakota County Soil and Water Conservation District*

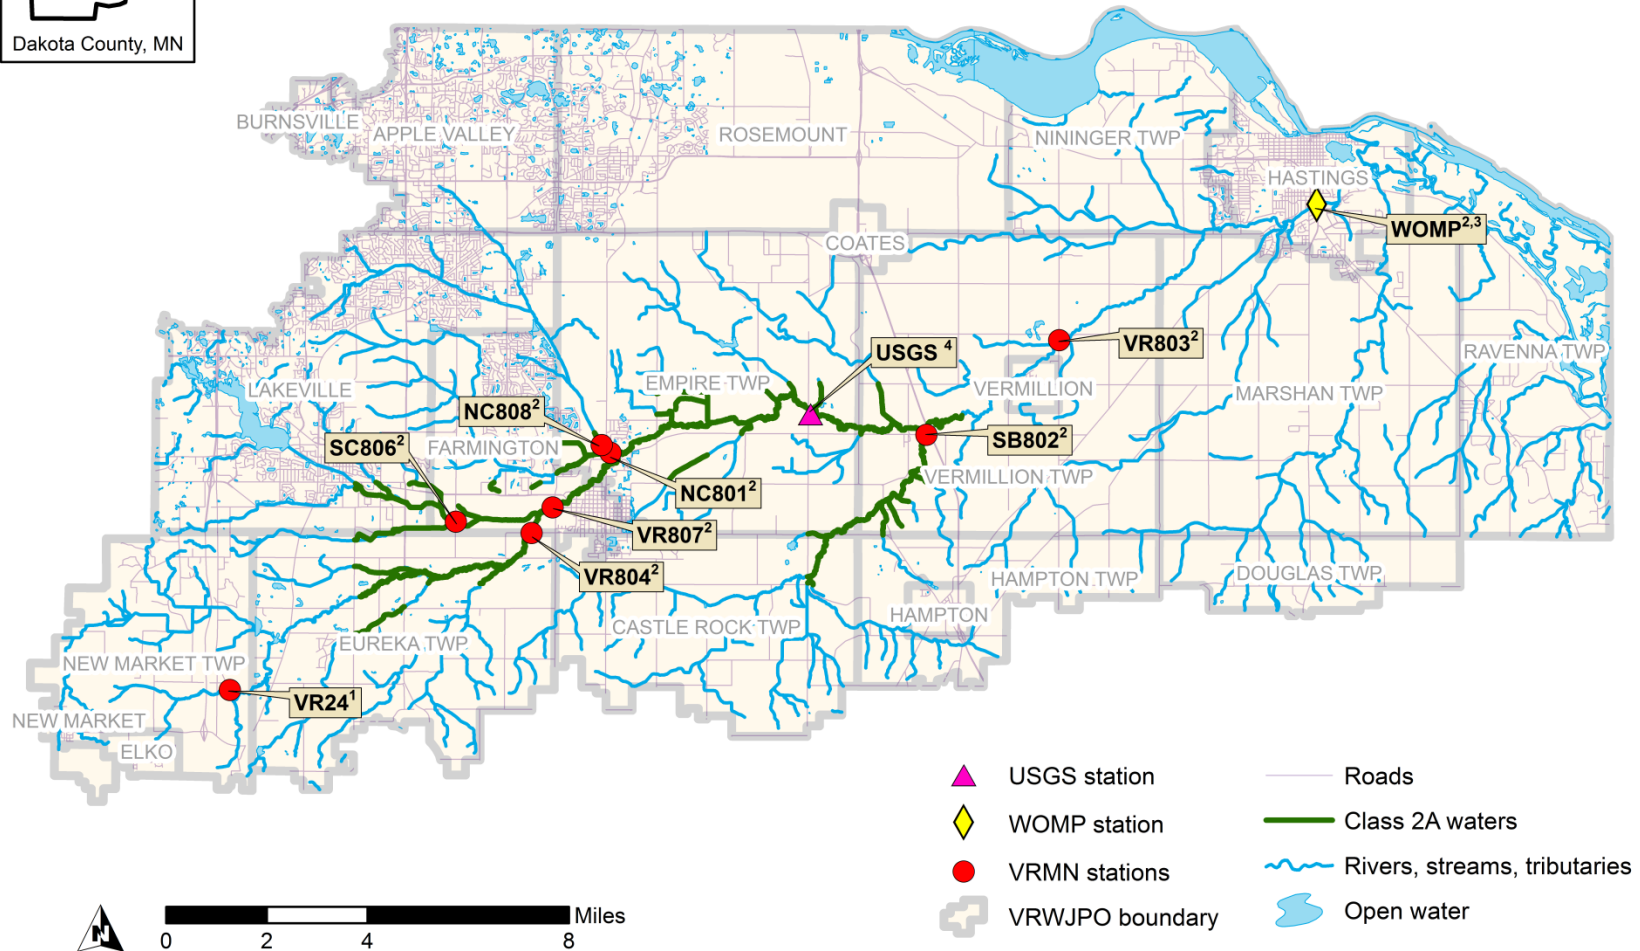
Chemistry and Flow Monitoring Stations

Vermillion River Monitoring Network

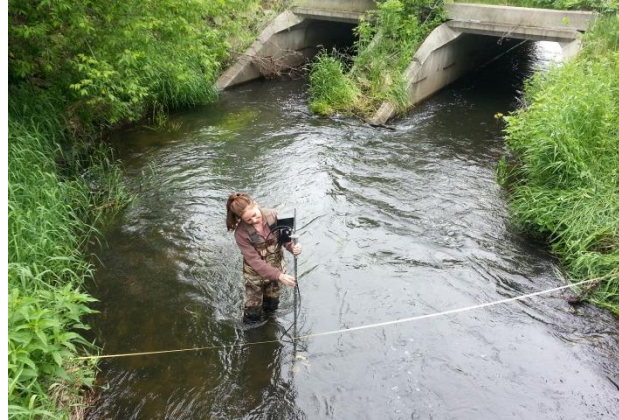
DCSWCD staff measuring flow at the NC808 monitoring site
Photo Credit – J. Van Der Werff Wilson

Flow is typically measured manually five to seven times per season at each site over a variety of flow regimes to develop a mathematical relationship in which flow can be estimated at any river level (stage). In doing so, DCSWCD staff follows United States Geological Survey (USGS) established protocols for measuring flow (Buchanan, 1969). Additionally, each station is equipped with automated data loggers which record continuous stage at fifteen minute intervals. With these two approaches, it is possible to get an accurate discharge rate at any water level.

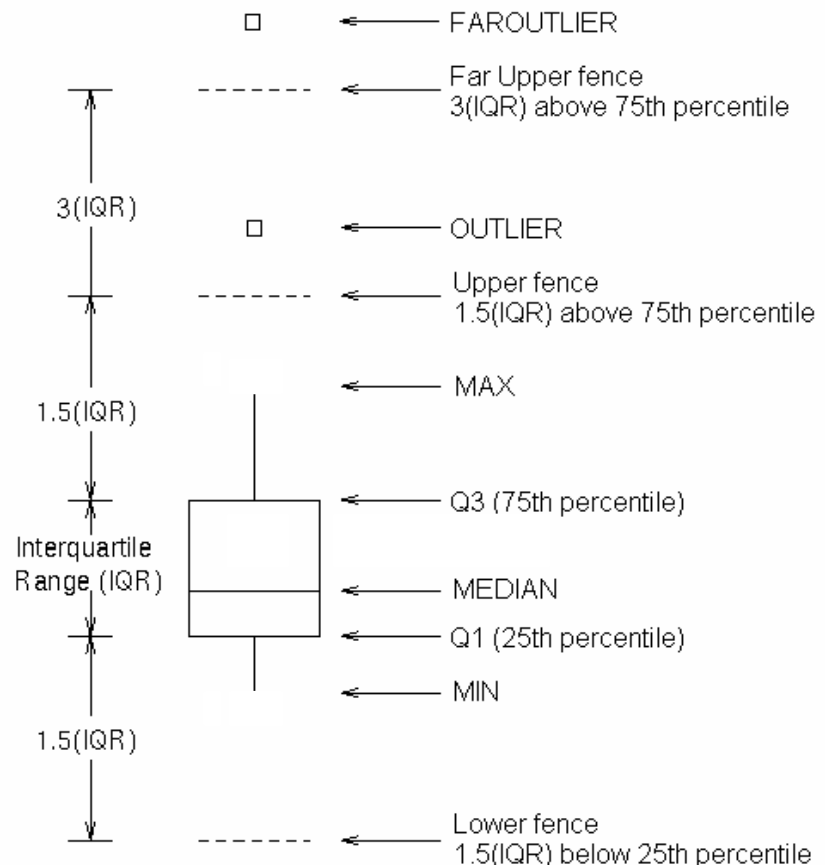
Figure 2. Vertical boxplot display key.

JMP 11 software was used to plot field and laboratory data. An explanation of box plot figures is shown in Figure 2. In the event that outliers exist, lines are not drawn to the minimum and maximum but instead are drawn to 1.5 times the interquartile range (IQR) and outliers are shown as dots. The IQR effectively trims the highest and lowest 25% of values, and represents the middle 50%. The median represents the value lying at the midpoint with an equal number of observed values above and below. N indicates sample size.

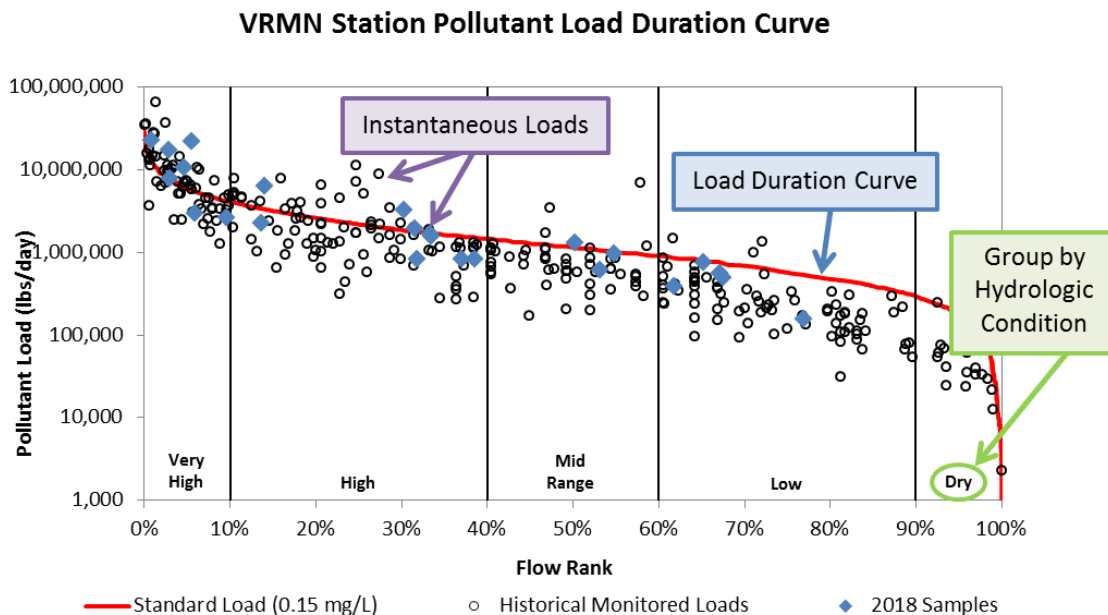
Figure 3. Example of a load duration curve.

Loads that display on the graph above the curve (calculated using the state standard) indicate a violation of the water quality standard, while those plotting below the load duration curve indicate that the standard is being met for that monitoring event.

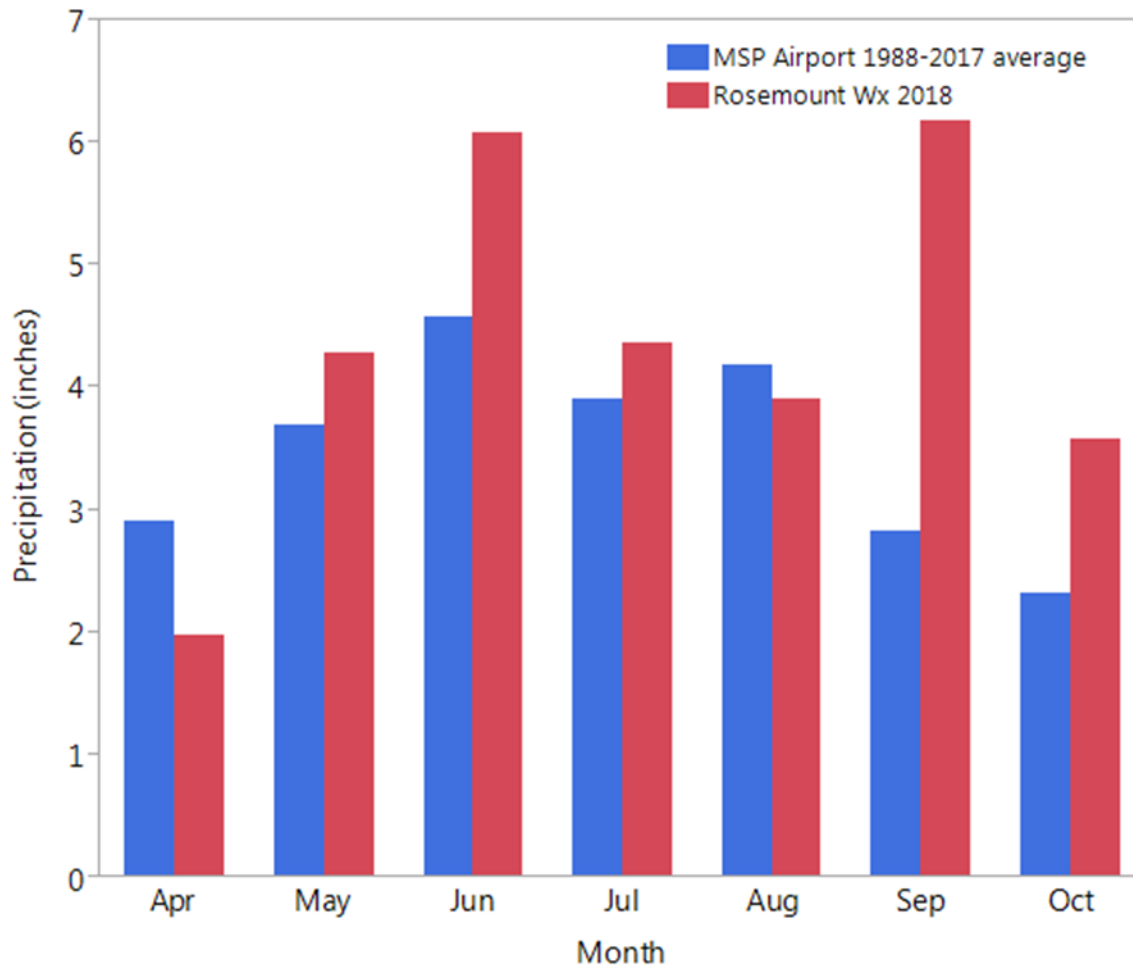
Figure 4. 30-year monthly average (1988-2017) precipitation at Minneapolis-St. Paul airport and 2018 monthly precipitation measured at the Rosemount weather station from April through October.

Precipitation records for the Minneapolis-St. Paul (MSP) airport were obtained from the Minnesota Climatology Working Group website (climate.umn.edu/) and serve as a benchmark to observe the deviation from normal precipitation for the current year. Monthly averages for the last 30 years were calculated and shown along with the precipitation data from the University of Minnesota weather station in Rosemount, Minnesota from April through October (Figure 4).

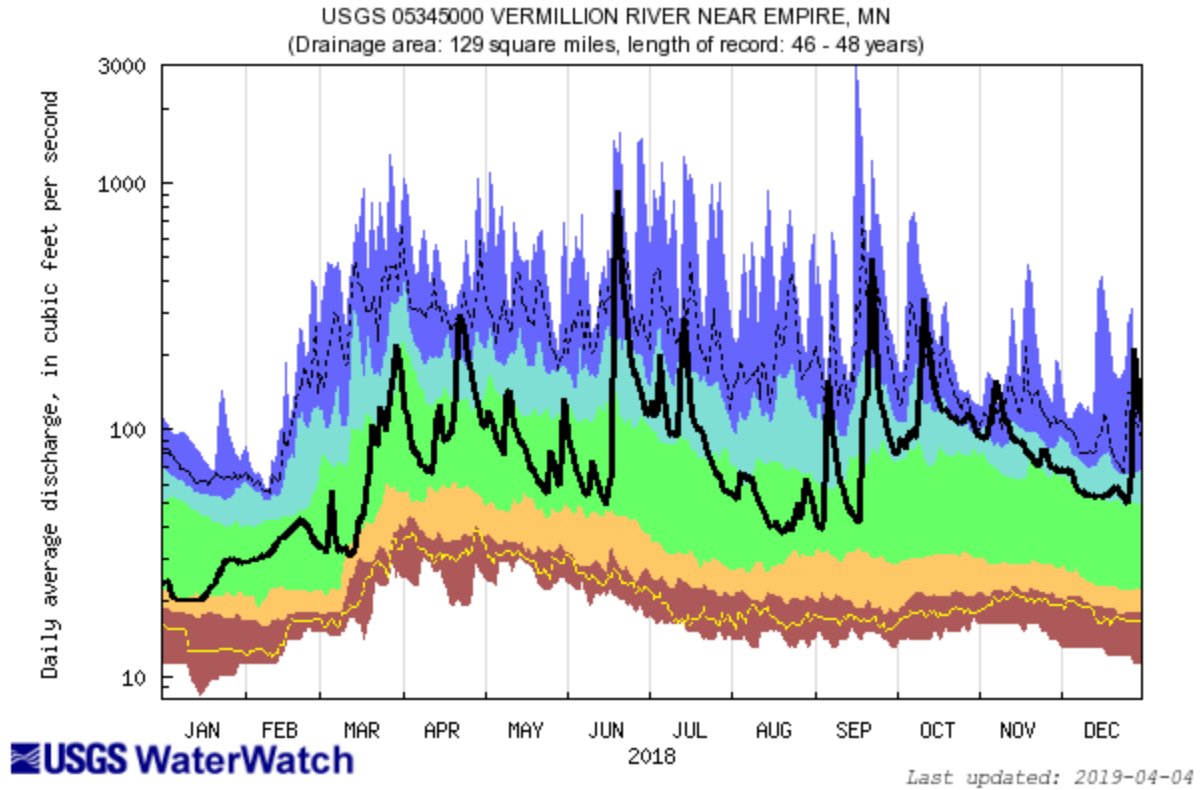
Figure 5. Daily average discharge (cfs) for the USGS station at Blaine Avenue in 2018.

Explanation - Percentile classes						
lowest- 10th percentile	5	10-24	25-75	76-90	95	90th percentile -highest
Much below Normal		Below normal	Normal	Above normal	Much above normal	
						Flow

Water levels spiked again in early September due to two large rain events (each greater than 1.5 inches). Water levels remained above normal through the remainder of the field season (Figure 5, courtesy of USGS).

Discharge is continuously monitored by the United States Geological Survey (USGS) at the monitoring station along Blaine Avenue in Empire Township, MN in cooperation with the Vermillion River Watershed Joint Powers Organization. Due to its central location and length of record, it is considered a sentinel site to observe flow patterns in the Vermillion River.

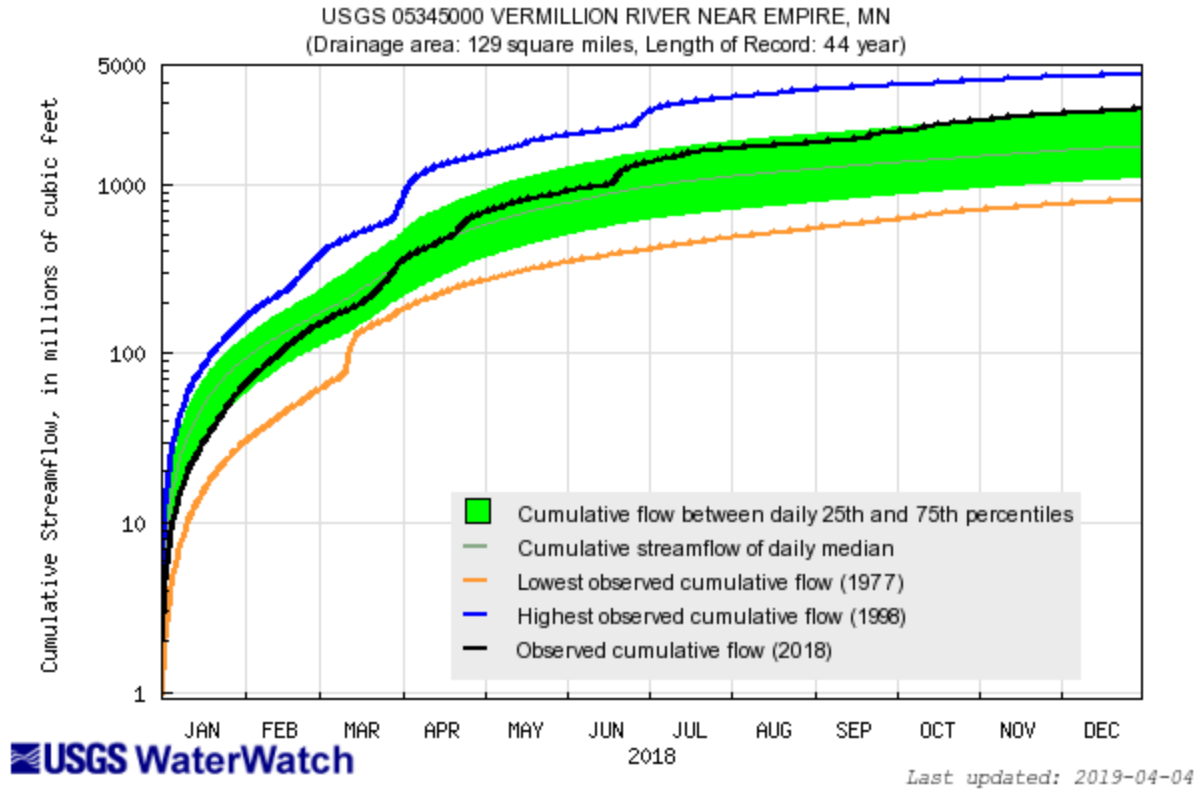
Figure 6. Cumulative flow for the USGS station at Blaine Avenue in 2018.

The cumulative flow of the Vermillion River for 2018 was within the normal range for most of the monitoring season. Stream discharge was at baseflow levels at the beginning of the year, with elevated levels in March and April due to multiple snowmelt events. Occasional heavy rainfall began in April and continued through July, resulting in short term spikes. Following September storms, elevated discharge levels continued through the remainder of the year, skirting the 75th percentile October through December (Figure 6, courtesy of USGS).

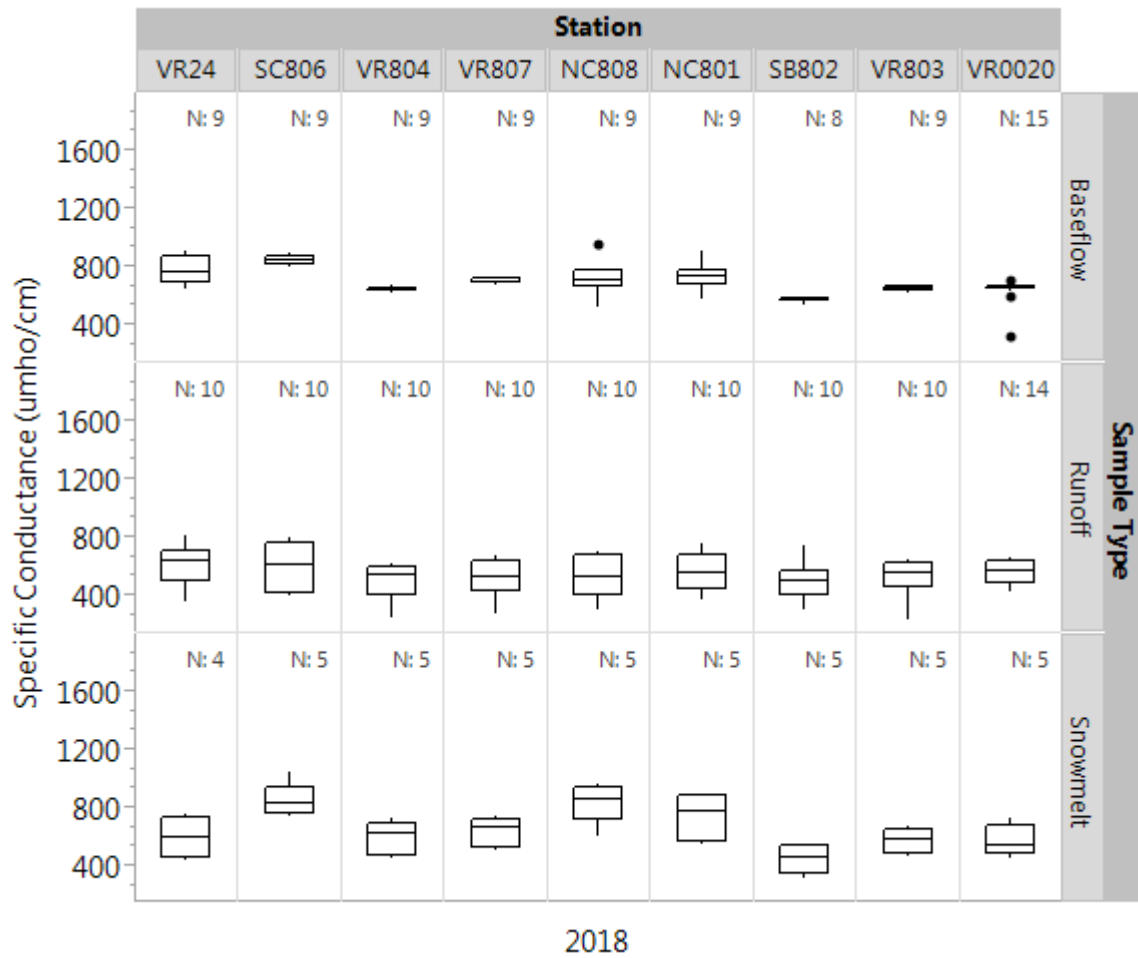
Figure 7. Specific conductance for each station, categorized by sample type, for 2018.

In 2018, baseflow conductivity is higher than conductivity measurements collected during runoff events at all sites (Figure 7). Groundwater tends to have more dissolved ions from geologic sources and rain water tends to have lower conductivity. Additionally, fields are often irrigated with groundwater during dry conditions. This high conductivity water then enters surface water through shallow groundwater discharge.

There do not appear to be major differences between stations with regards to specific conductance in 2018; median levels appear to be about the same throughout the watershed during baseflow and runoff conditions. Conductivity concentrations following snowmelt events show increased variability at SC806, NC801, and NC808 – the more urban tributaries in the watershed.

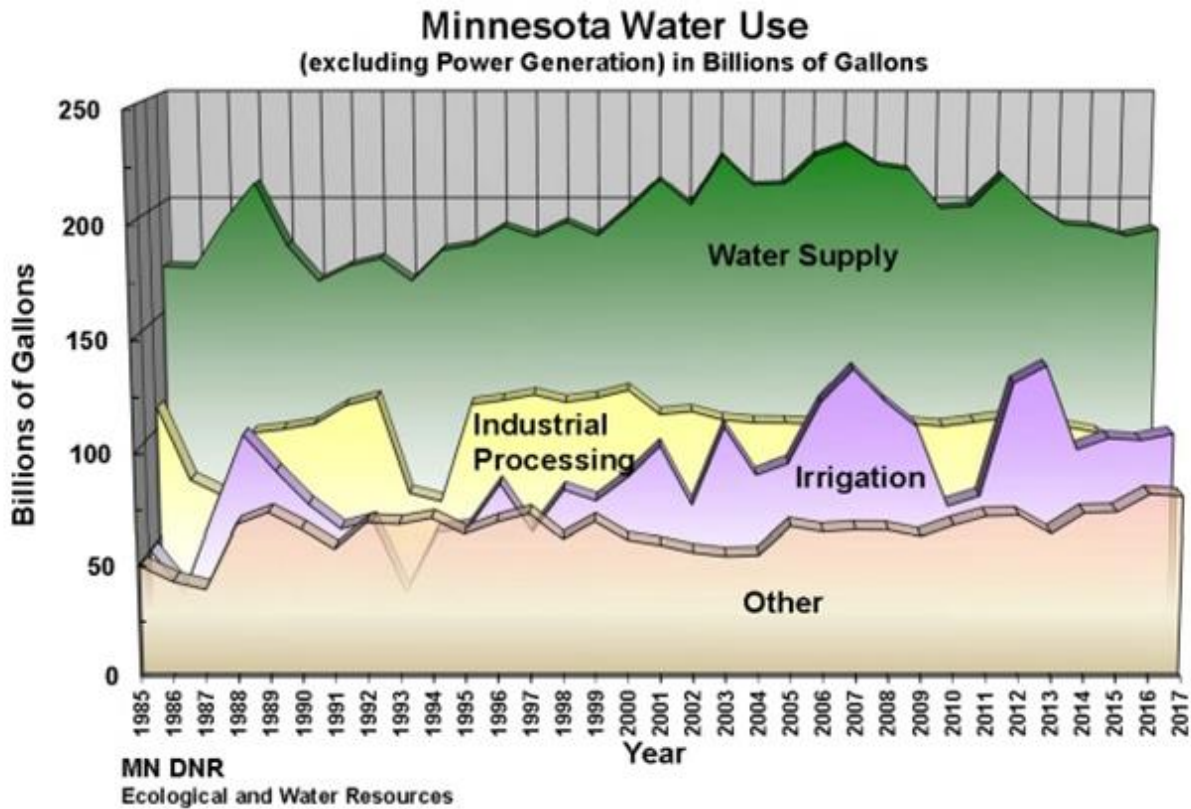
Figure 8. MNDNR Water Use - Water Appropriations Permit Program.
(http://www.dnr.state.mn.us/waters/watermgmt_section/appropriations/wateruse.html)

A few sites show baseflow conductivity increasing until about 2007, then leveling off or decreasing. MN DNR water use data shows that irrigation in the state increased through the 1990s and 2000s, peaking in 2007 (Figure 8). Since then, irrigation activities have decreased. Dakota County showed a similar pattern to the state water use data. Specific conductivity appears to be rising in the North Creek tributary, and may be related to residential irrigation, although further investigation is needed to determine the cause.

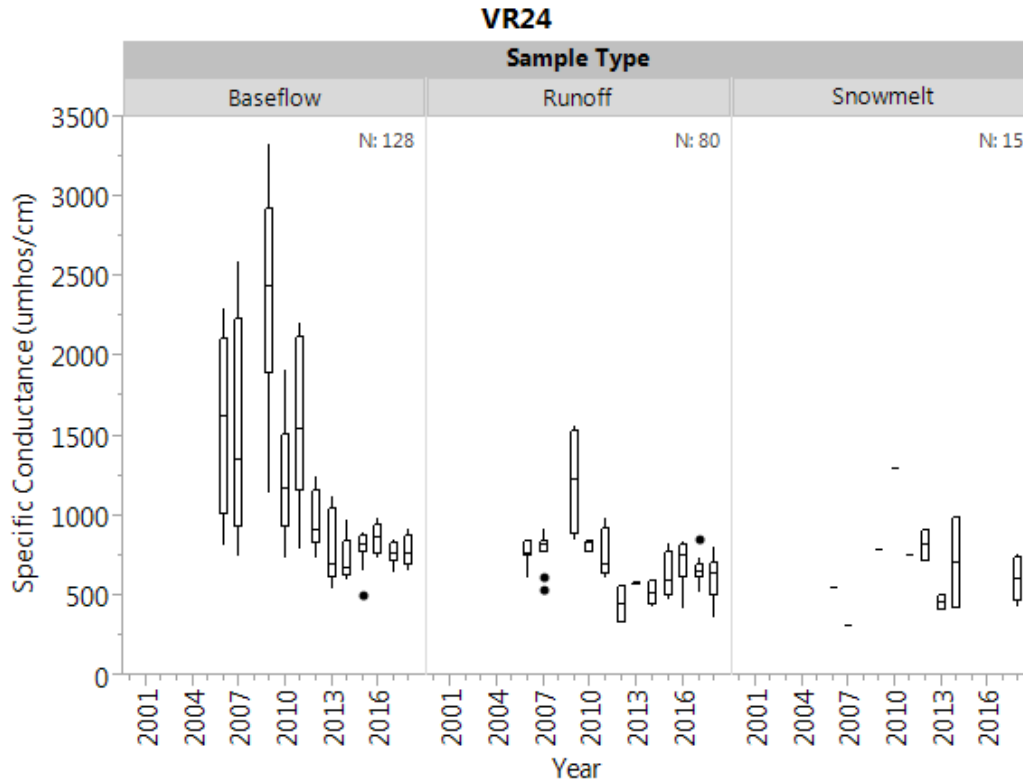
Figure 9a. Historical specific conductance by sample type at VR24. **Note the scale difference between VR24 and other monitoring sites.

Station VR24 has much higher conductivity values compared to other stations in the network (take note of scale, Figures 9a-i). Conductivity tends to be higher downstream of WWTPs; a pattern that can be seen at VR24 and VR803 (Ort, 2008). Following the WWTP upstream of VR24 being redirected to the Empire WWTP in 2012, a decrease in conductivity has been observed and is expected to continue to decrease in the future. Additionally, a portion of the land use upstream of VR24 is sod farming, where the land is drained via tile and ditches as well as irrigated with groundwater, which may be contributing to the elevated conductivity values. After the Empire WWTP was rerouted to the Mississippi River, the conductivity measured at VR803 showed a noticeable decrease in both the baseflow and runoff values.

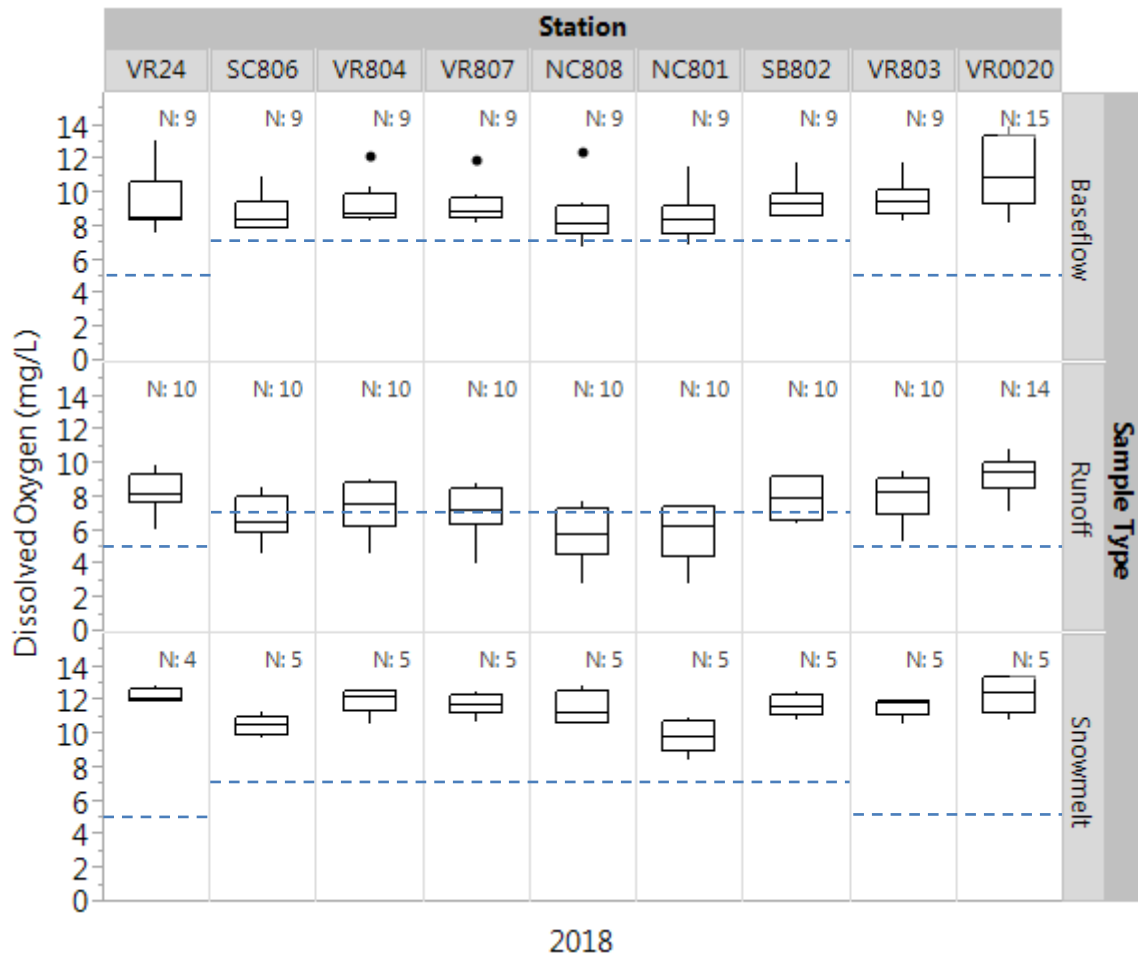
Figure 10. Dissolved oxygen for each station, categorized by sample type, for 2018. Dashed blue lines indicate standards with 7.0 mg/L (2A streams) and 5.0 mg/L (2B streams) as acceptable daily minimums.

In 2018, the median dissolved oxygen concentration was above the lower limit for warm water (2B) streams (5.0 mg/L as daily minimum) and cold water (2A) streams (7.0 mg/L as daily minimum) during baseflow conditions (Figure 10). Median concentrations for runoff samples at five of the nine reaches were above the threshold; median concentrations at SC806, VR807, NC808, and NC801 were at or below the standard threshold. Lower dissolved oxygen levels during or following runoff events could be the result of warmer water that is less capable of holding dissolved oxygen, flux of organic material which increases the biochemical oxygen demand, and/or flushing of warm ponded water or water draining directly from warm impervious surfaces from upstream. Snowmelt samples had relatively high dissolved oxygen medians at all stations. This is expected because the time of year is characterized by very cold water and minor biochemical oxygen demand.

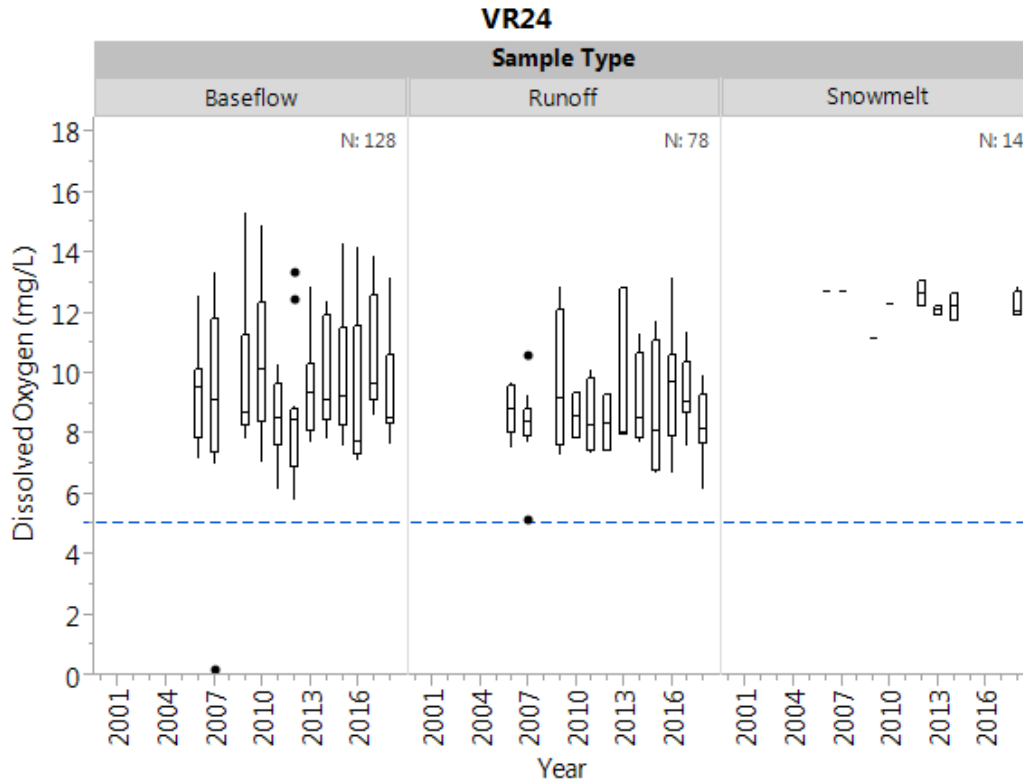
Figure 11a. Historical dissolved oxygen by sample type at VR24. Blue dashed line indicates the acceptable daily minimum DO level for 2B streams (5.0 mg/L) as per the approved state standards.

Historically, snowmelt sample medians for dissolved oxygen were above (not violating) the standard at all stations in all years (Figures 11a-i). Only a few sites (SC806, VR807, NC808, and NC801) had dissolved oxygen medians for baseflow samples that violated the standard during at least one year in the historical record. Runoff events, which often bring warmer water and organic pollutants to the stream, had some of the lowest dissolved oxygen annual medians monitored within the watershed. The three monitoring sites in warm water reaches, VR24, VR803, and VR0020, have a lower minimum dissolved oxygen threshold than the other sites. None of these three had a dissolved oxygen median that fell below the minimum acceptable value in any year with monitoring data.

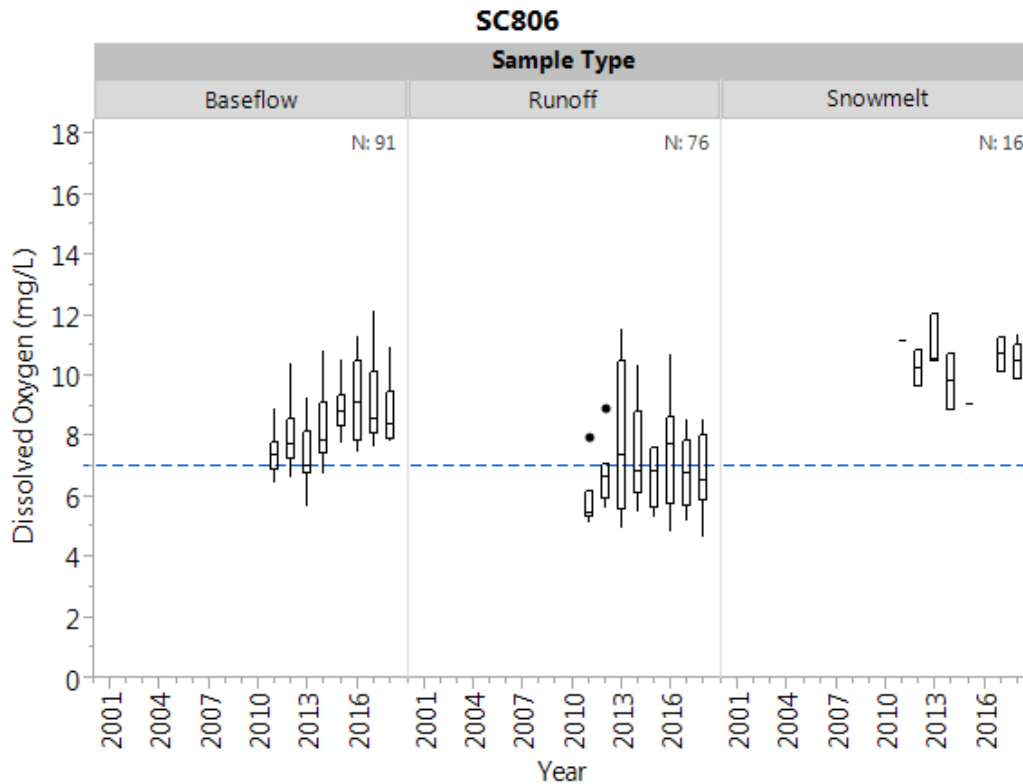
Figure 11b. Historical dissolved oxygen by sample type at SC806. Blue dashed line indicates the acceptable daily minimum DO level for 2A streams (7.0 mg/L) as per the approved state standards.

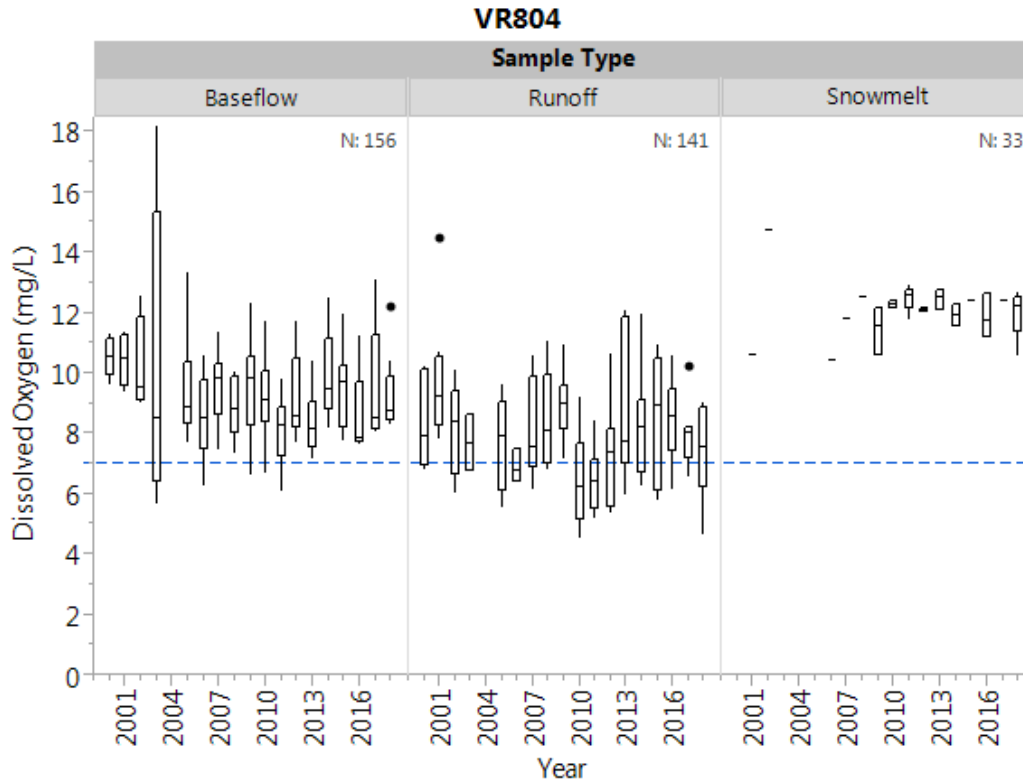
Figure 11c. Historical dissolved oxygen by sample type at VR804. Blue dashed line indicates the acceptable daily minimum DO level for 2A streams (7.0 mg/L) as per the approved state standards.

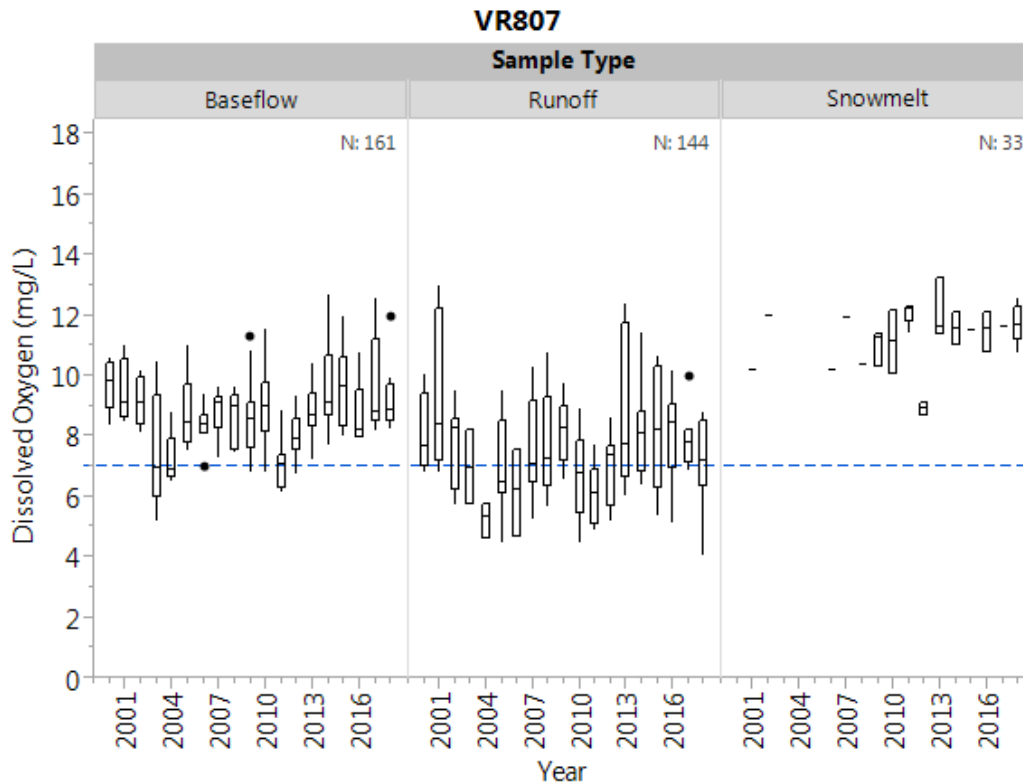
Figure 11d. Historical dissolved oxygen by sample type at VR807. Blue dashed line indicates the acceptable daily minimum DO level for 2A streams (7.0 mg/L) as per the approved state standards.

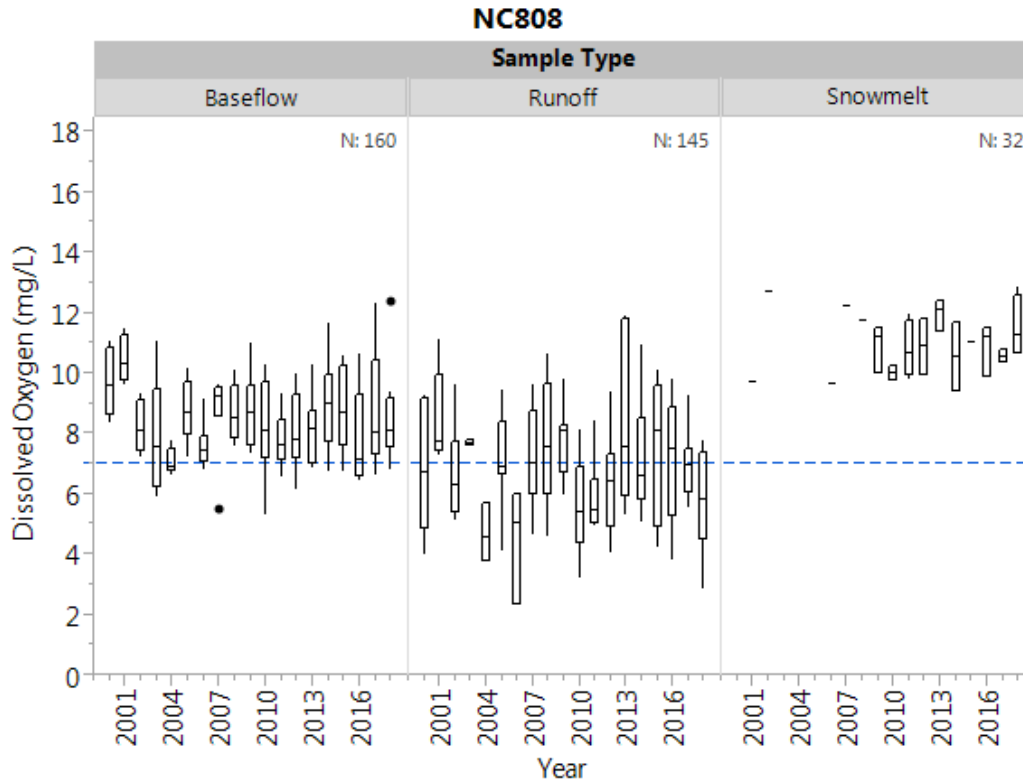
Figure 11e. Historical dissolved oxygen by sample type at NC808. Blue dashed line indicates the acceptable daily minimum DO level for 2A streams (7.0 mg/L) as per the approved state standards.

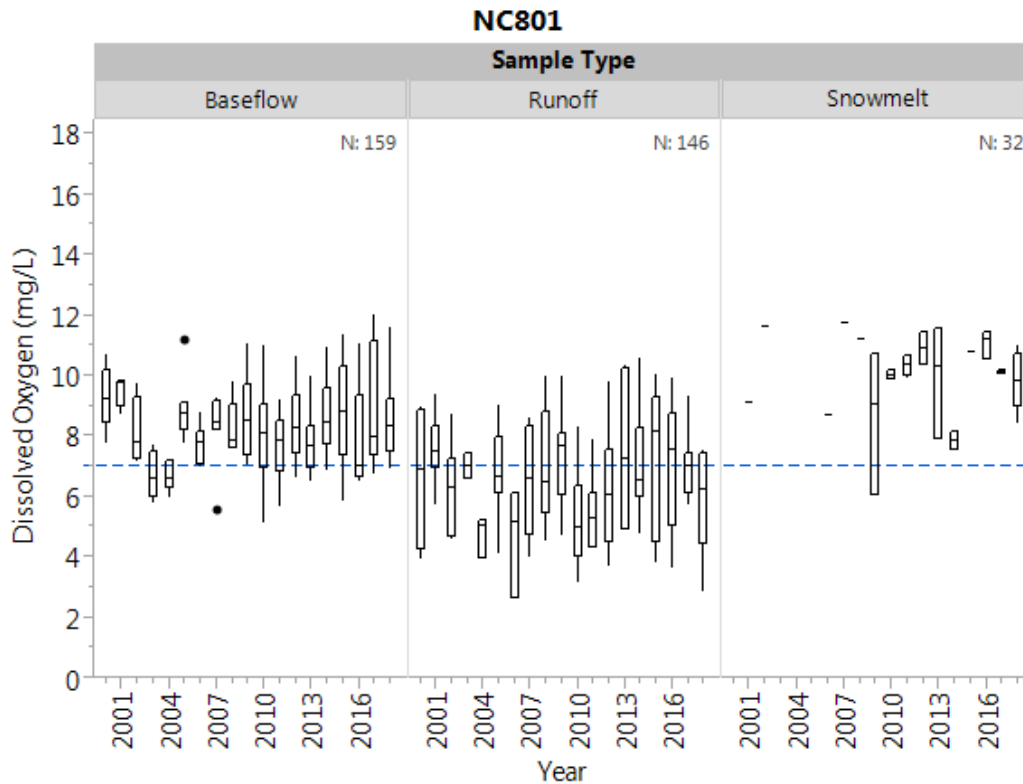
Figure 11f. Historical dissolved oxygen by sample type at NC801. Blue dashed line indicates the acceptable daily minimum DO level for 2A streams (7.0 mg/L) as per the approved state standards.

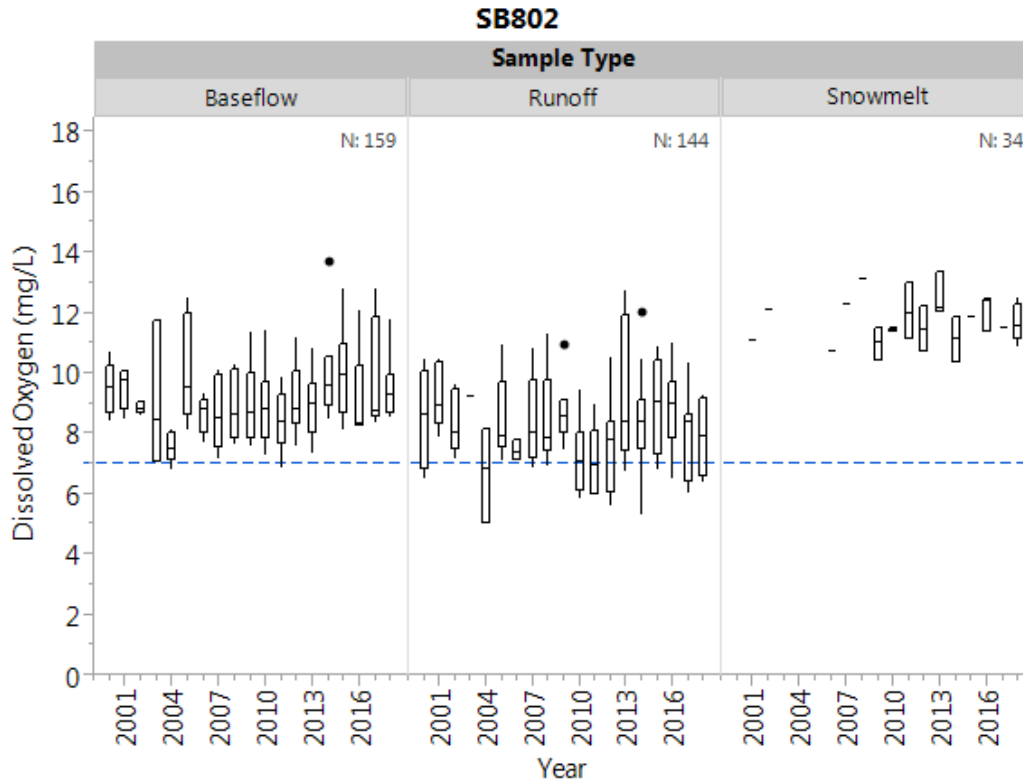
Figure 11g. Historical dissolved oxygen by sample type at SB802. Blue dashed line indicates the acceptable daily minimum DO level for 2A streams (7.0 mg/L) as per the approved state standards.

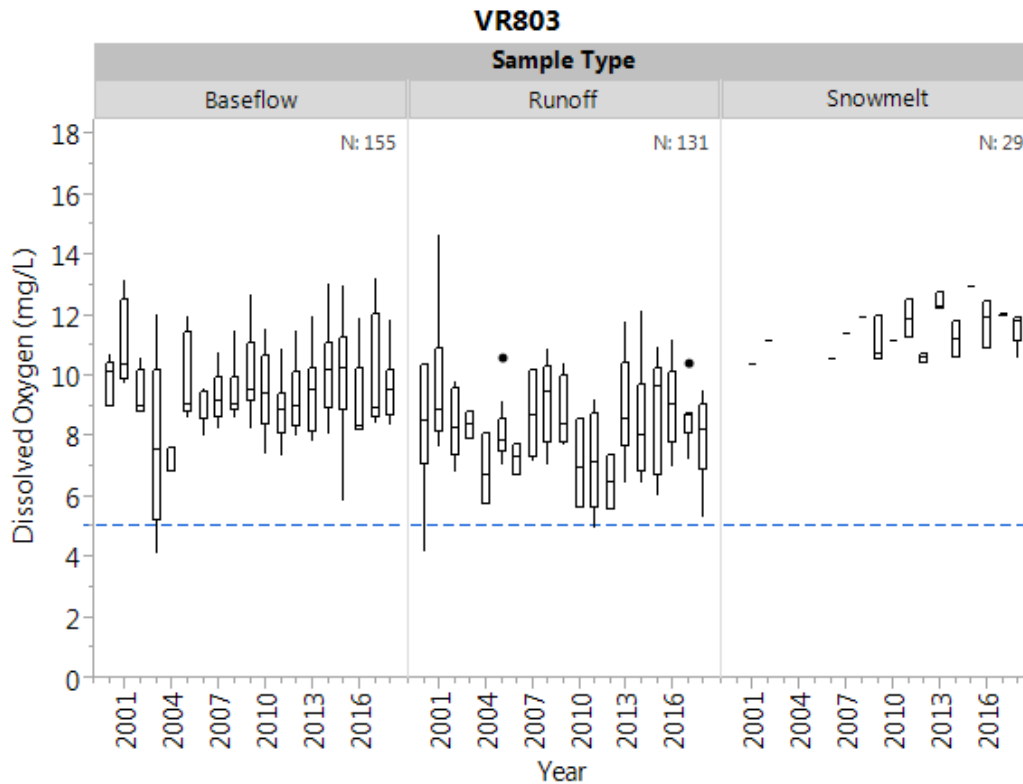
Figure 11h. Historical dissolved oxygen by sample type at VR803. Blue dashed line indicates the acceptable daily minimum DO level for 2B streams (5.0 mg/L) as per the approved state standards.

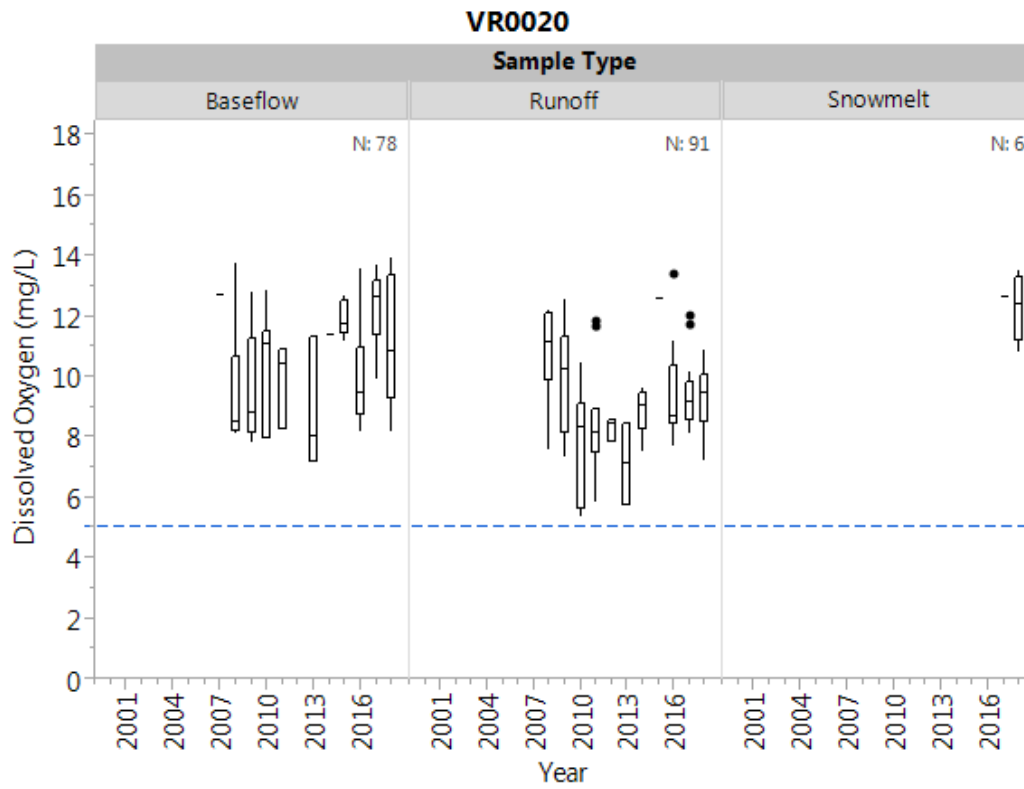
Figure 11i. Historical dissolved oxygen by sample type at VR0020. Blue dashed line indicates the acceptable daily minimum DO level for 2B streams (5.0 mg/L) as per the approved state standards.

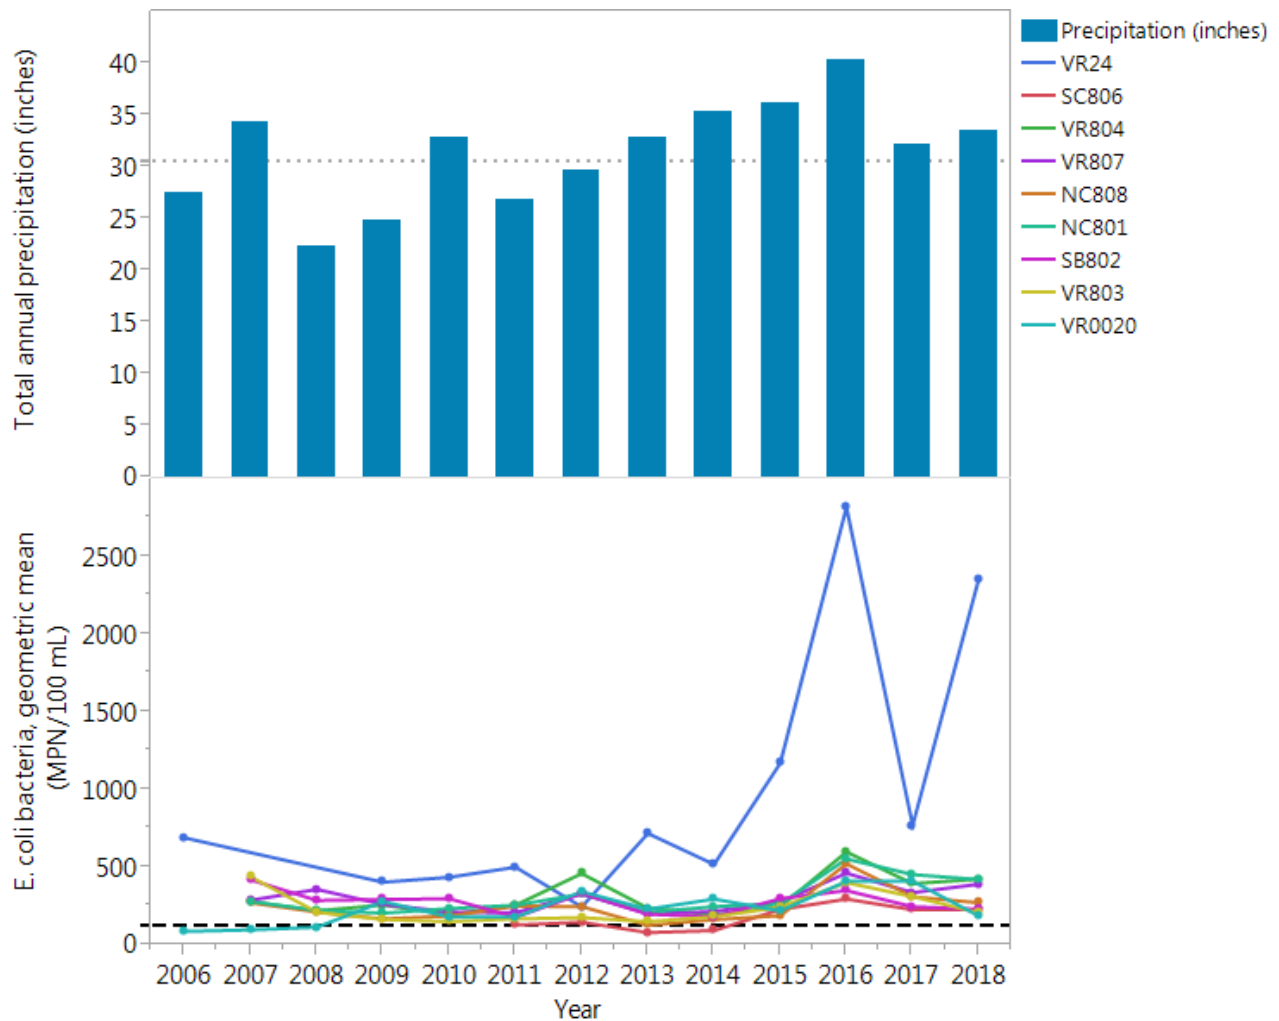
Figure 12. Annual geometric mean of *Escherichia coli* (*E. coli*) bacteria for all stations by year. MPN stands for most probable number of organisms. Black dashed line indicates the 30-day geometric mean standard (for data collected April through October) of ≤ 126 MPN/100 mL. Bars represent total annual precipitation for each year. Gray dotted line indicates the 30 year (1988-2017) total annual average precipitation at the Minneapolis – St. Paul airport weather station of 24.46 inches.

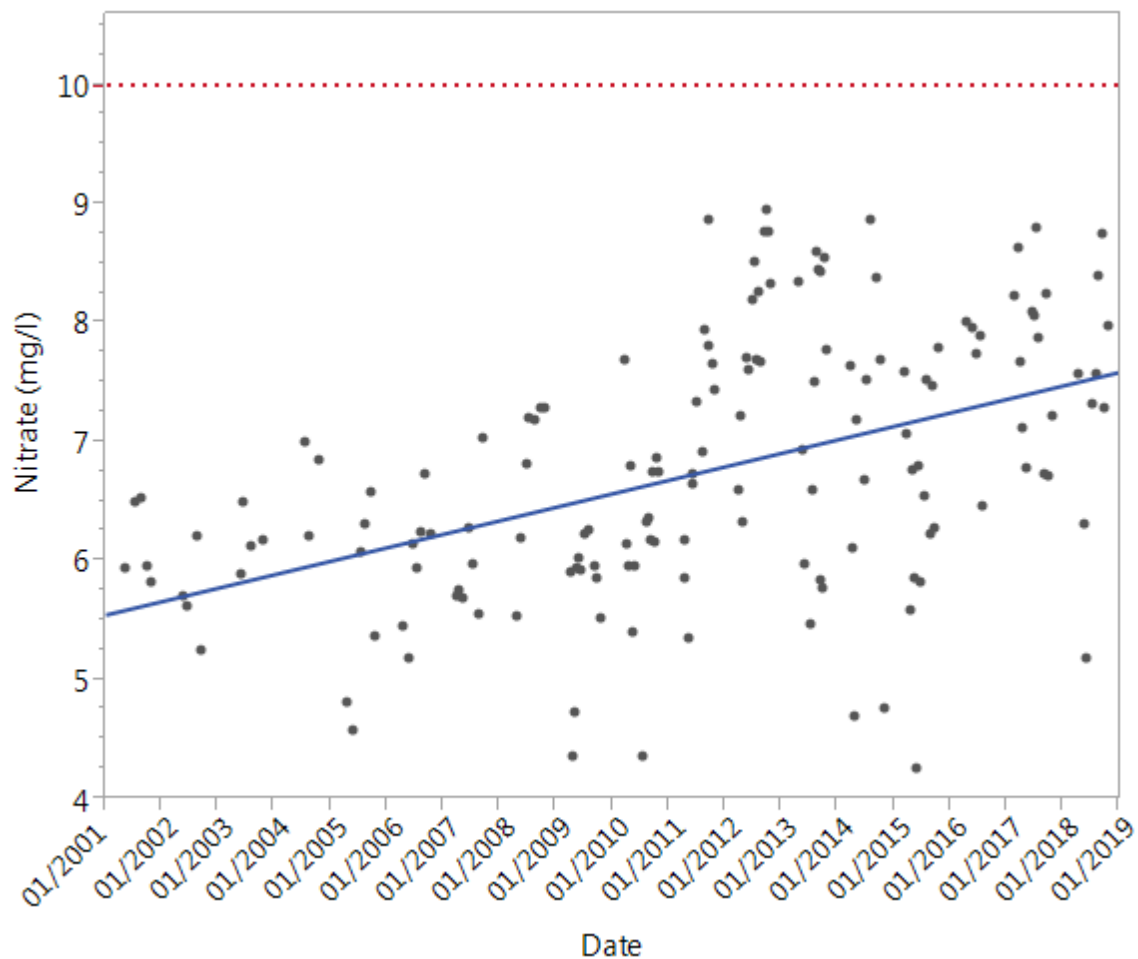
Figure 13. Baseflow nitrate concentration in South Branch Vermillion River, measured at 200th Street East near Highway 52, Dakota County. Samples reflect surface water baseflow conditions (March – October) from 2001 - 2018. Blue solid line represents linear regression. Red dotted line indicates upper limit of state standard, 10 mg/L.

The increasing nitrate in the watershed may be the result of one of the following factors - 1) an increase in the amount of drain tile installed, 2) the turnover of marginal land not in production (or lands in conservation programs) to lands in production with concurrent nitrogen application, 3) poor nutrient management resulting in the improper rate, source, time or placement of nitrogen fertilizers, or 4) an increase in the total acreage of agricultural land in the watershed, which in turn results in greater application of fertilizer to said land. All of these factors can result in elevated nitrate levels in the soil,
