Vermillion River Monitoring Network 2018 Annual Report

*Prepared for the Vermillion River Watershed Joint Powers Organization
by the Dakota County Soil and Water Conservation District*

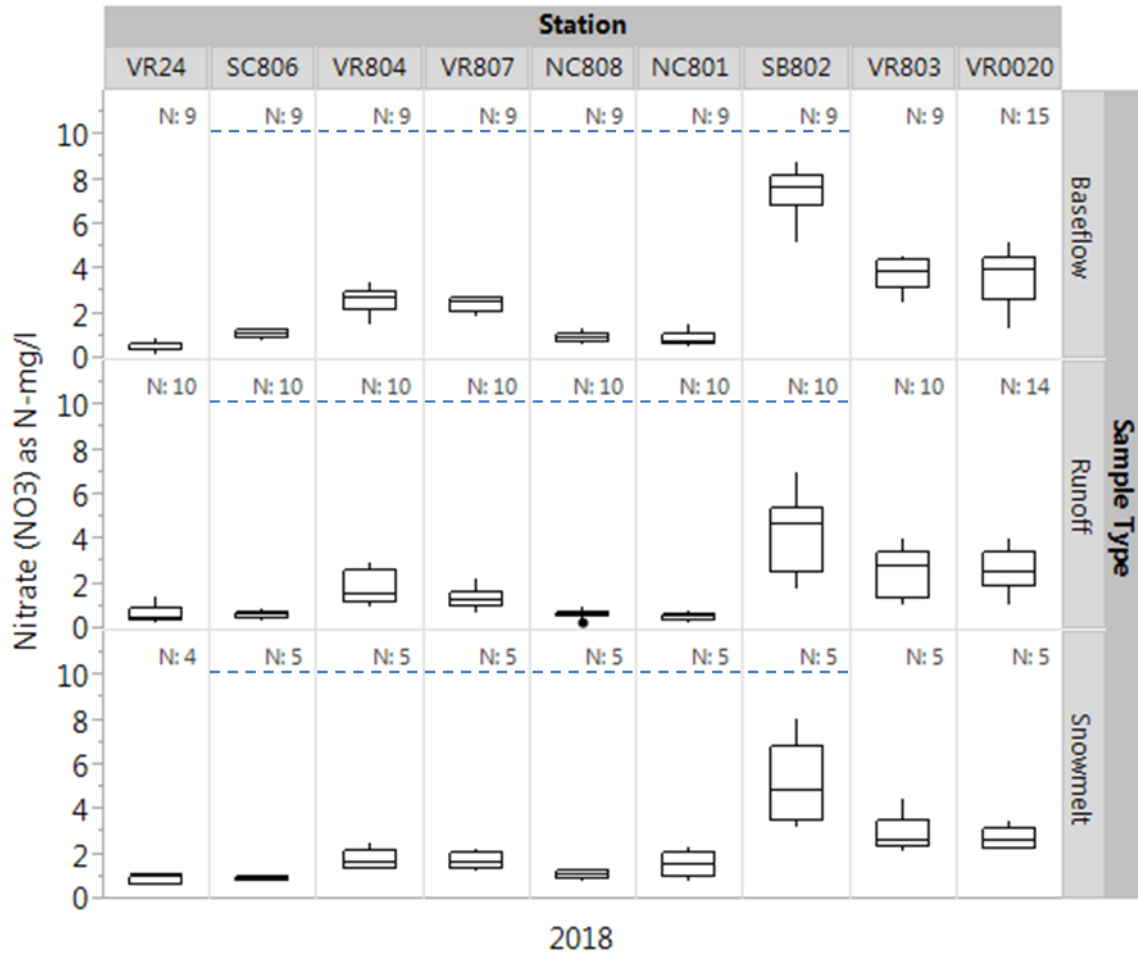
Figure 14. Nitrate nitrogen for each station, categorized by sample type, for 2018. Blue dashed line represents the domestic consumption state standard (≤ 10 mg/L).

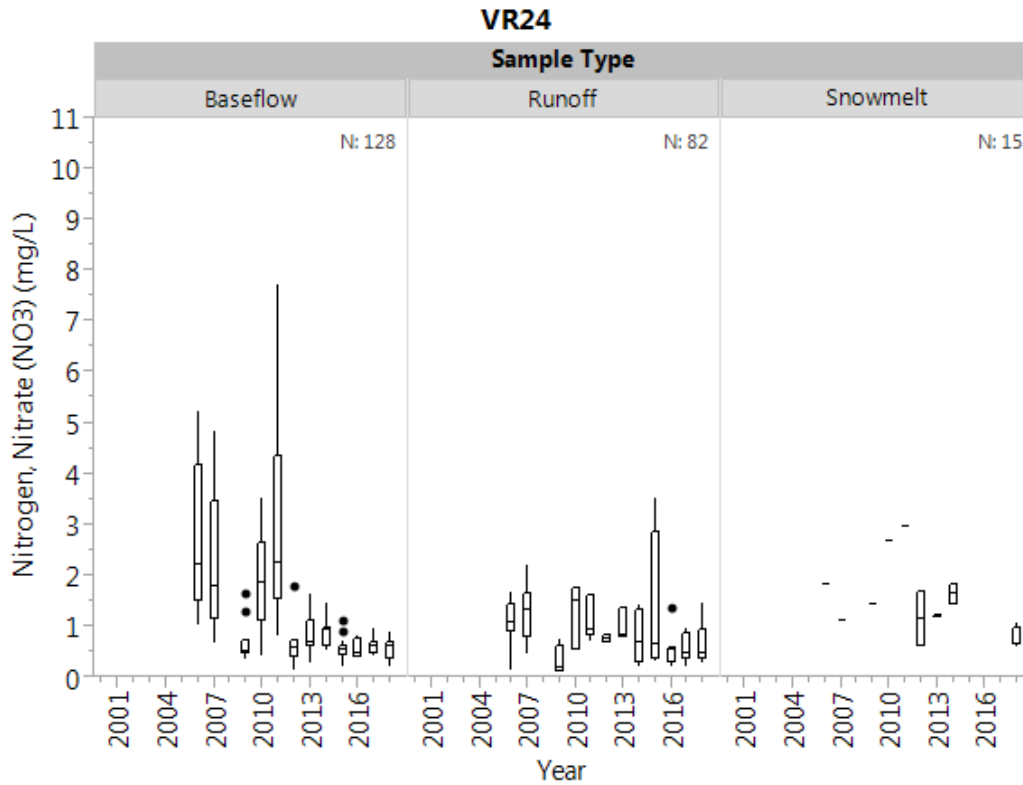
Figure 15a. Historical nitrate by sample type for VR24. The domestic consumption standard (≤ 10 mg/L) does not apply to 2B streams.

Historical nitrate nitrogen levels for each station are shown in Figures 15a - i. Nitrate concentrations at VR803 have dropped in 2007 which corresponds to the updates (2006) and eventual rerouting (2008) of the Empire WWTP. Since 2008, both baseflow and runoff sample concentrations have dropped. When looking at the historical record, VR24 shows higher nitrate concentrations in previous years. Rerouting the Elko New Market WWTP in 2012 may explain the apparent drop in median concentration in the same year.

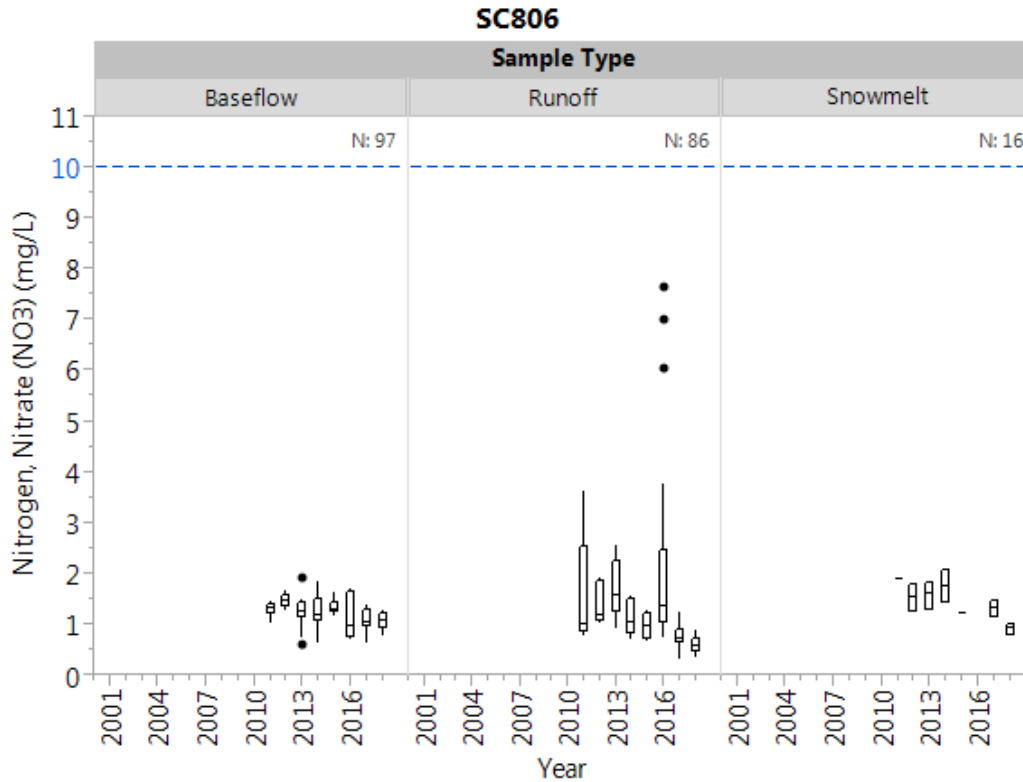
Figure 15b. Historical nitrate by sample type for SC806. Blue dashed line indicates the domestic consumption standard of ≤ 10 mg/L.

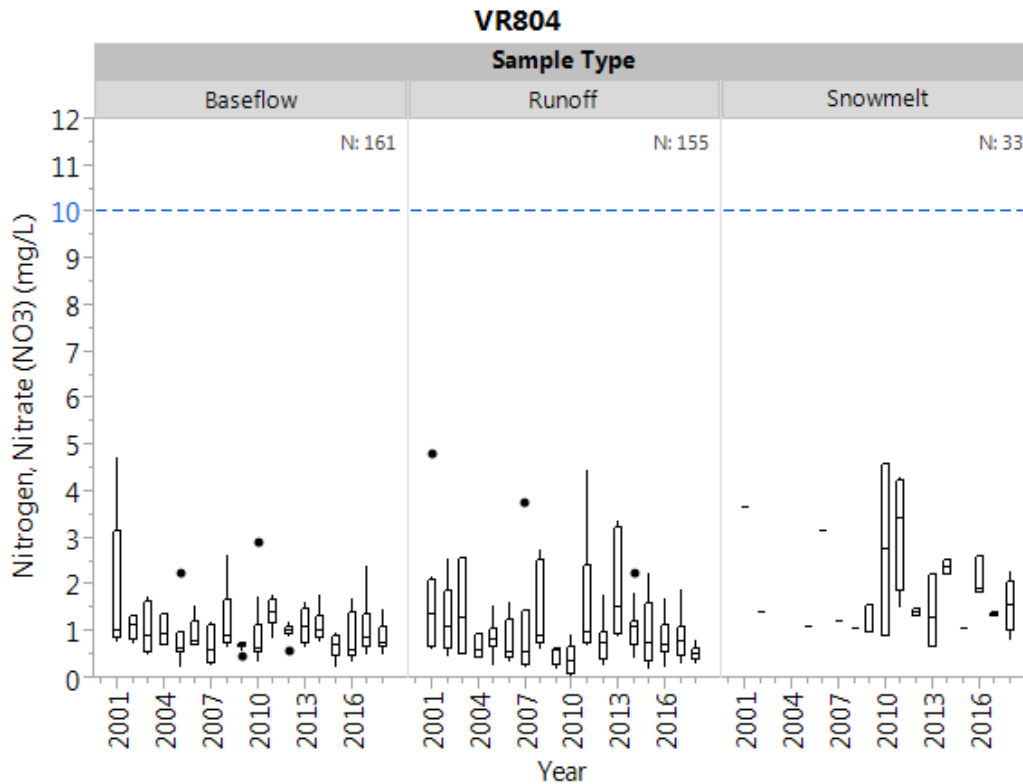
Figure 15c. Historical nitrate by sample type for VR804. Blue dashed line indicates the domestic consumption standard of ≤ 10 mg/L.

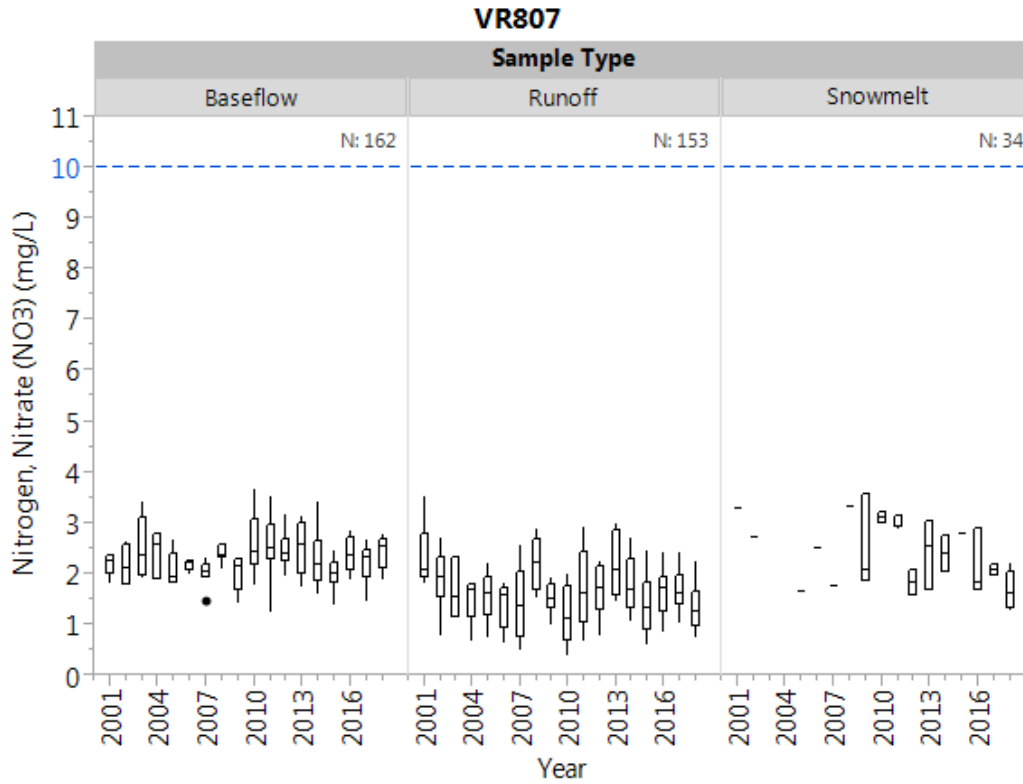
Figure 15d. Historical nitrate by sample type for VR807. Blue dashed line indicates the domestic consumption standard of ≤ 10 mg/L.

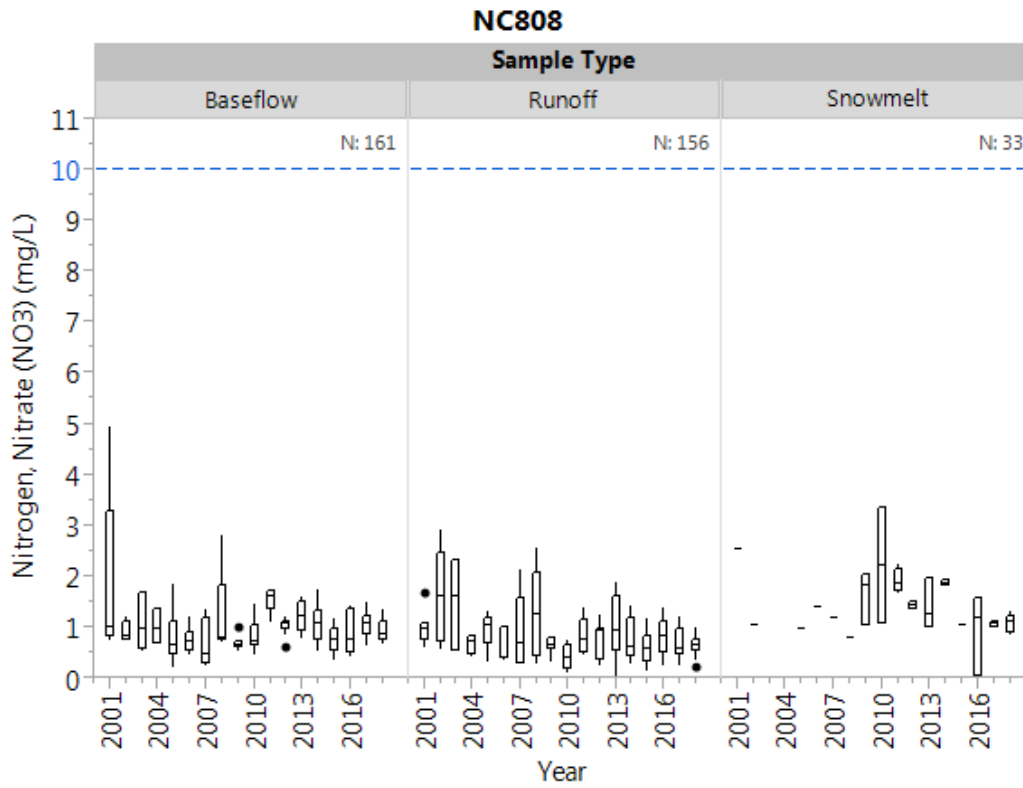
Figure 15e. Historical nitrate by sample type for NC808. Blue dashed line indicates the domestic consumption standard of ≤ 10 mg/L.

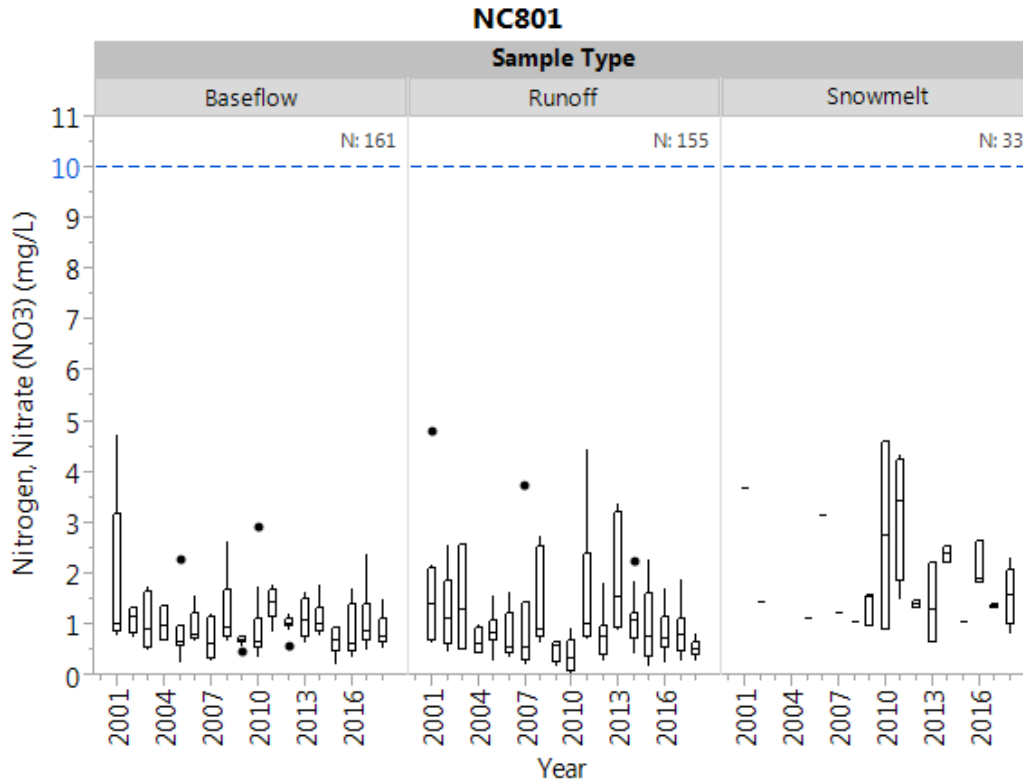
Figure 15f. Historical nitrate by sample type for NC801. Blue dashed line indicates the domestic consumption standard of ≤ 10 mg/L.

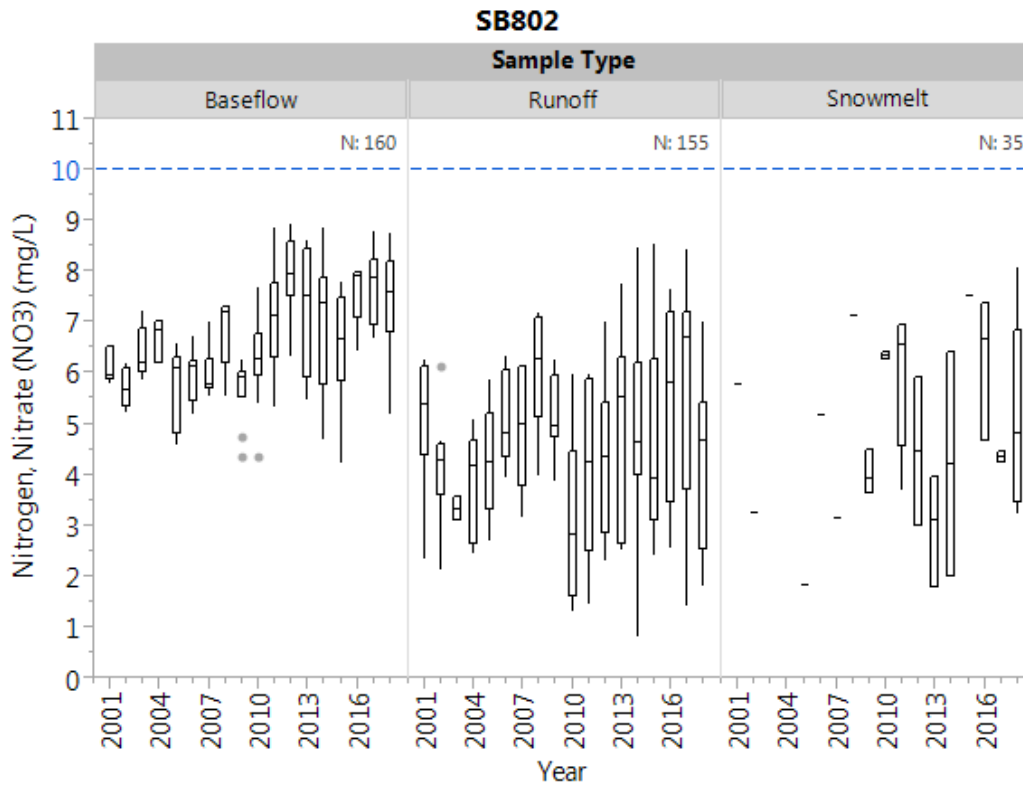
Figure 15g. Historical nitrate by sample type for SB802. Blue dashed line indicates the domestic consumption standard of ≤ 10 mg/L.

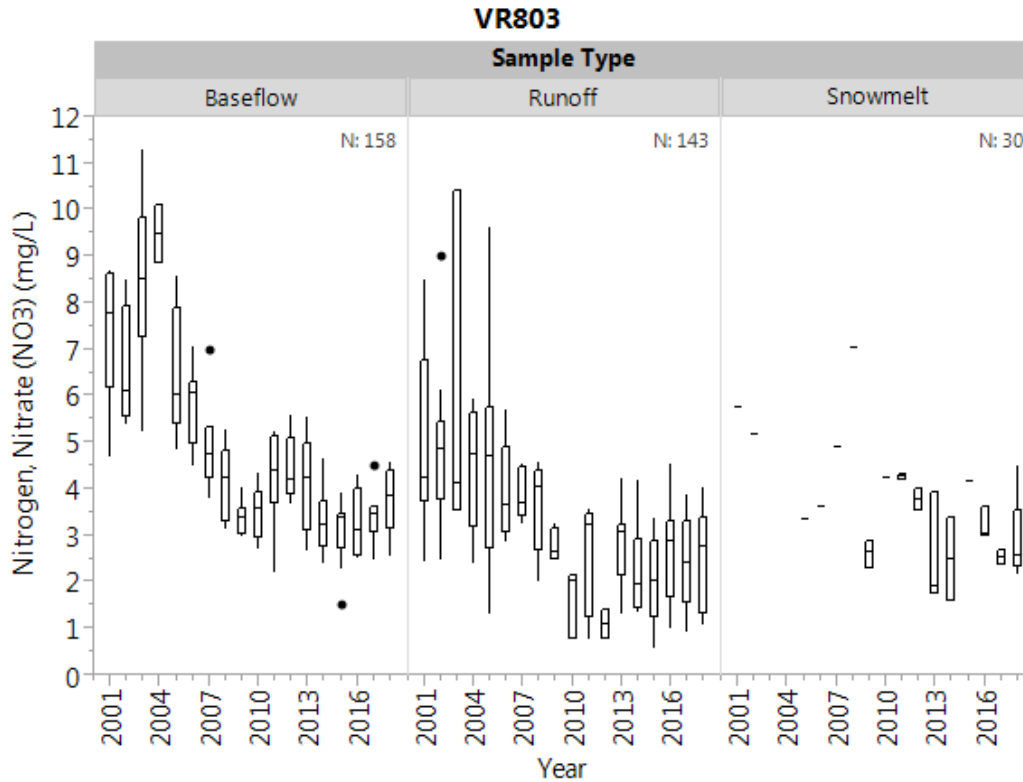
Figure 15h. Historical nitrate by sample type for VR803. The domestic consumption standard (≤ 10 mg/L) does not apply to 2B streams.

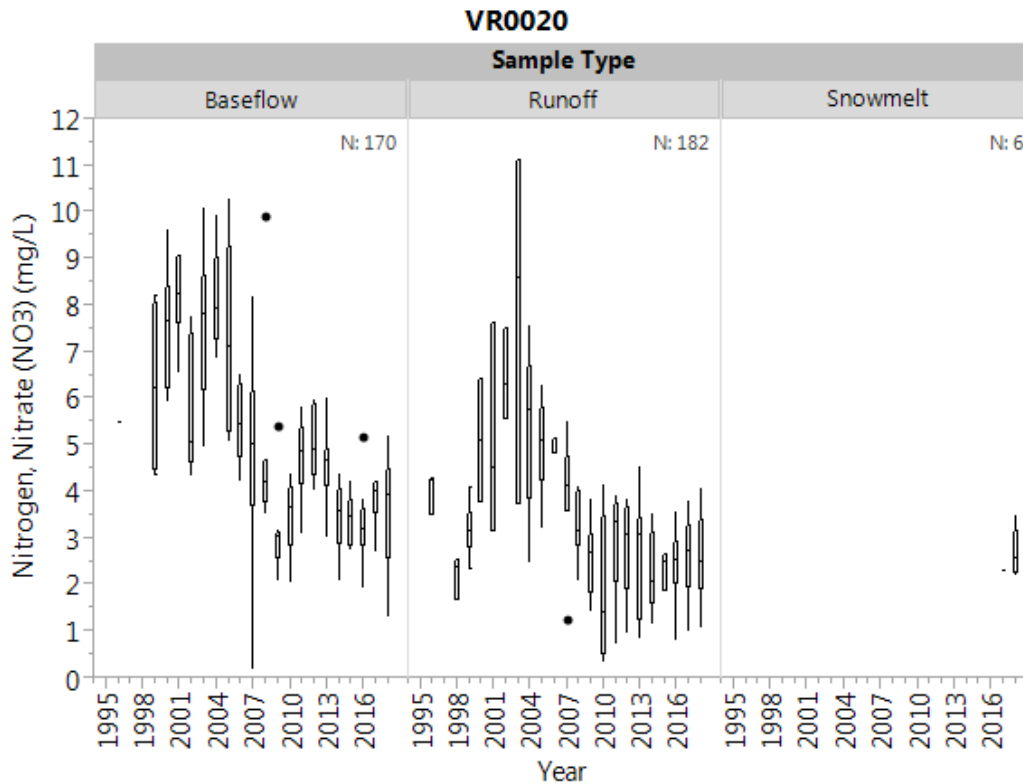
Figure 15i. Historical nitrate by sample type for VR0020. The domestic consumption standard (≤ 10 mg/L) does not apply to 2B streams.

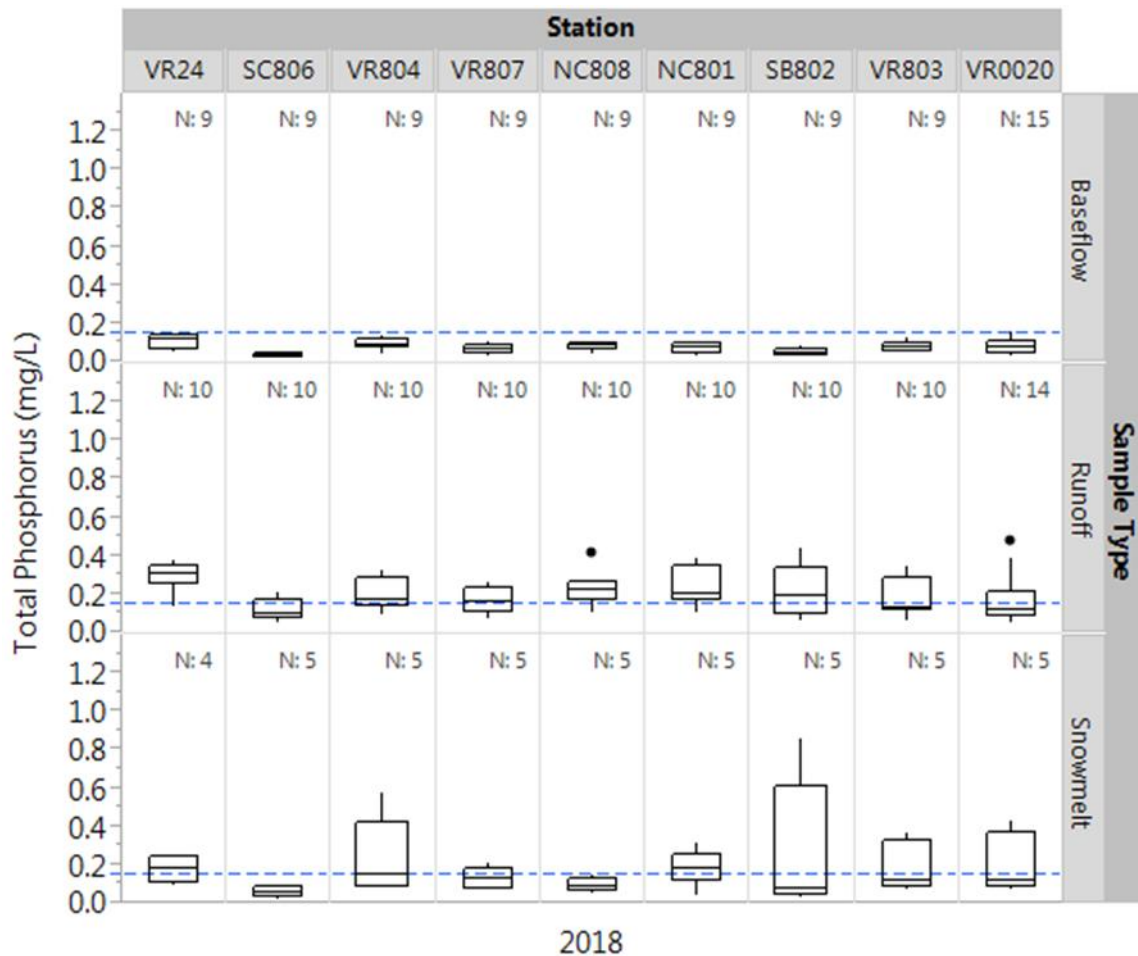
Figure 16. Total phosphorus (TP) for each station, categorized by sample type, for 2018. Blue dashed line represents the state standard for total phosphorus, ≤ 0.15 mg/L.

Figure 16 shows total phosphorus (TP) for each station categorized by sample type. All stations had a median baseflow TP concentration below the state standard of 0.15mg/L. The median for runoff samples was above the standard at the majority of monitoring sites. Individual samples exceeded the standard at all of the monitoring sites during runoff conditions. Phosphorus levels during snowmelt events varied, with the median phosphorus level below the standard in seven of the nine monitoring sites in the watershed.

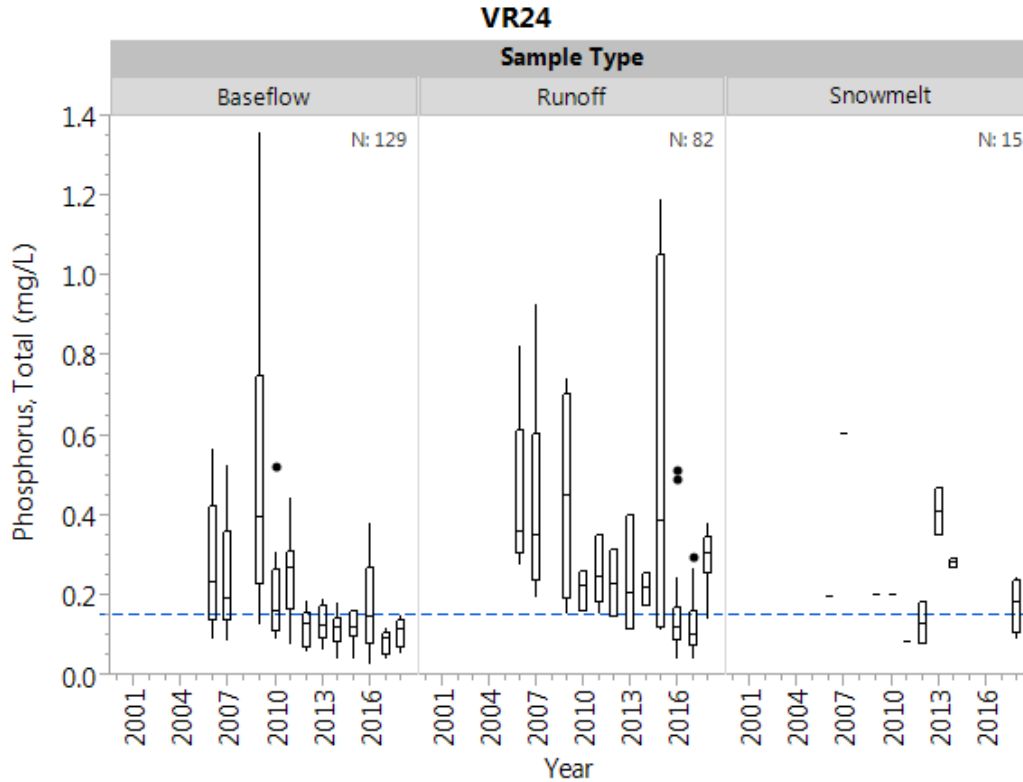
Figure 17a. Historical total phosphorus by sample type at VR24. Blue dashed line indicates state phosphorus standard of ≤ 0.15 mg/L.

Historical total phosphorus data for each station are shown in Figures 17a - i. At station VR24, data has been collected annually since 2006, except in 2008 when no samples were collected. For the seventh year in a row, the TP baseflow median was at or below the state standard at VR24. Unlike 2016, the TP median for runoff samples was near or above the state standard for the majority of sites showing an increase in median concentrations from the last few years.

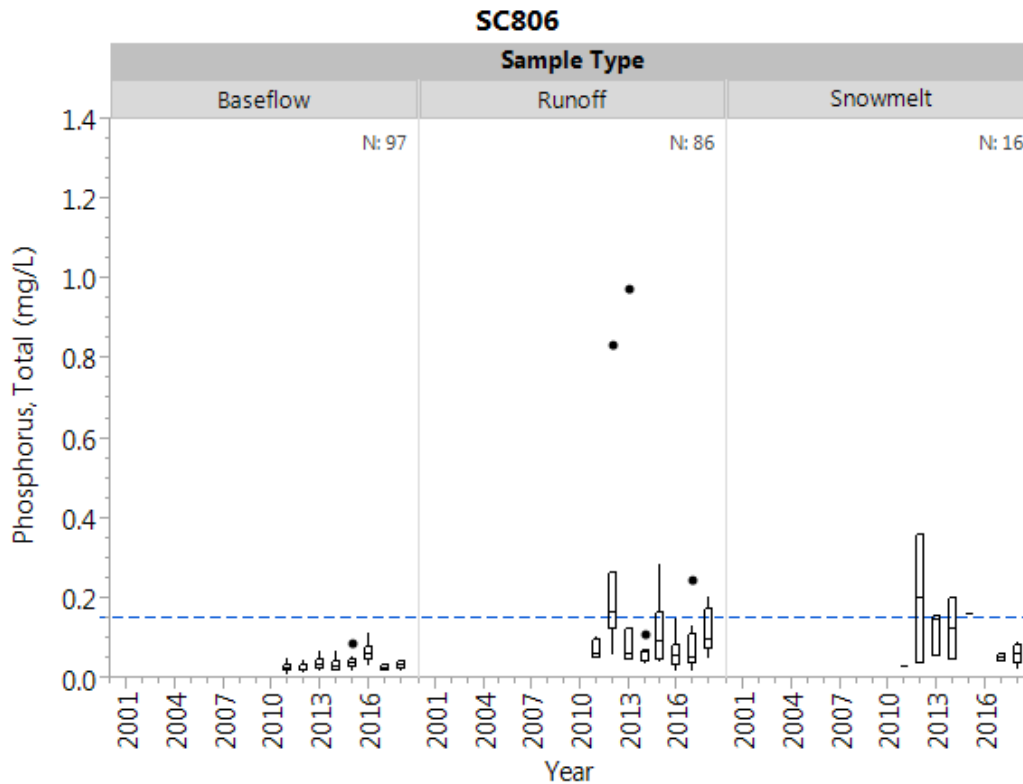
Figure 17b. Historical total phosphorus by sample type at SC806. Blue dashed line indicates state phosphorus standard of ≤ 0.15 mg/L.

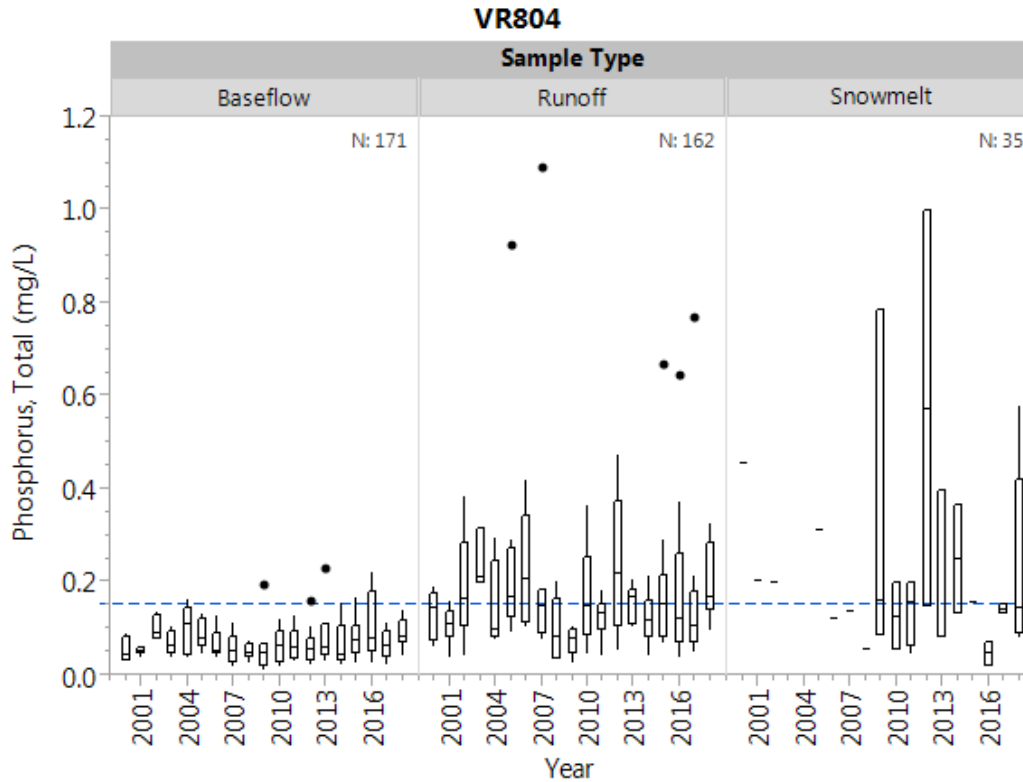
Figure 17c. Historical total phosphorus by sample type at VR804. Blue dashed line indicates state phosphorus standard of ≤ 0.15 mg/L.

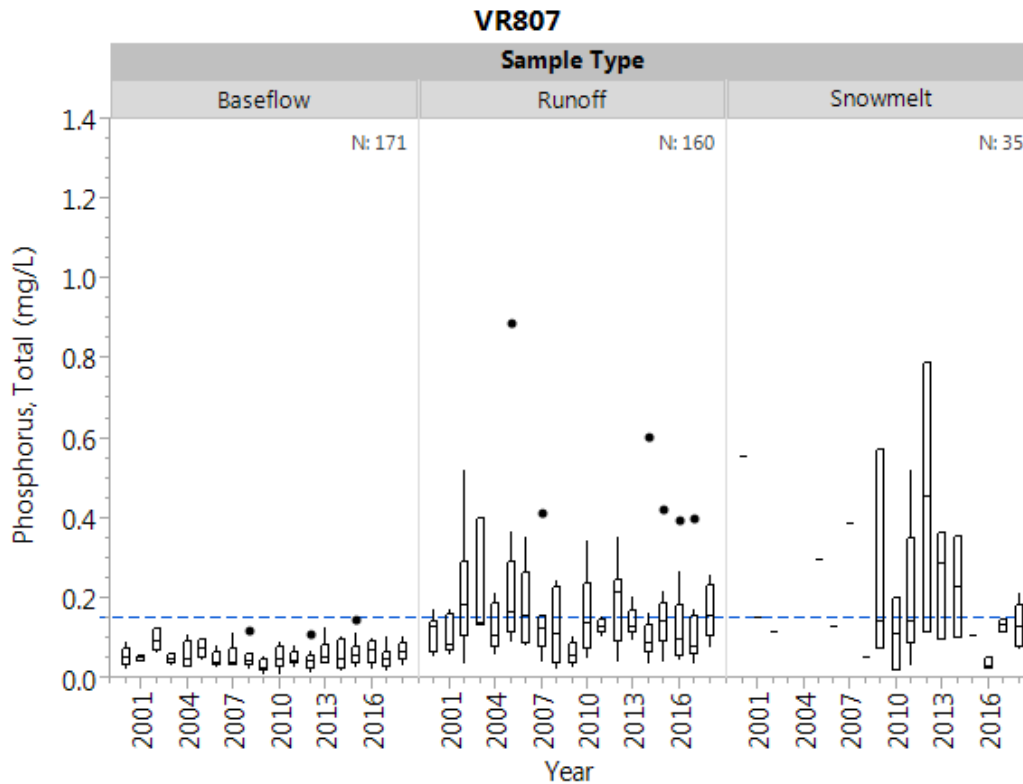
Figure 17d. Historical total phosphorus by sample type at VR807. Blue dashed line indicates state phosphorus standard of ≤ 0.15 mg/L.

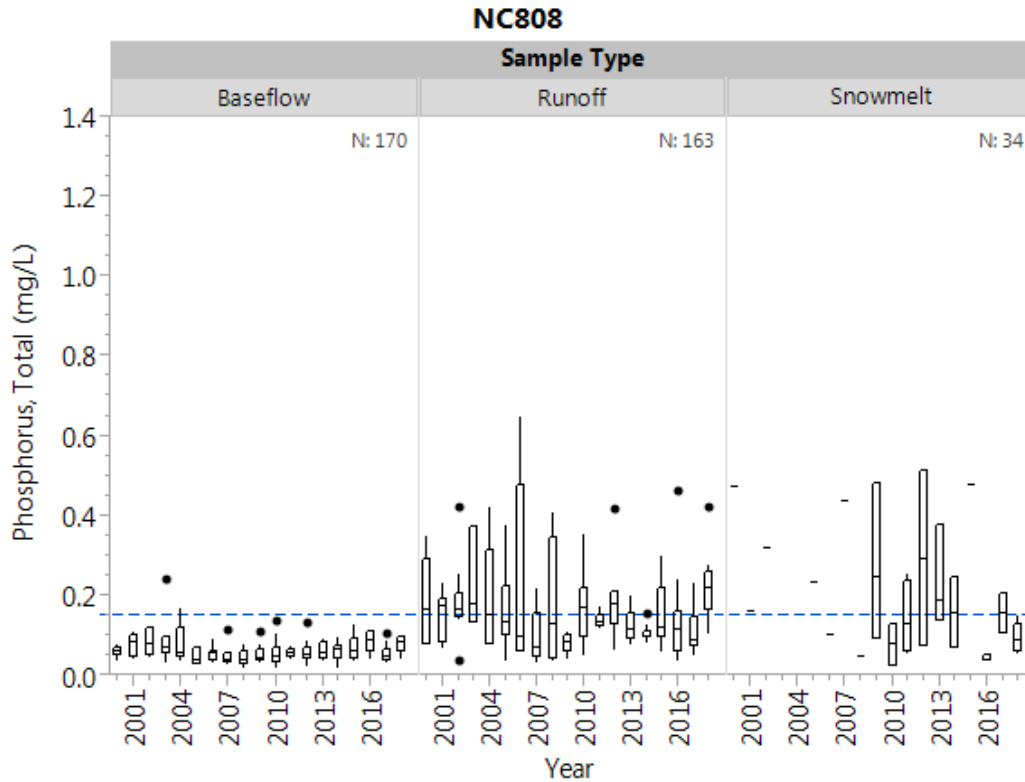
Figure 17e. Historical total phosphorus by sample type at NC808. Blue dashed line indicates state phosphorus standard of ≤ 0.15 mg/L.

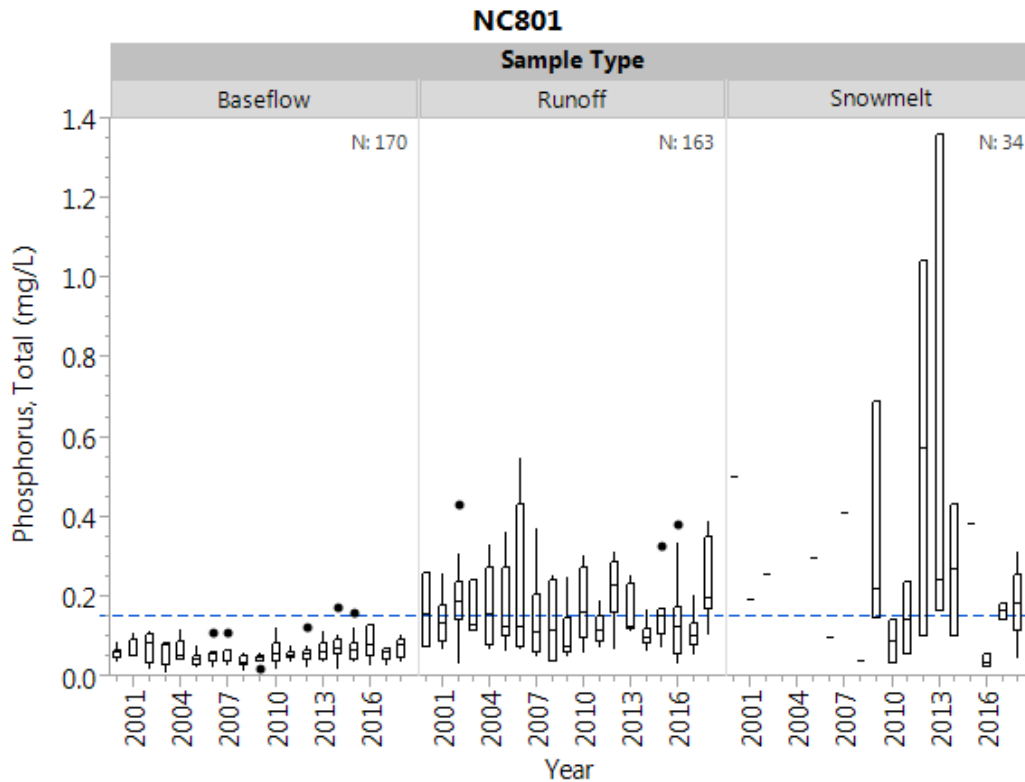
Figure 17f. Historical total phosphorus by sample type at NC801. Blue dashed line indicates state phosphorus standard of ≤ 0.15 mg/L.

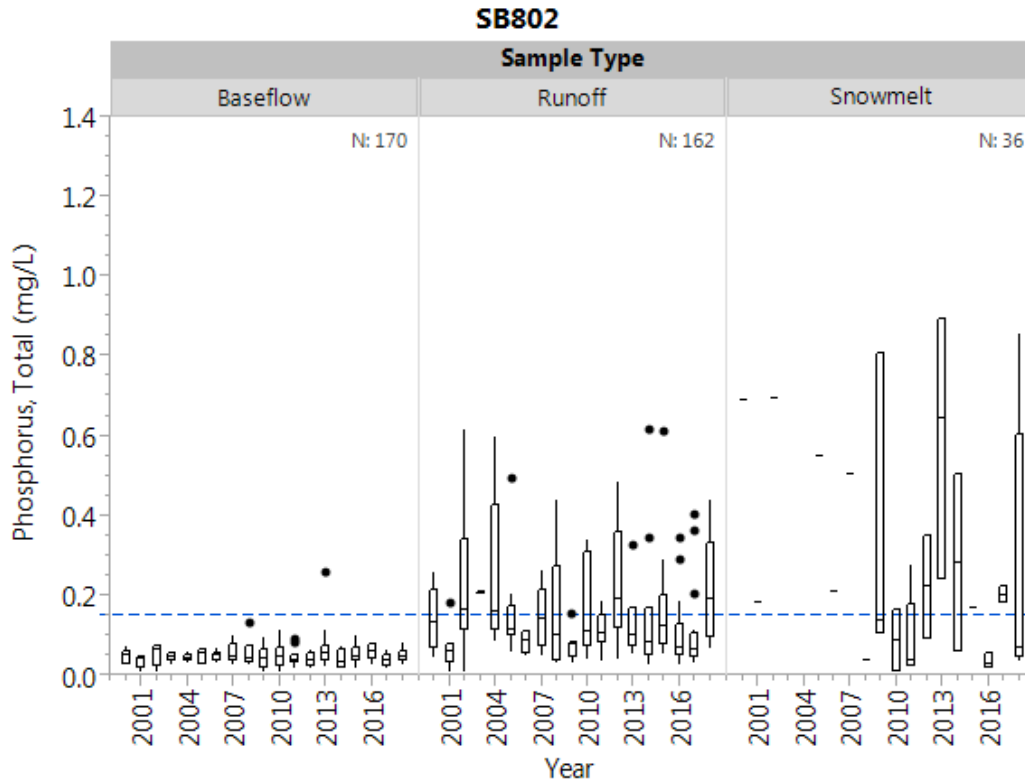
Figure 17g. Historical total phosphorus by sample type at SB802. Blue dashed line indicates state phosphorus standard of ≤ 0.15 mg/L.

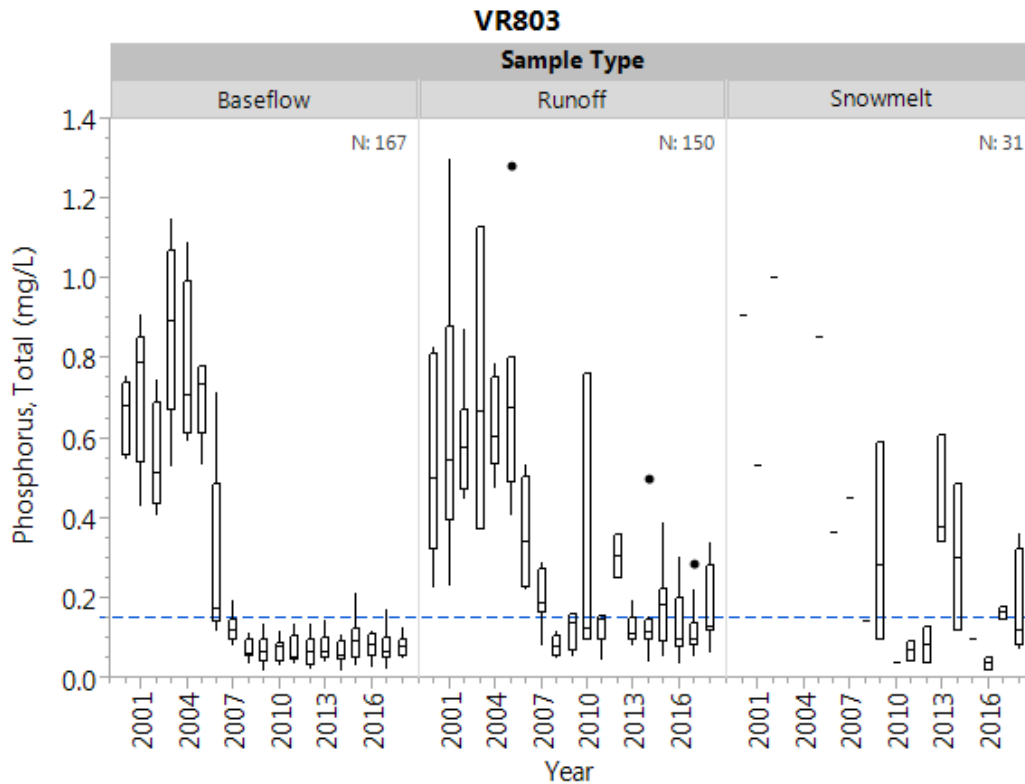
Figure 17h. Historical total phosphorus by sample type at VR803. Blue dashed line indicates state phosphorus standard of ≤ 0.15 mg/L.

In 2006, the Empire Wastewater Treatment Plant went through some upgrades which had a positive impact on water quality, reducing the total phosphorus downstream of the plant. TP at VR803 and VR0020 prior to 2006 was high during baseflow conditions, exceeding the proposed standard every year, and by a large margin. Since the upgrades, the baseflow TP median dropped below the proposed standard. TP measured during runoff conditions and snowmelt has also been noticeably reduced since 2006. Rerouting of the wastewater treatment plant in 2008 further benefitted water quality in the Vermillion River Watershed as effluent bypassed the Vermillion River and discharged directly into the Mississippi River.

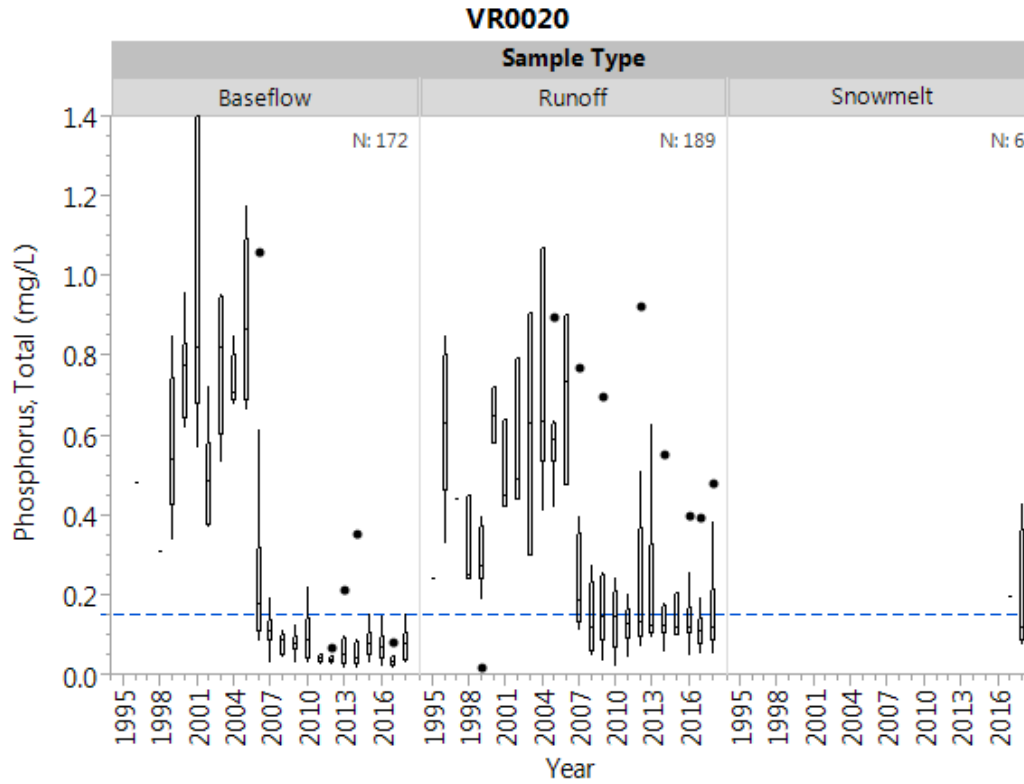
Figure 17i. Historical total phosphorus by sample type at VR0020. Blue dashed line indicates state phosphorus standard of ≤ 0.15 mg/L. **VR0020 maximum for 2001 baseflow sample extends to 4 mg/L.

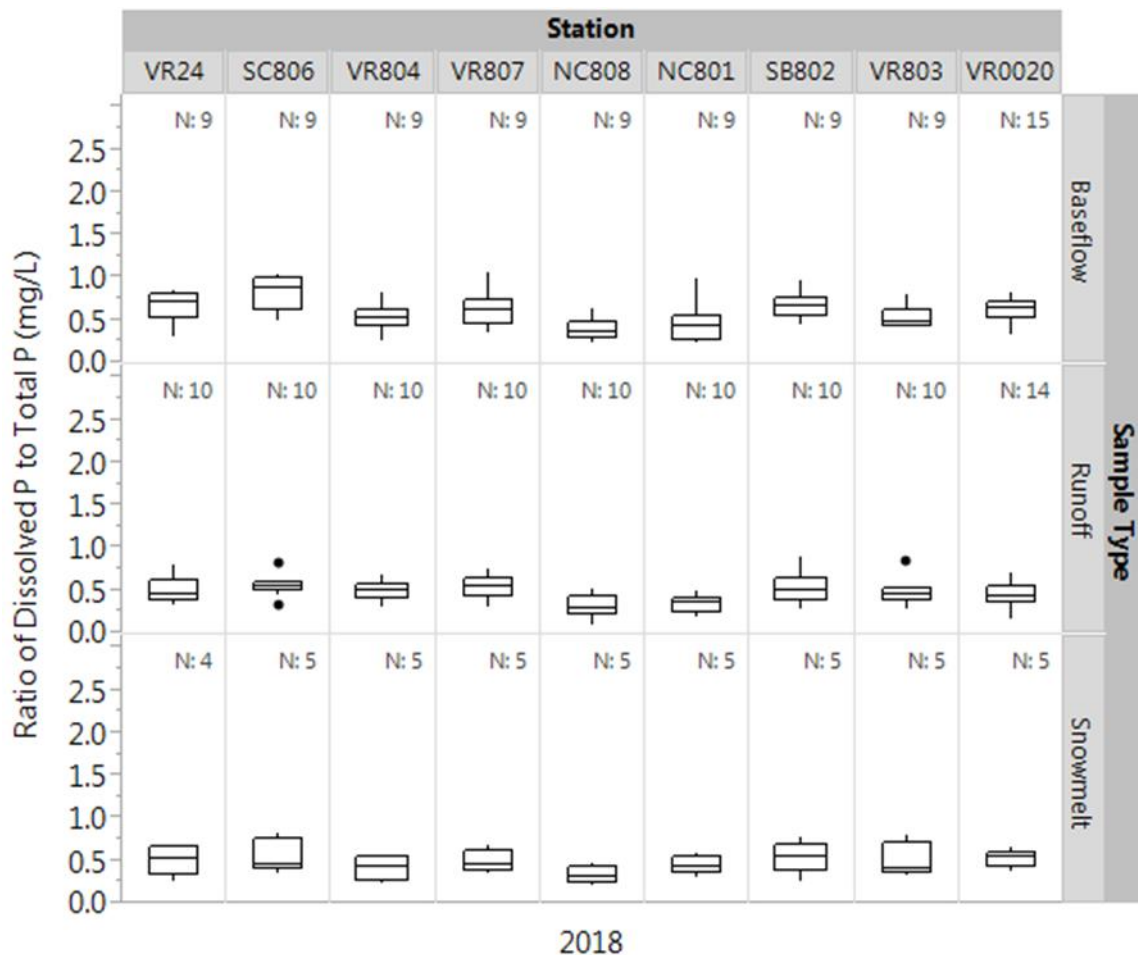
Figure 18. Ratio of dissolved phosphorus (TDP) to total phosphorus (TP) for each station, categorized by sample type, for 2018.

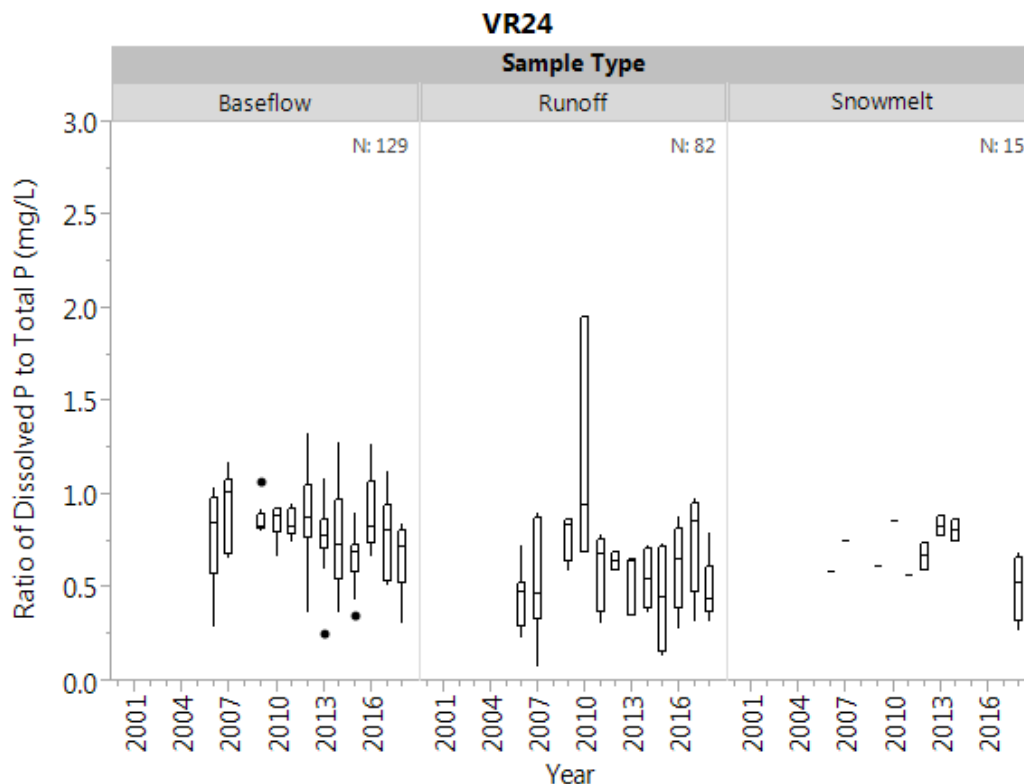
Figure 19a. Historical ratio of dissolved phosphorus to total phosphorus by sample type at VR24.

Historical TDP to TP ratio boxplots for each station are shown in Figures 19a - i. The TDP:TP ratios for runoff samples were generally lower than that of baseflow samples, which is in continuation of the trend for all sites when considering the historical data. Runoff event samples contain more suspended particulate material which has phosphorus adsorbed to it. This particulate phosphorus could be washed in from the land surface and/or resuspended from the stream bed resulting in a higher TDP to TP ratio.

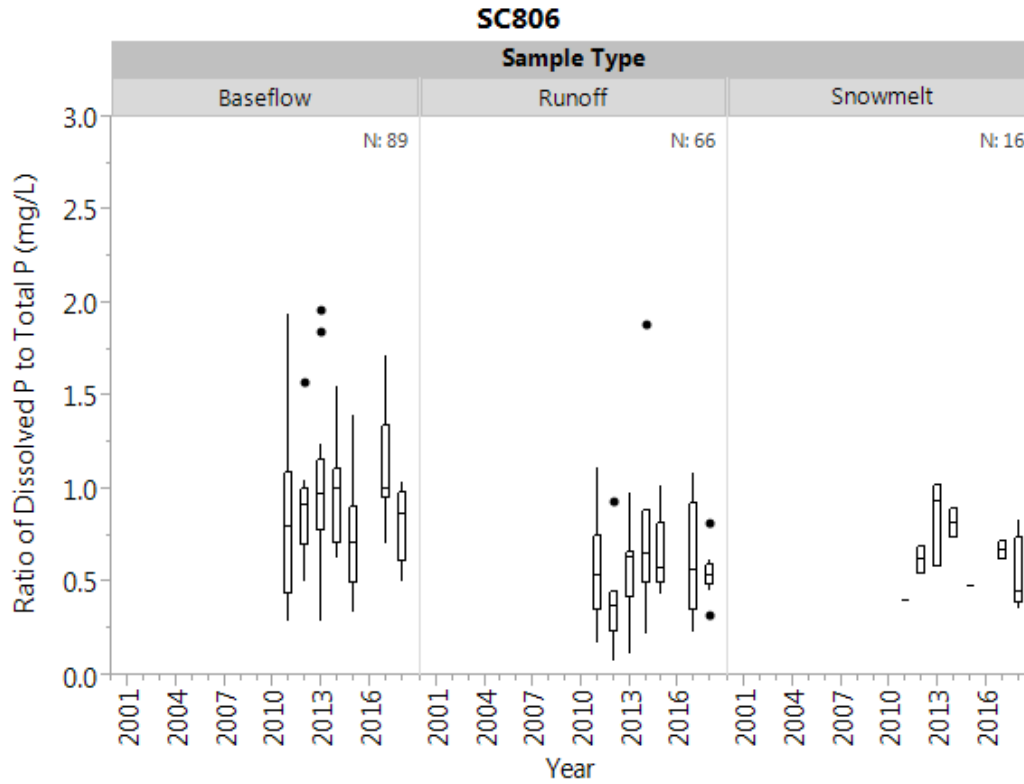
Figure 19b. Historical ratio of dissolved phosphorus to total phosphorus by sample type at SC806.

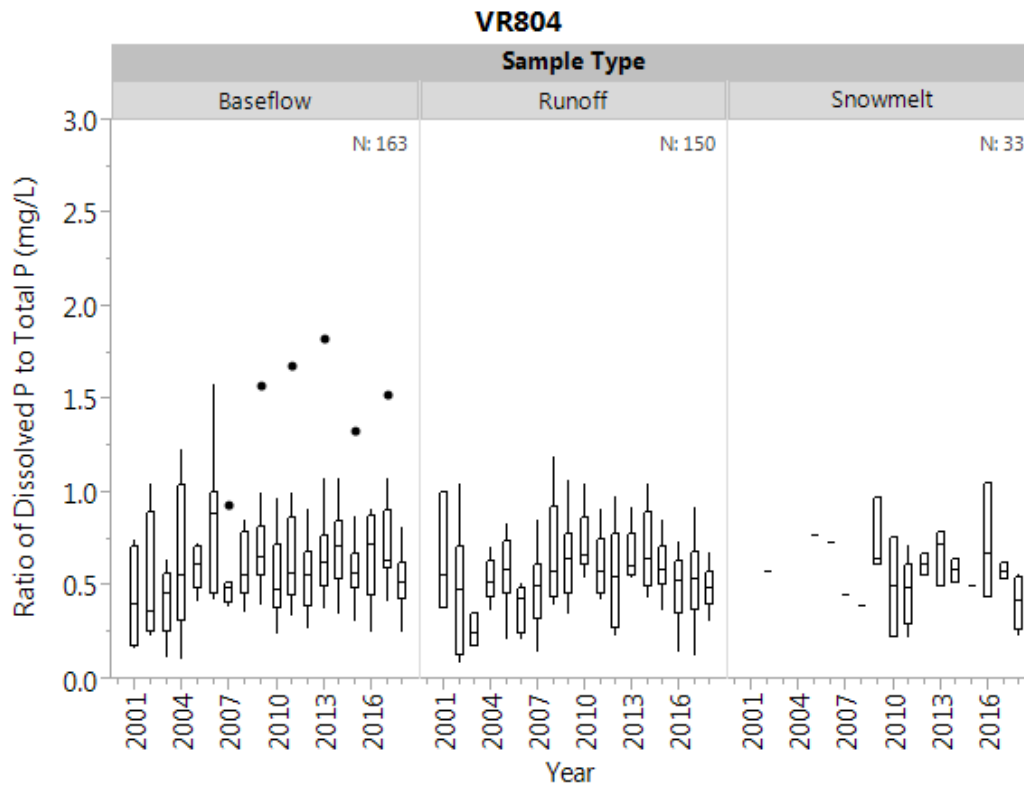
Figure 19c. Historical ratio of dissolved phosphorus to total phosphorus by sample type at VR804.

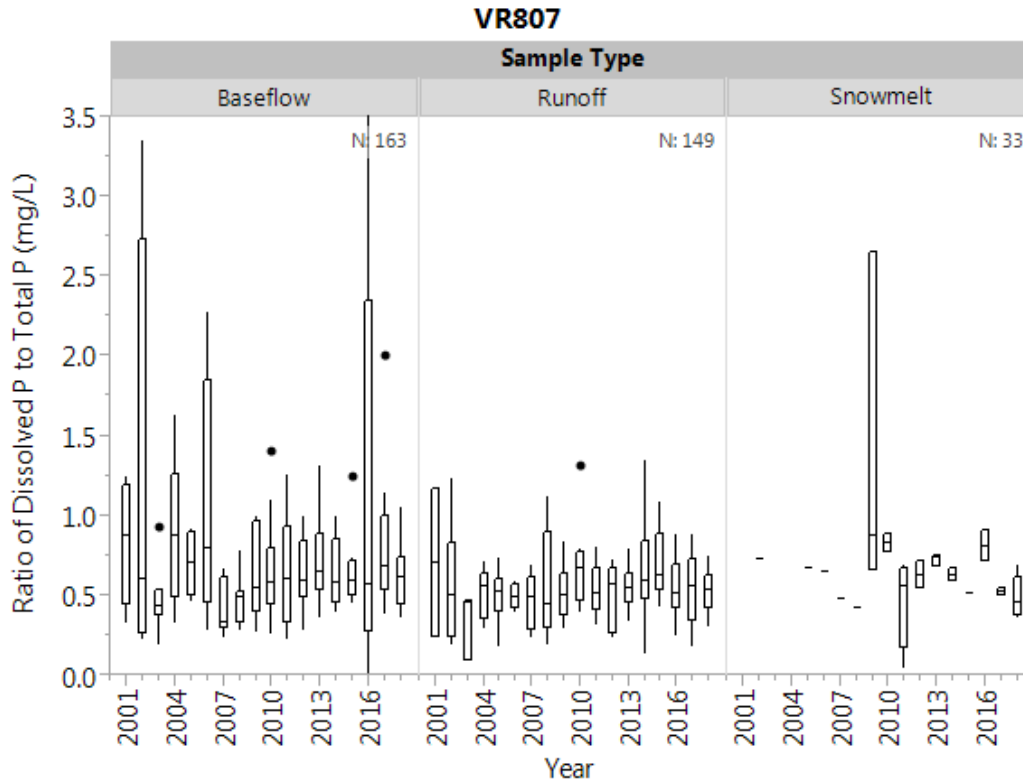
Figure 19d. Historical ratio of dissolved phosphorus to total phosphorus by sample type at VR807.
 **VR807 maximum for 2016 baseflow sample extends to 3.77 mg/L.
