Vermillion River Monitoring Network 2018 Annual Report

*Prepared for the Vermillion River Watershed Joint Powers Organization
by the Dakota County Soil and Water Conservation District*

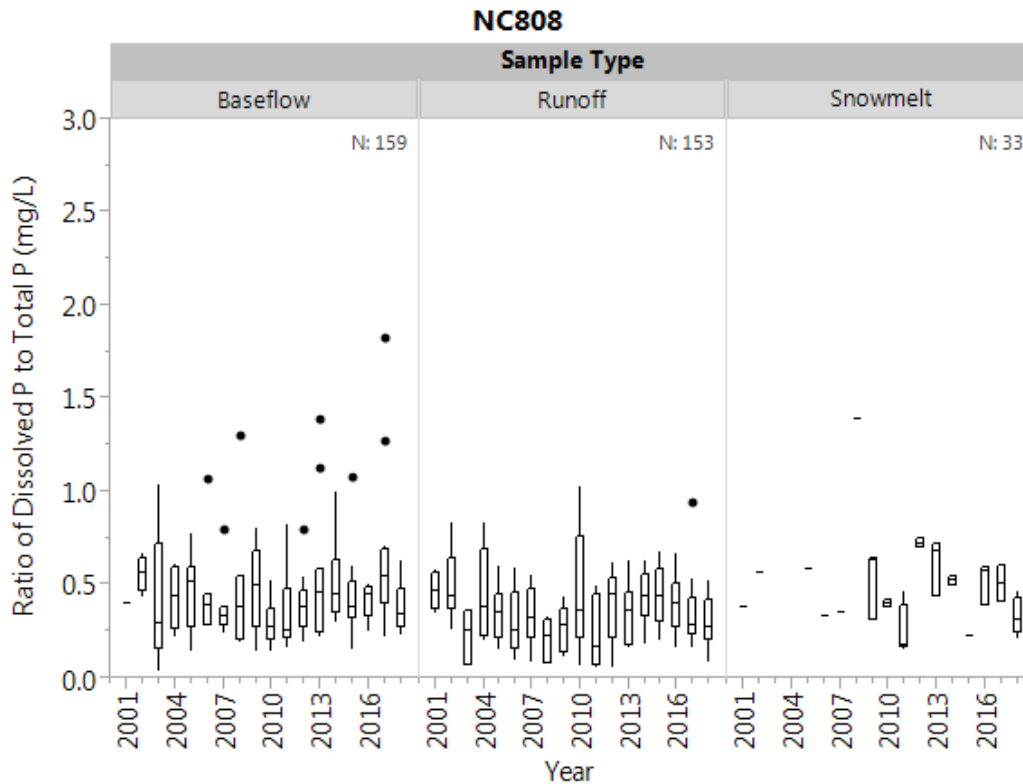
Figure 19e. Historical ratio of dissolved phosphorus to total phosphorus by sample type at NC808.

Historical TDP to TP ratio boxplots for each station are shown in Figures 19a - i. The TDP:TP ratios for runoff samples were generally lower than that of baseflow samples, which is in continuation of the trend for all sites when considering the historical data. Runoff event samples contain more suspended particulate material which has phosphorus adsorbed to it. This particulate phosphorus could be washed in from the land surface and/or resuspended from the stream bed resulting in a higher TDP to TP ratio.

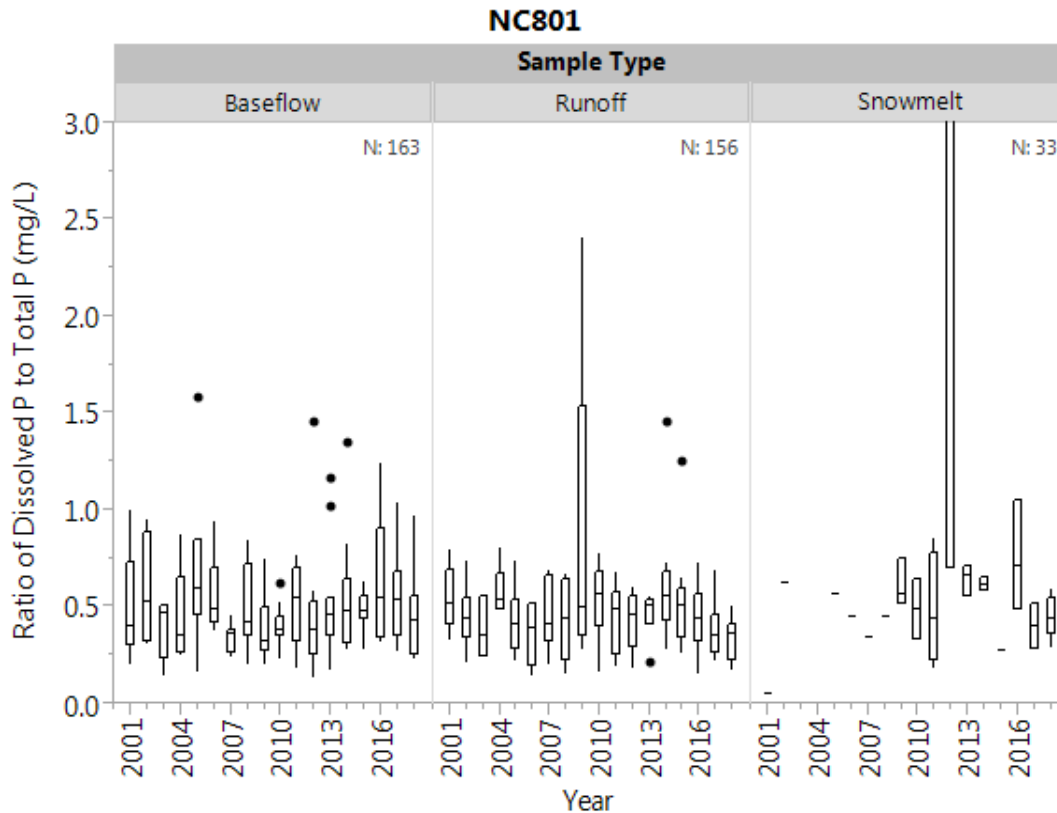
Figure 19f. Historical ratio of dissolved phosphorus to total phosphorus by sample type at NC801.
 **NC801 has an outlier for 2003 baseflow at 3.7 mg/L and the maximum for 2012 snowmelt sample extends to 5.67 mg/L.

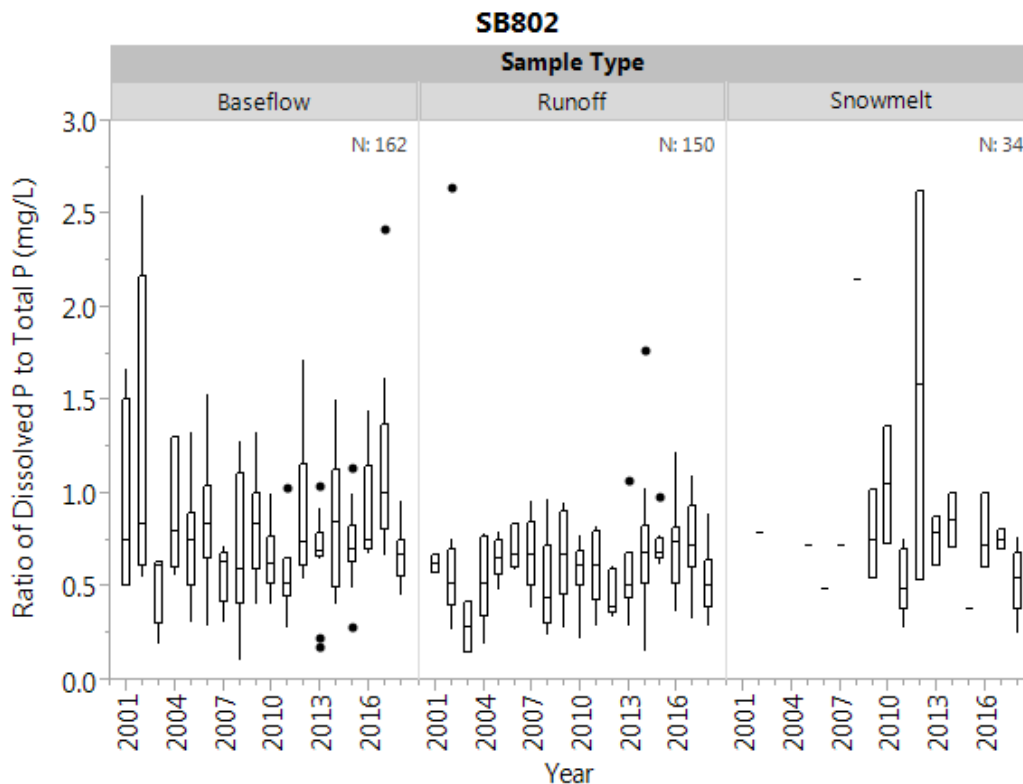
Figure 19g. Historical ratio of dissolved phosphorus to total phosphorus by sample type at SB802.

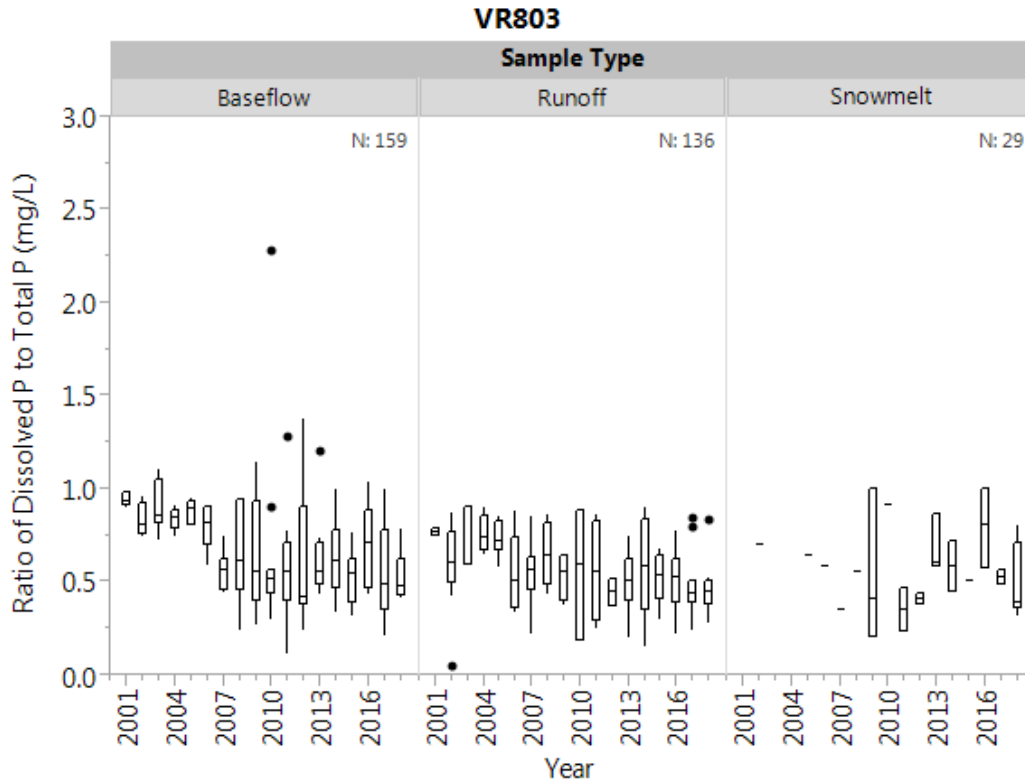
Figure 19h. Historical ratio of dissolved phosphorus to total phosphorus by sample type at VR803.

During baseflow conditions, the TDP:TP ratio at VR803 had decreased about the time that wastewater treatment upgrades were implemented in 2006. Discharges from the wastewater treatment plant were likely the source of the TDP fraction; organic phosphorus excreted by organisms (including humans) would be dissolved, as opposed to particulate. WWTP upgrades in 2006 were important in reducing TDP levels at VR803 and significant reductions were apparent by 2007.

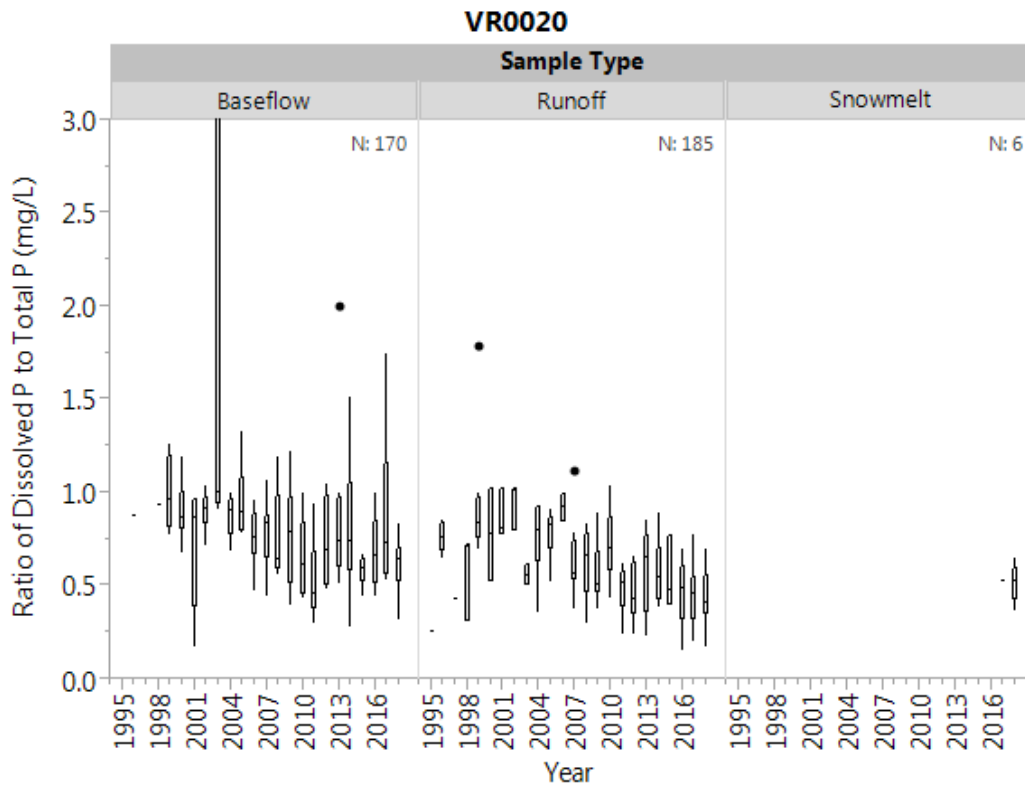
Figure 19i. Historical ratio of dissolved phosphorus to total phosphorus by sample type at VR0020.

**VR0020 has an outlier for 2003 baseflow at 37.9 mg/L.

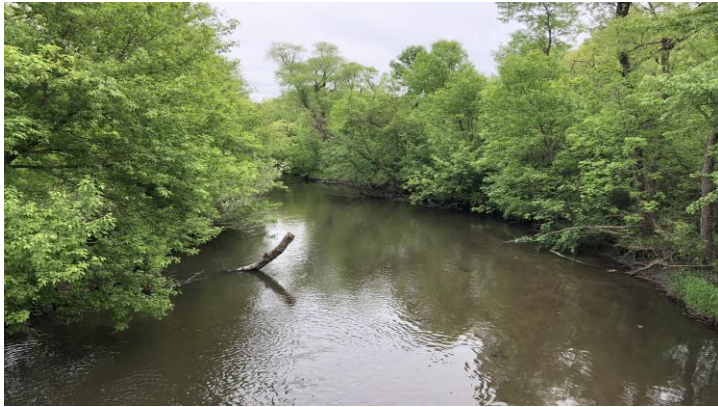
VR803 at *baseflow* conditions.
Small amount of suspended particles
being transported downstream.
Water transparency is high.

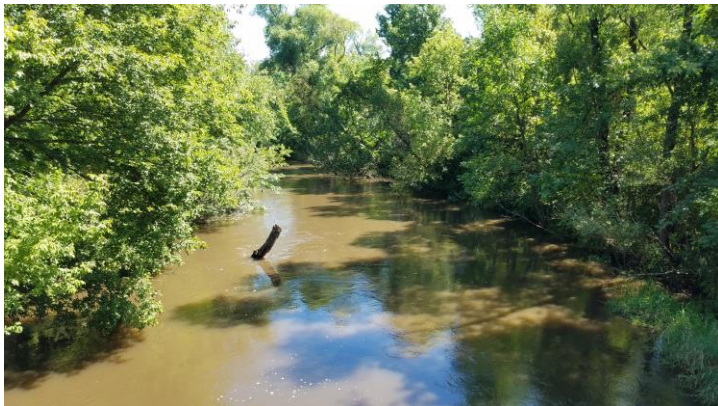
VR803 under *runoff* conditions.
Water is murky and there is a high level
of suspended sediment in the water.
Water transparency is low.

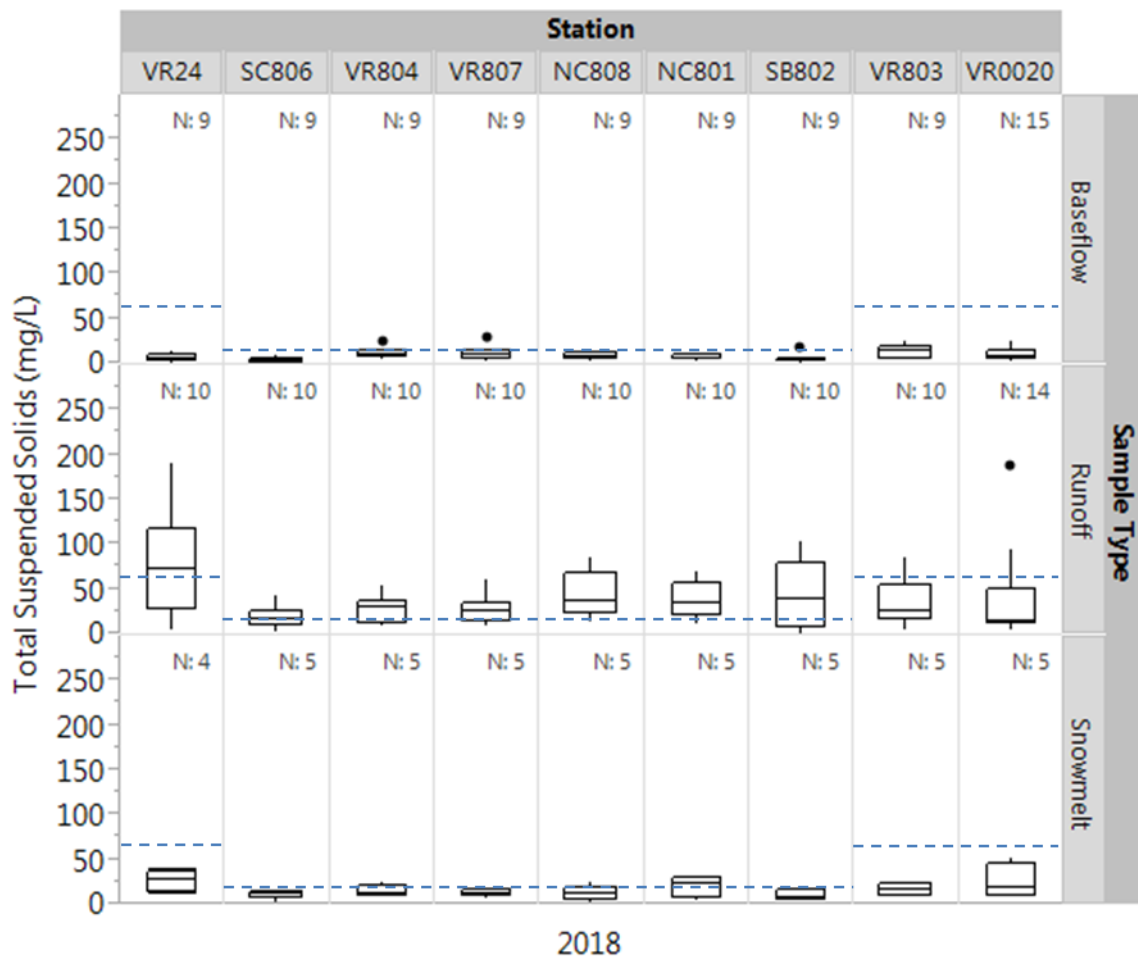
Figure 20. Total suspended solids categorized by sample type for 2018. Blue dashed line represents the state standard for cold 2A (≤ 10 mg/L) and warm 2B (≤ 65 mg/L) waters.

State standards were recently developed for TSS. For cold water (2A) streams the standard is ≤ 10 mg/L and for warm water (2B) streams the standard is ≤ 65 mg/L. These standards apply from April through September; however, data shown here includes the entire monitoring season which goes from snowmelt (mid-March) through November 1st. Sample medians were below the state standard at all stations during baseflow conditions, whereas sample medians for the six cold water monitoring sites were at or above the standard (as was the sample median for VR24 (warmwater)) during runoff monitoring (Figure 20).

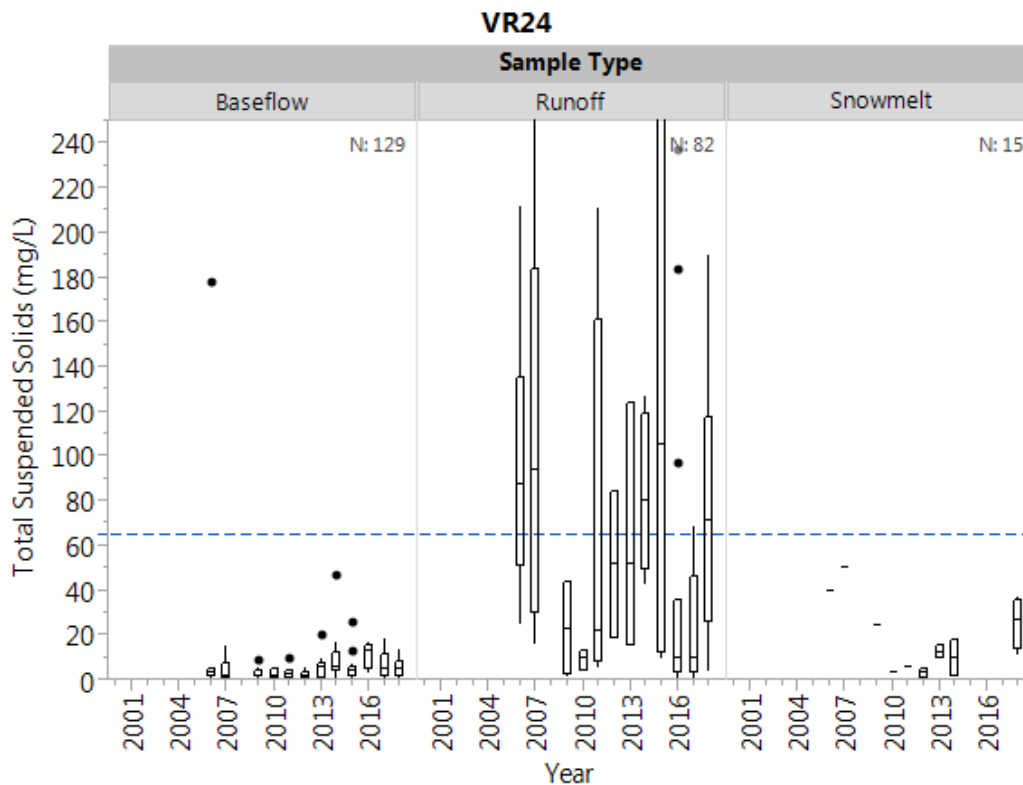
Figure 21a. Historical total suspended solids by sample type at VR24. Blue dashed line indicates the upper limit of the state standard (65 mg/L). **VR24 maximum for 2007 runoff sample extends to 365 mg/L and has an outlier at 434 mg/L and the maximum for 2015 runoff sample extends to 468 mg/L.

Storm duration and intensity play a role in contributing high suspended solids to a stream. The years with samples from larger storms have higher TSS than years with samples from smaller storms with lesser rainfall amounts and/or intensity. The historical record shows that runoff sample medians violated the state standard for cold water streams in most years, but baseflow samples often met the standard (Figure 21a-i). Stations VR803 and VR0020 had baseflow and runoff sample medians below the proposed standard under all regimes during all years. Station VR24 meets the standard during baseflow conditions, but often exceeds the standard during higher flow conditions following runoff events.

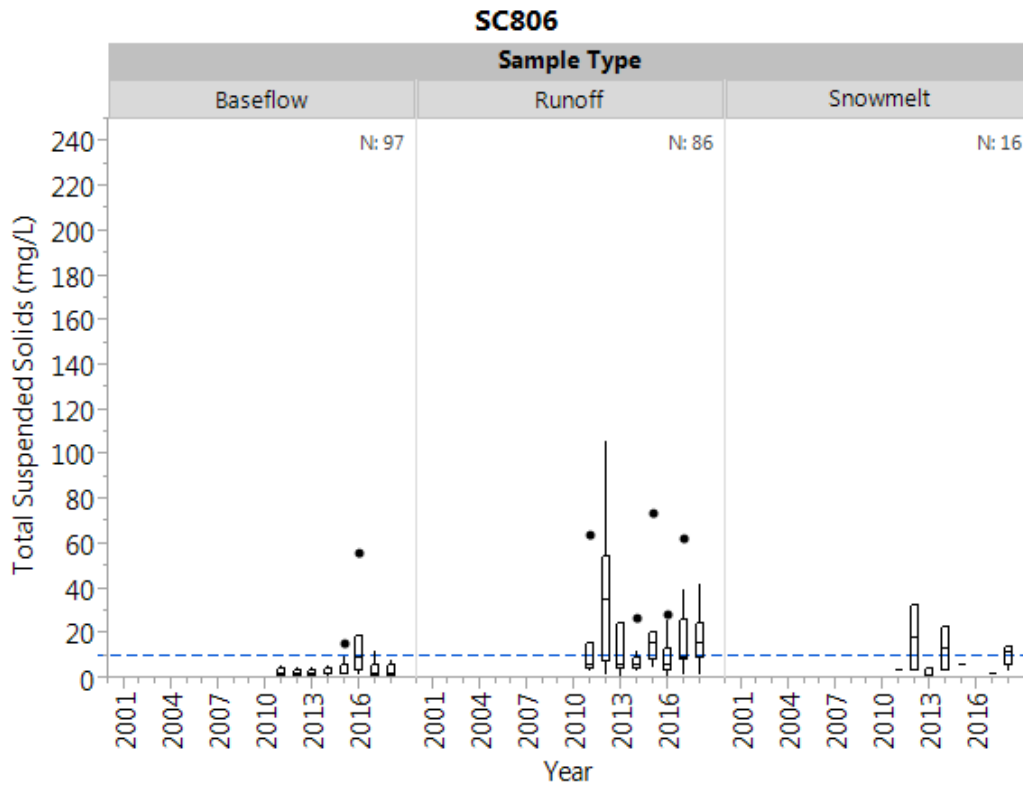
Figure 21b. Historical total suspended solids by sample type at SC806. Blue dashed line indicates the upper limit of the state standard (10 mg/L).

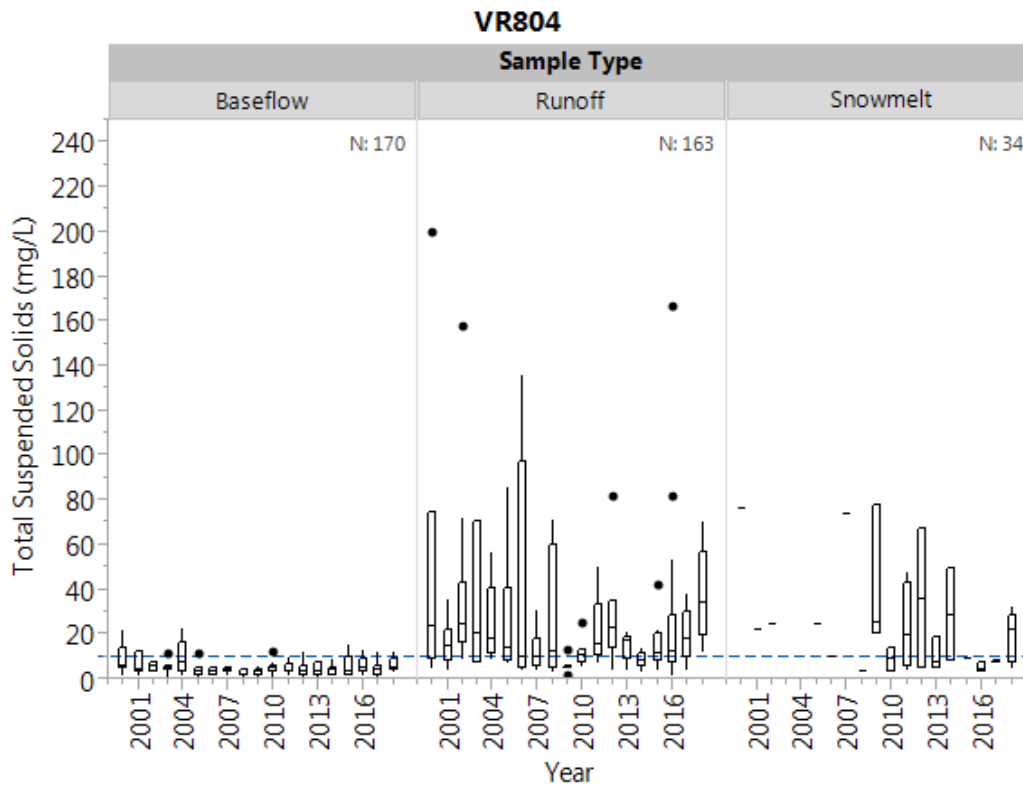
Figure 21c. Historical total suspended solids by sample type at VR804. Blue dashed line indicates the upper limit of the state standard (10 mg/L).

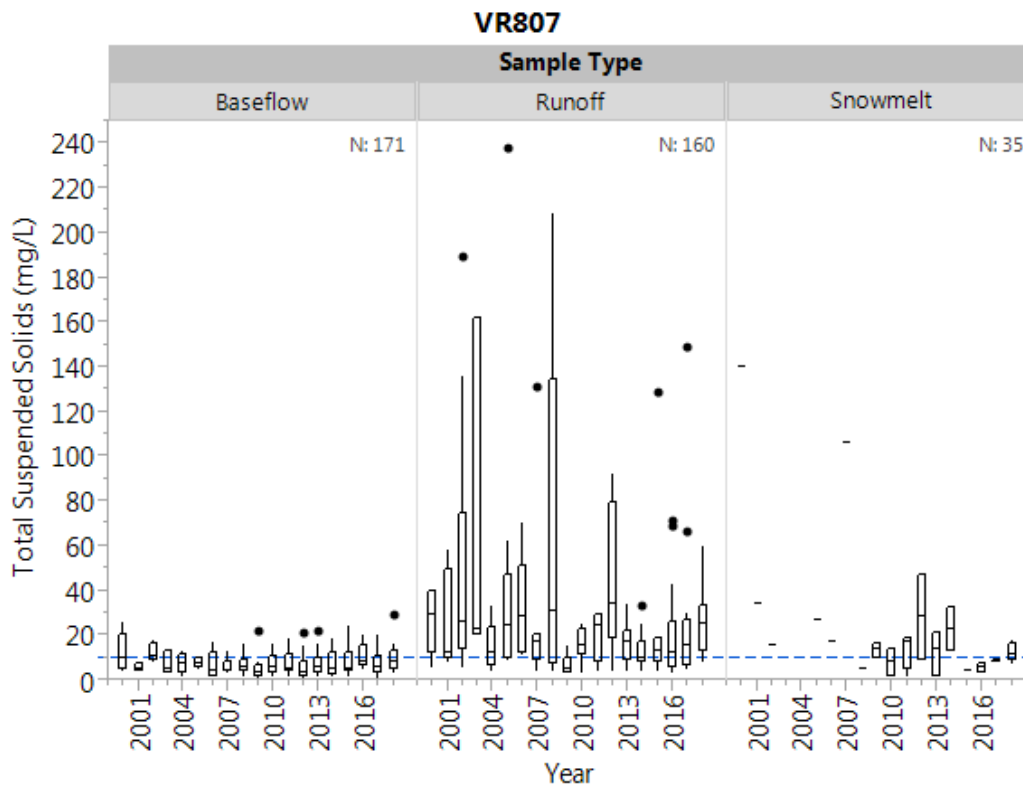
Figure 21d. Historical total suspended solids by sample type at VR807. Blue dashed line indicates the upper limit of the state standard (10 mg/L).

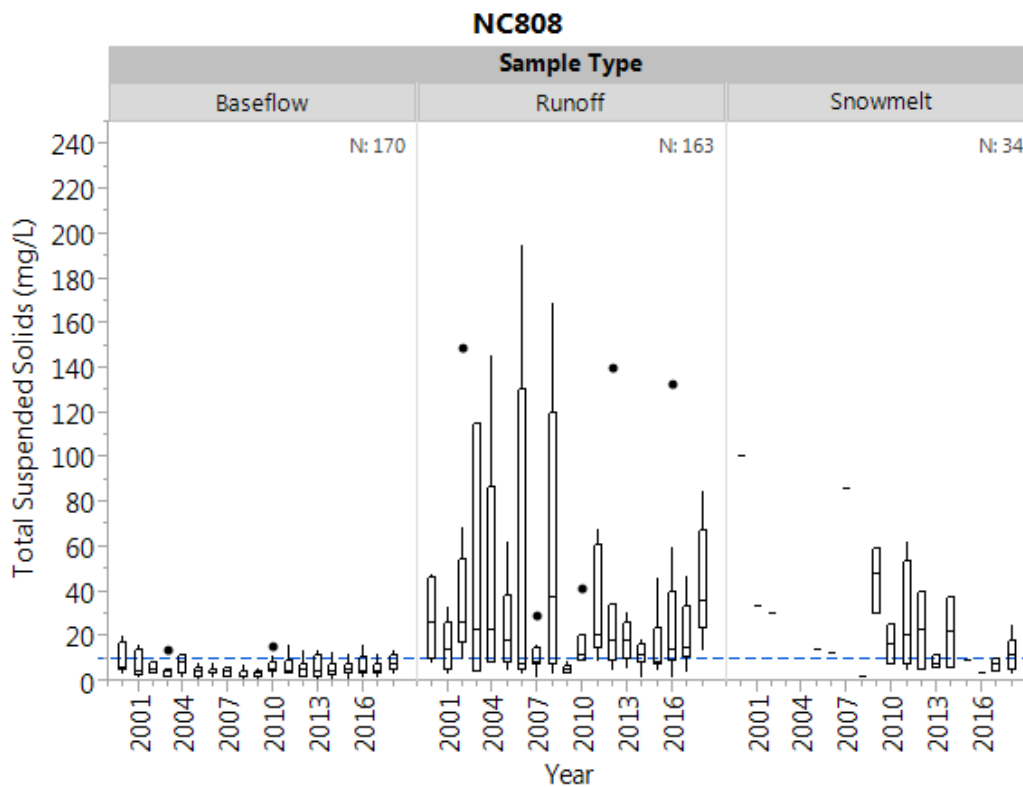
Figure 21e. Historical total suspended solids by sample type at NC808. Blue dashed line indicates the upper limit of the state standard (10 mg/L).

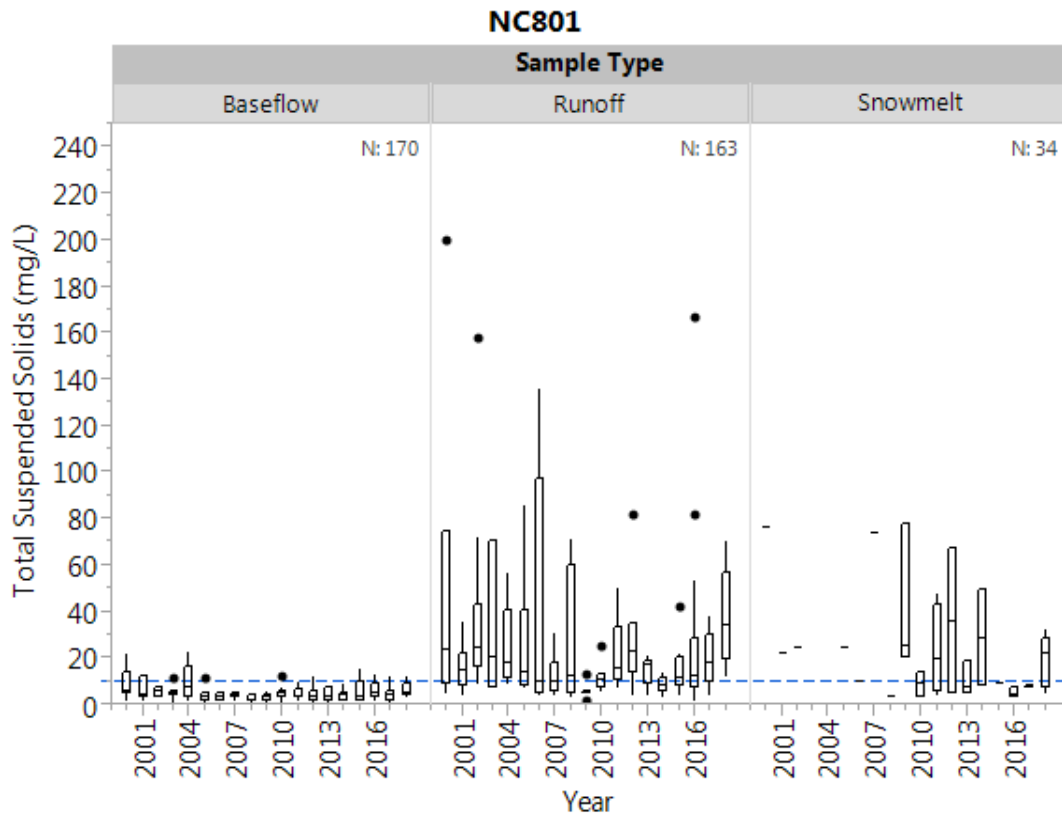
Figure 21f. Historical total suspended solids by sample type at NC801. Blue dashed line indicates the upper limit of the state standard (10 mg/L).

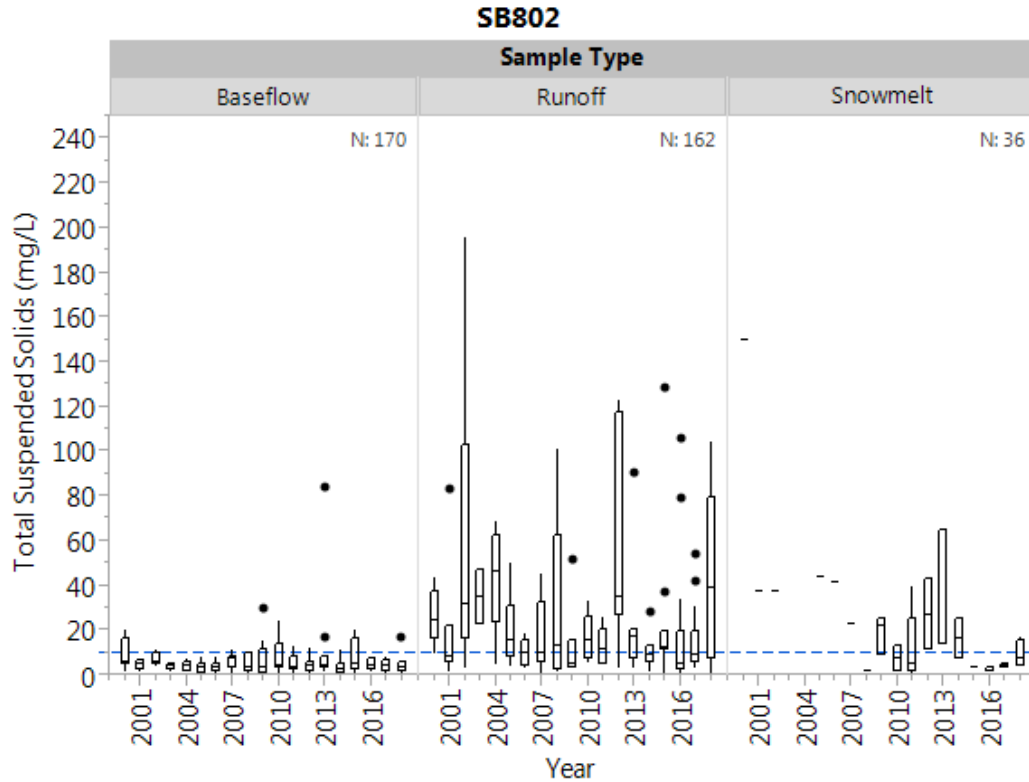
Figure 21g. Historical total suspended solids by sample type at SB802. Blue dashed line indicates the upper limit of the state standard (10 mg/L).

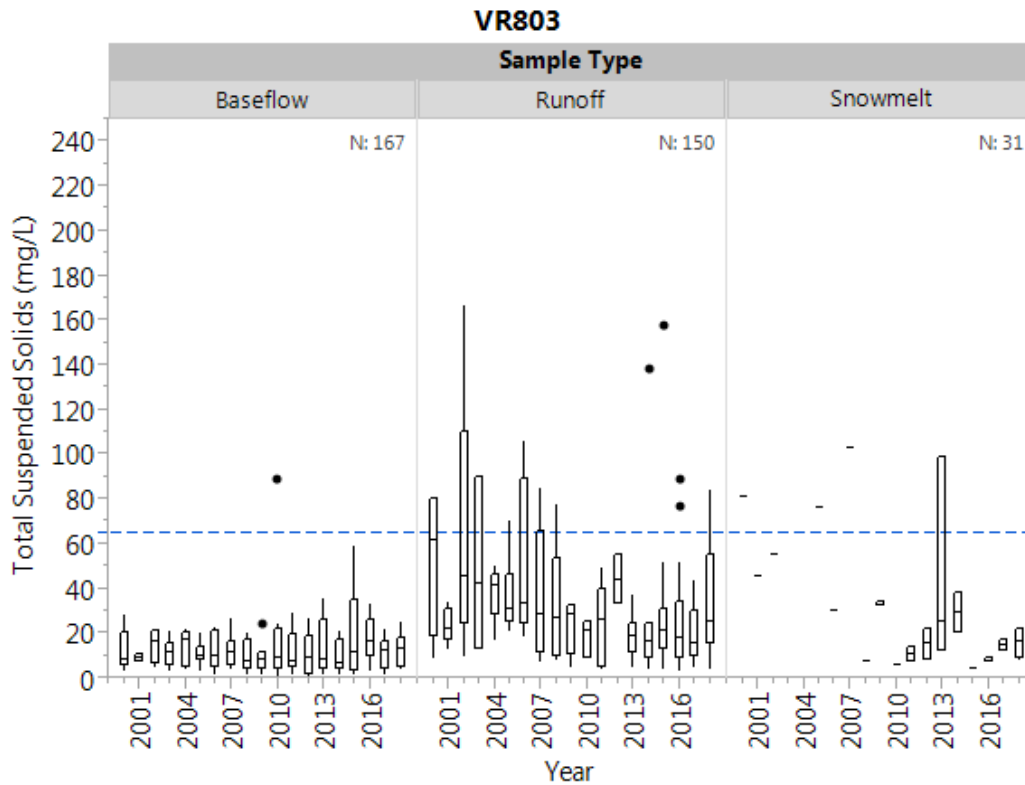
Figure 21h. Historical total suspended solids by sample type at VR803. Blue dashed line indicates the upper limit of the state standard (65 mg/L).

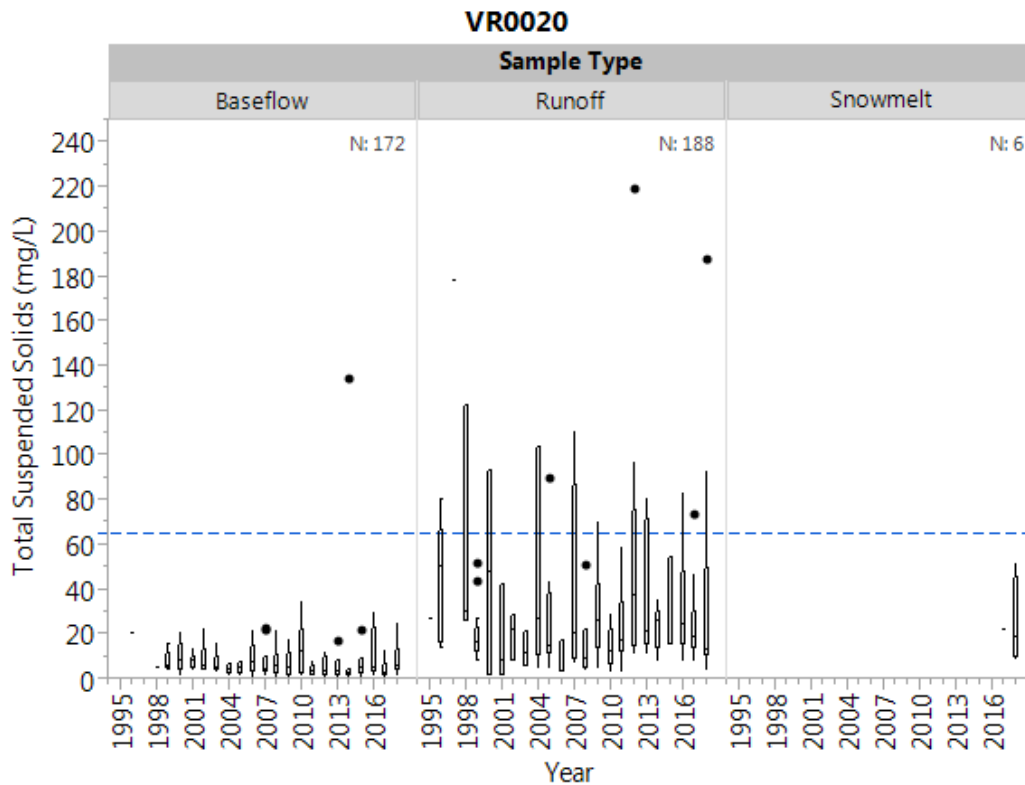
Figure 21i. Historical total suspended solids by sample type at VR0020. Blue dashed line indicates the upper limit of the state standard (65 mg/L).

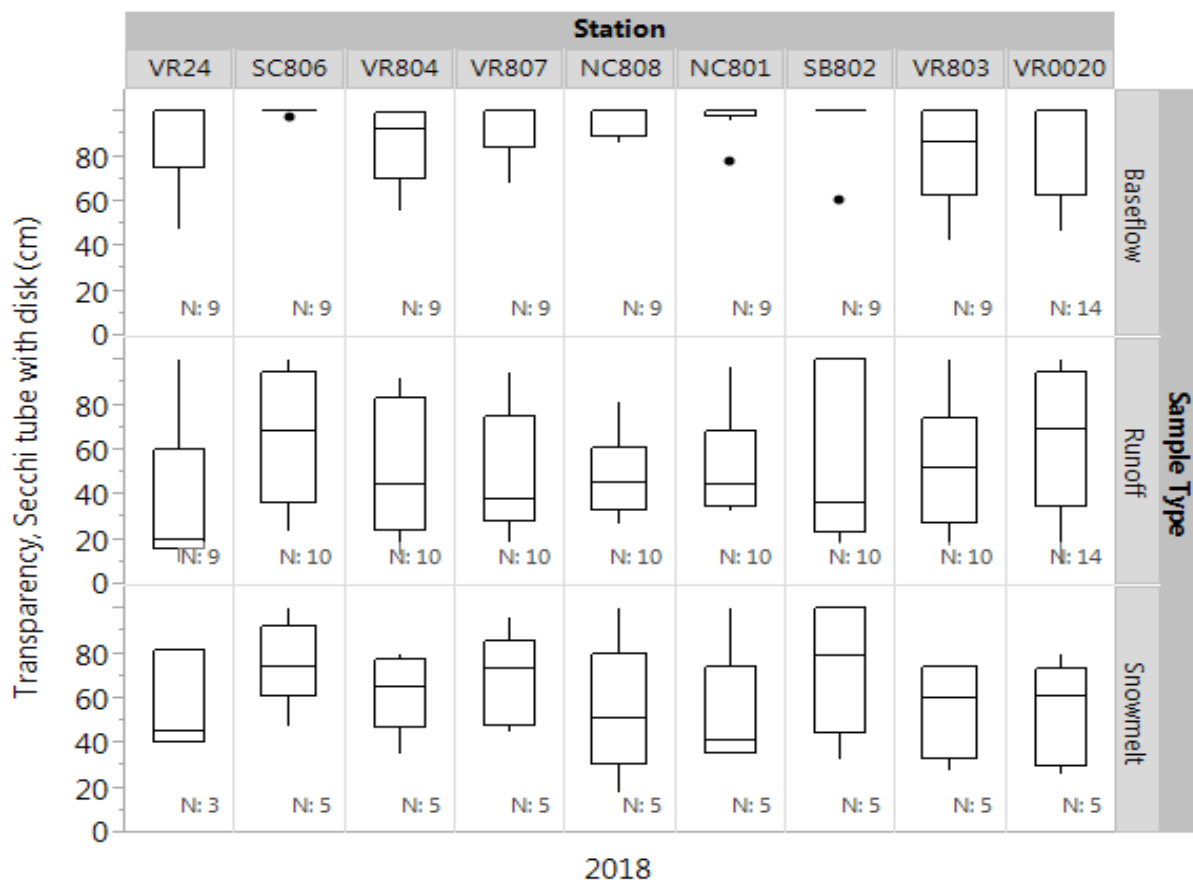
Figure 22. Transparency, categorized by sample type, for 2018.

Water is relatively clear during baseflow conditions at all stations, often exceeding the measurement limit of 100 cm (Figure 22). Station VR804 has the poorest baseflow sample medians relative to the other monitoring sites in the watershed. Sandy soils dominate the area and the stream bed contains a lot of sand. Sandy substrate is easily suspended in the water column, making the water cloudy.

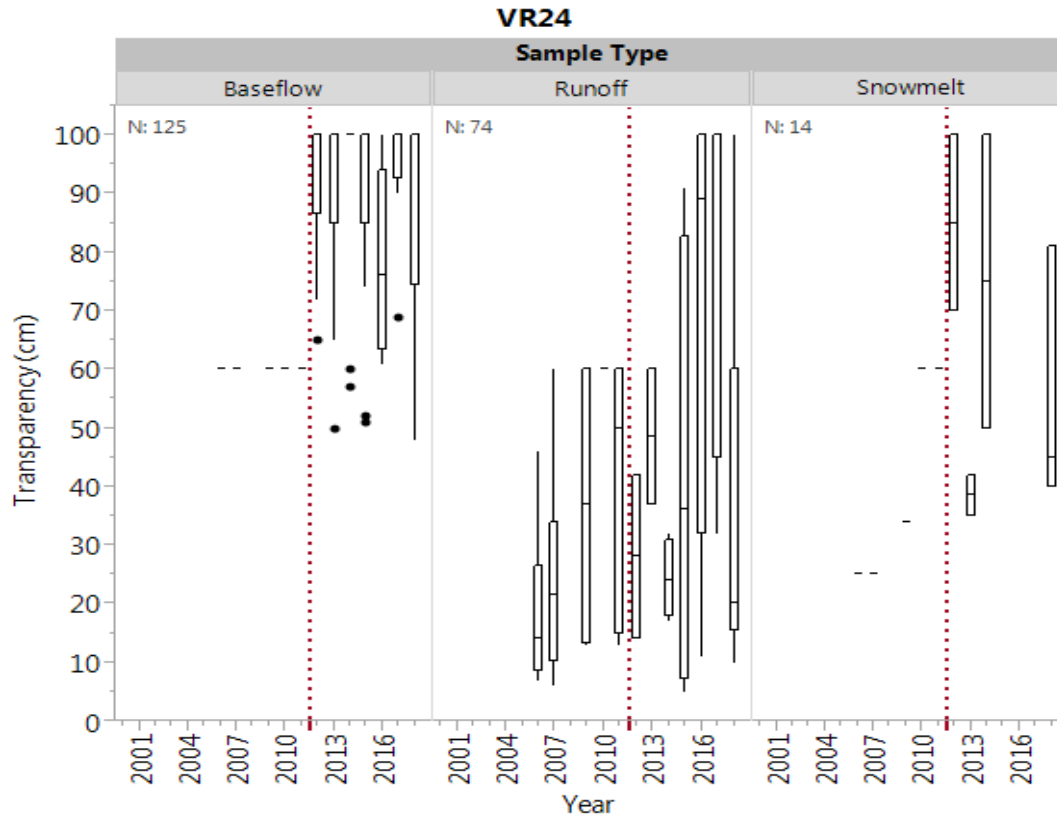
Figure 23a. Historical transparency by sample type for VR24. Secchi tube (100cm length) use began in 2012 (red dotted line).

The historical data in Figure 23a-i shows a lot of year-to-year variability, closely related to rainfall amount and intensity. Overall, baseflow condition measurements show greater clarity than runoff conditions and snowmelt measurements tend to be relatively clear, though not as clear as baseflow condition measurements. The vertical red line in each of the historical figures indicates when the 60 cm transparency tubes were phased out and the 100 cm Secchi tubes were introduced in 2012.

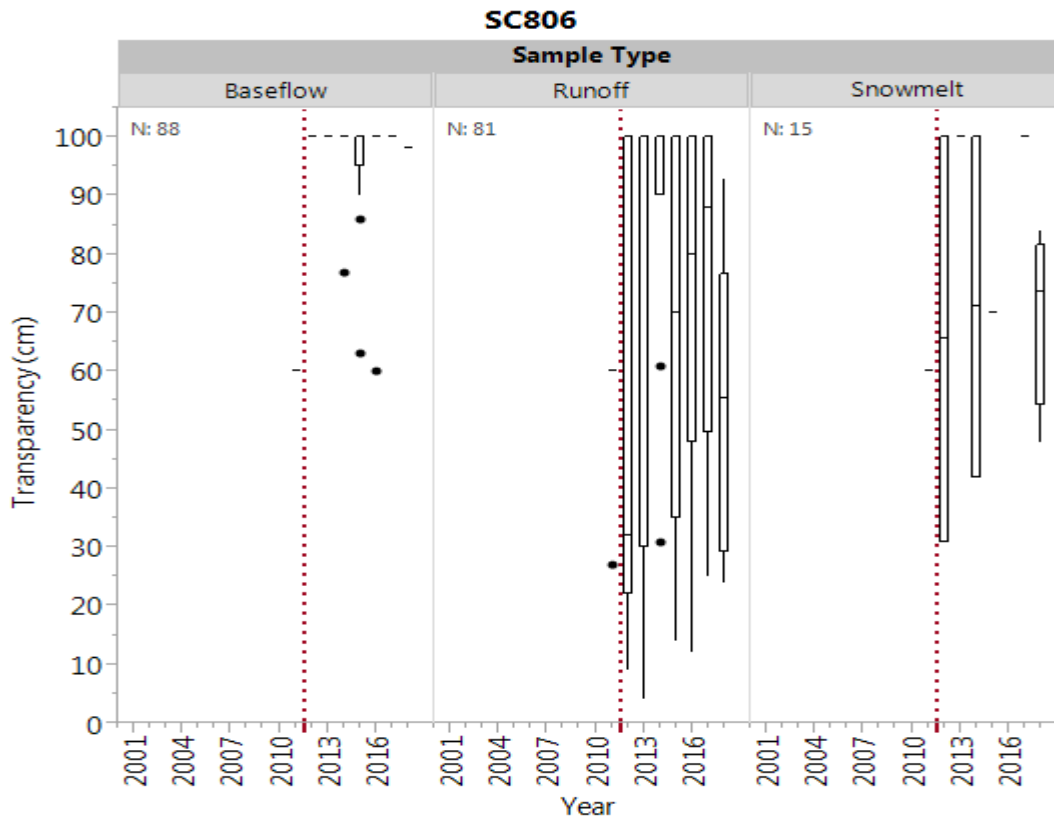
Figure 23b. Historical transparency by sample type for SC806. Secchi tube (100cm length) use began in 2012 (red dotted line).

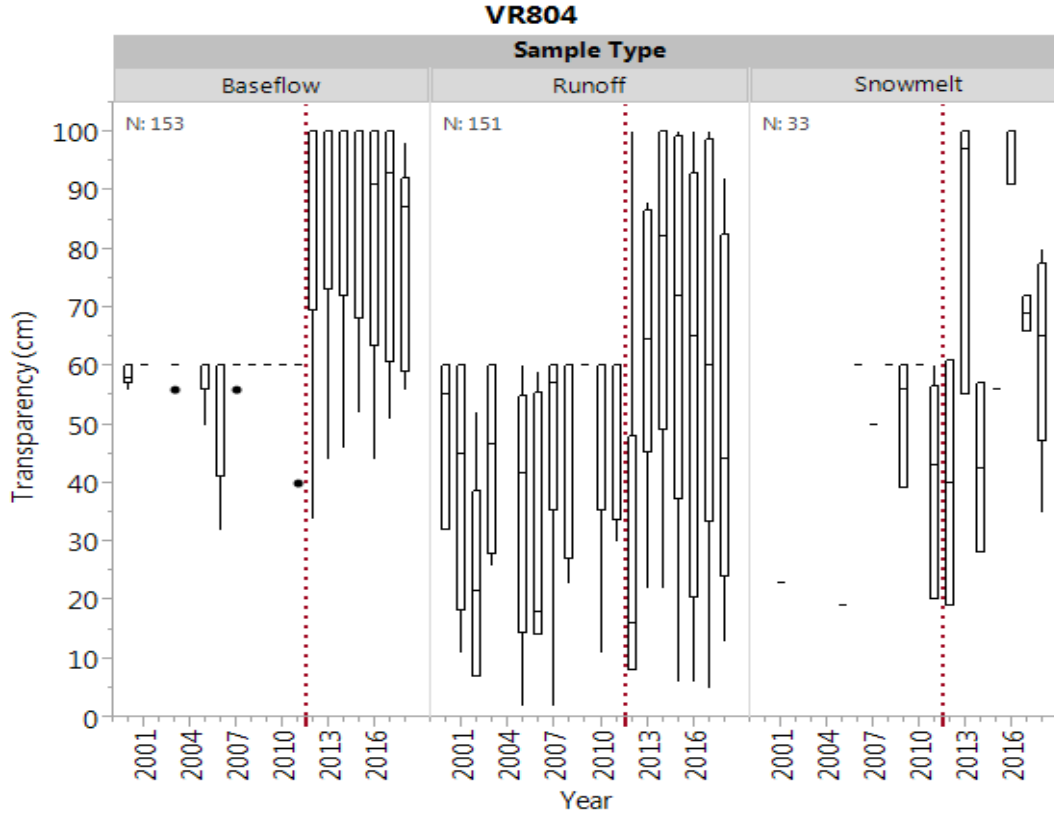
Figure 23c. Historical transparency by sample type for VR804. Secchi tube (100cm length) use began in 2012 (red dotted line).

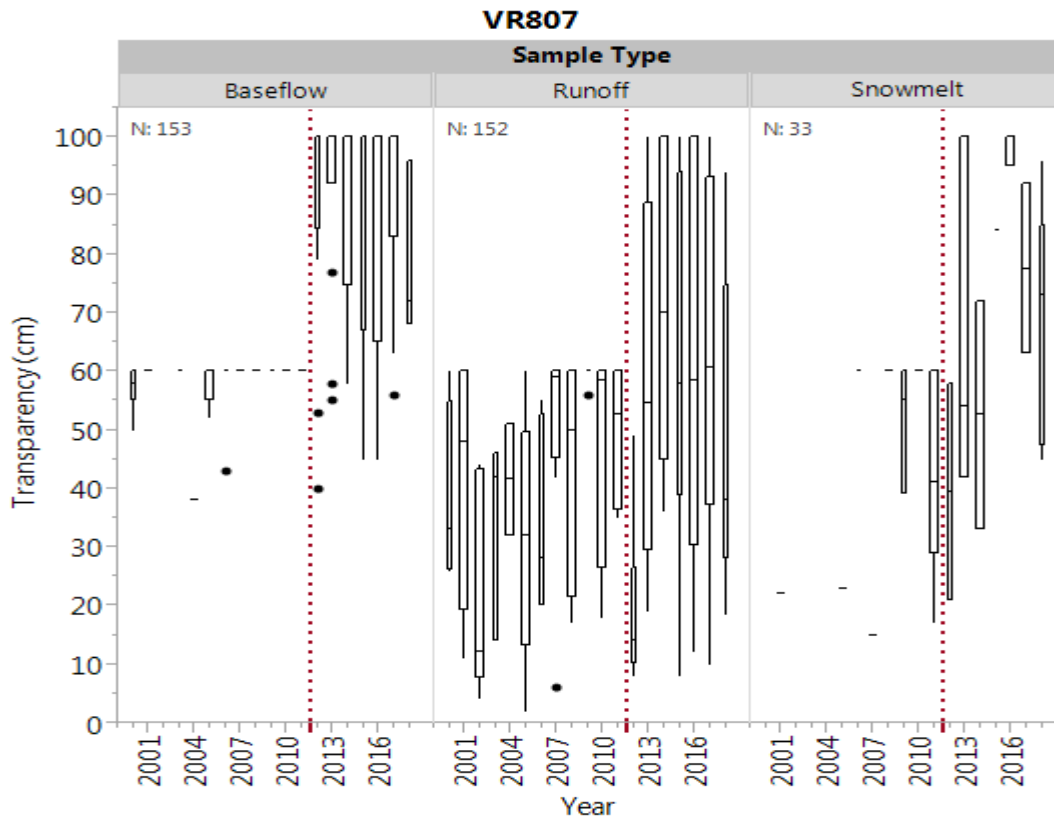
Figure 23d. Historical transparency by sample type for VR807. Secchi tube (100cm length) use began in 2012 (red dotted line).

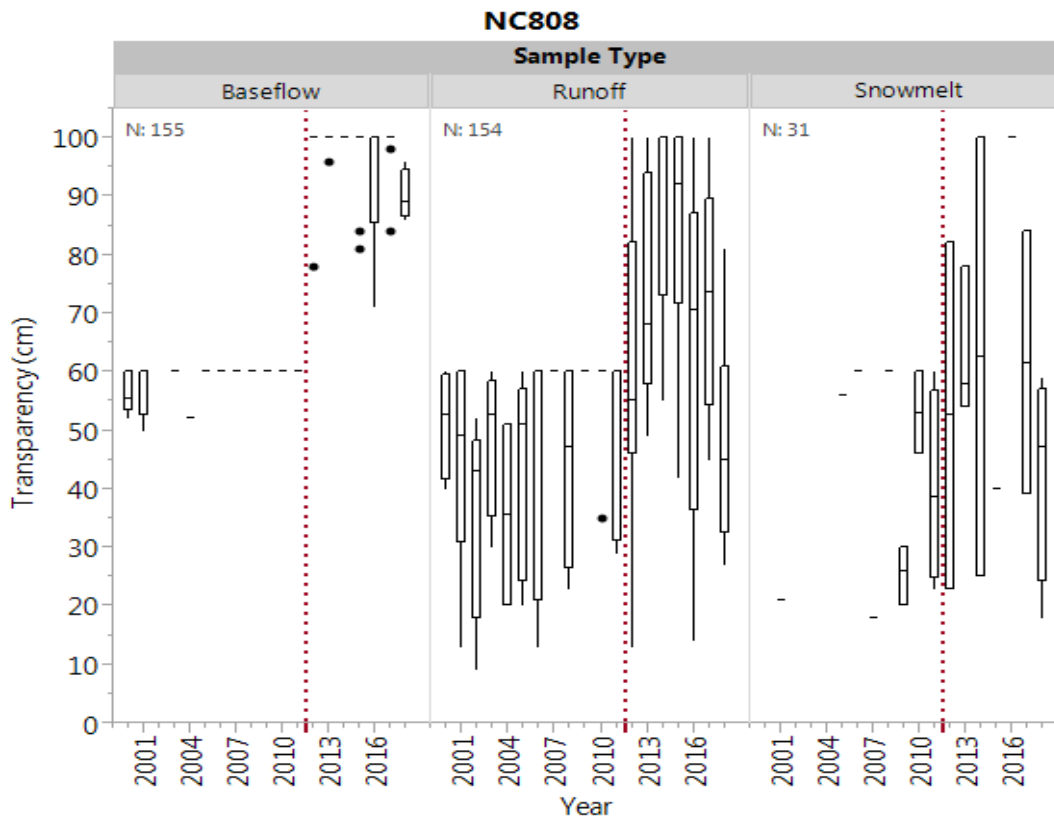
Figure 23e. Historical transparency by sample type for NC808. Secchi tube (100cm length) use began in 2012 (red dotted line).

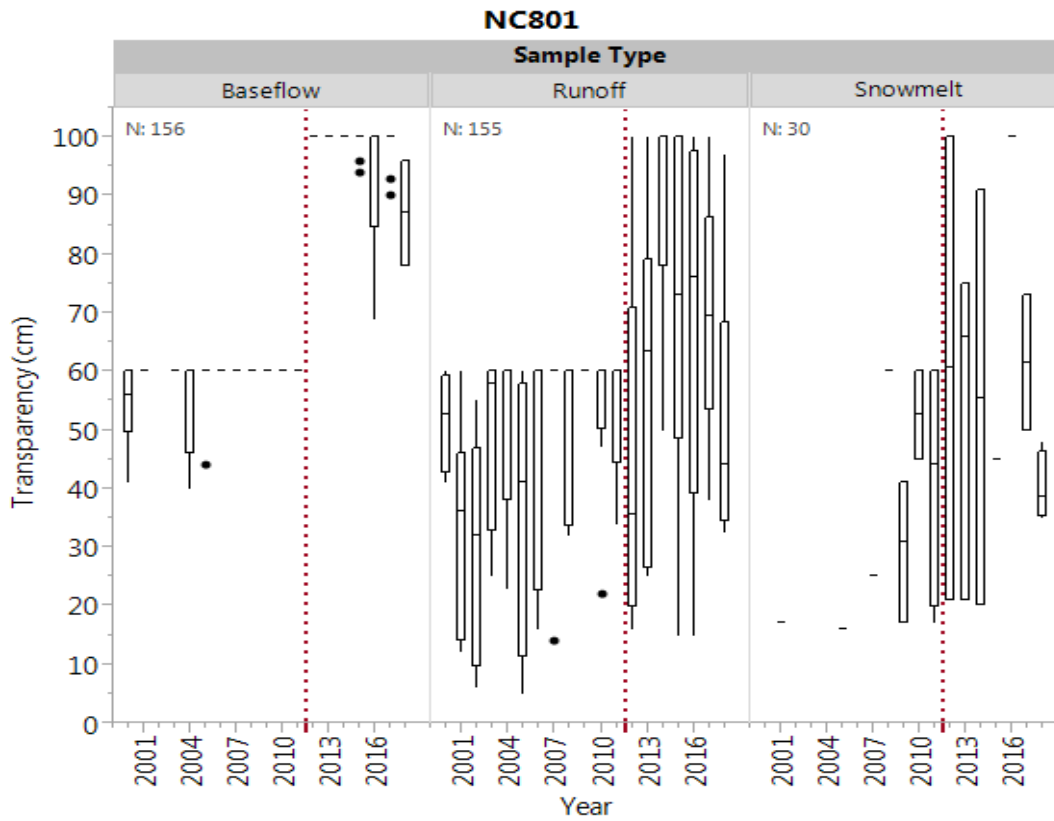
Figure 23f. Historical transparency by sample type for NC801. Secchi tube (100cm length) use began in 2012 (red dotted line).

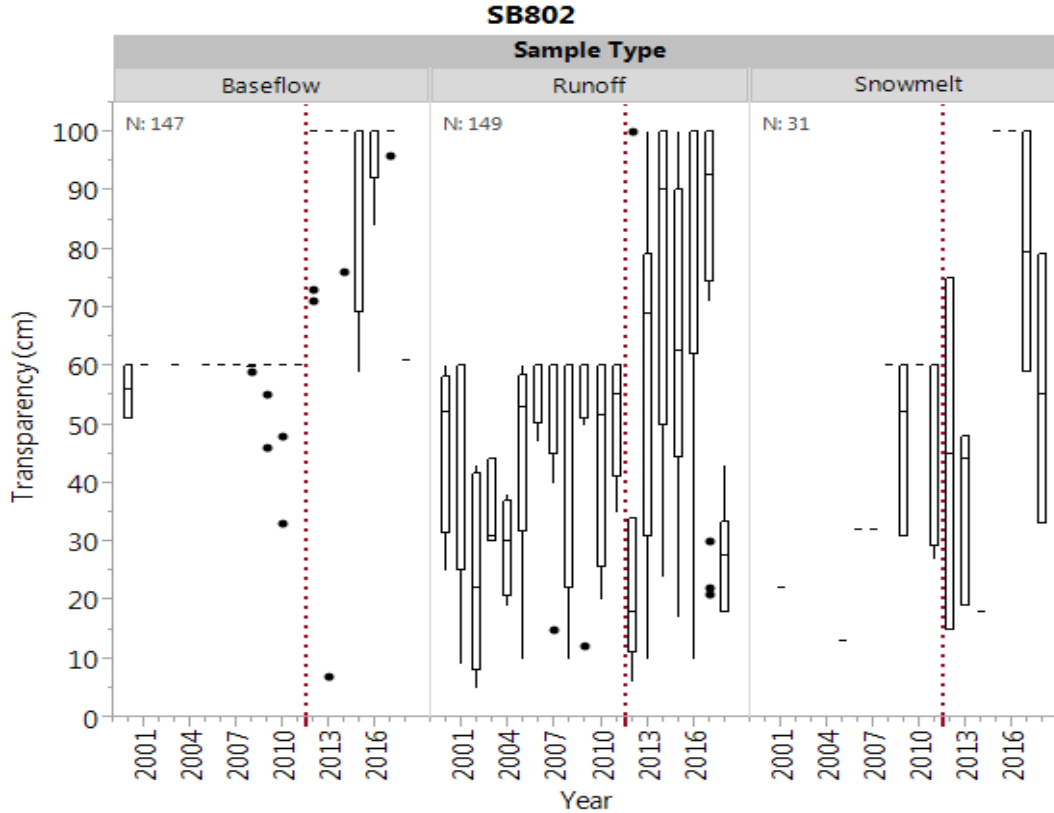
Figure 23g. Historical transparency by sample type for SB802. Secchi tube (100cm length) use began in 2012 (red dotted line).

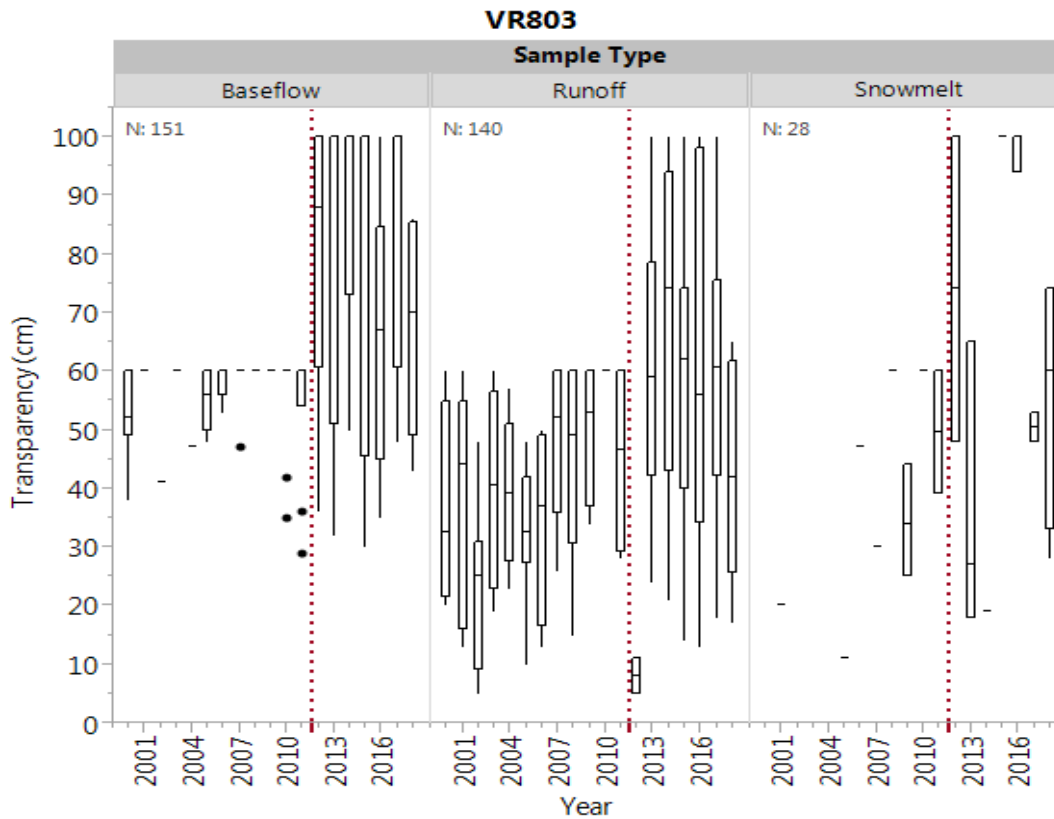
Figure 23h. Historical transparency by sample type for VR803. Secchi tube (100cm length) use began in 2012 (red dotted line).
