Vermillion River Monitoring Network 2018 Annual Report

*Prepared for the Vermillion River Watershed Joint Powers Organization
by the Dakota County Soil and Water Conservation District*

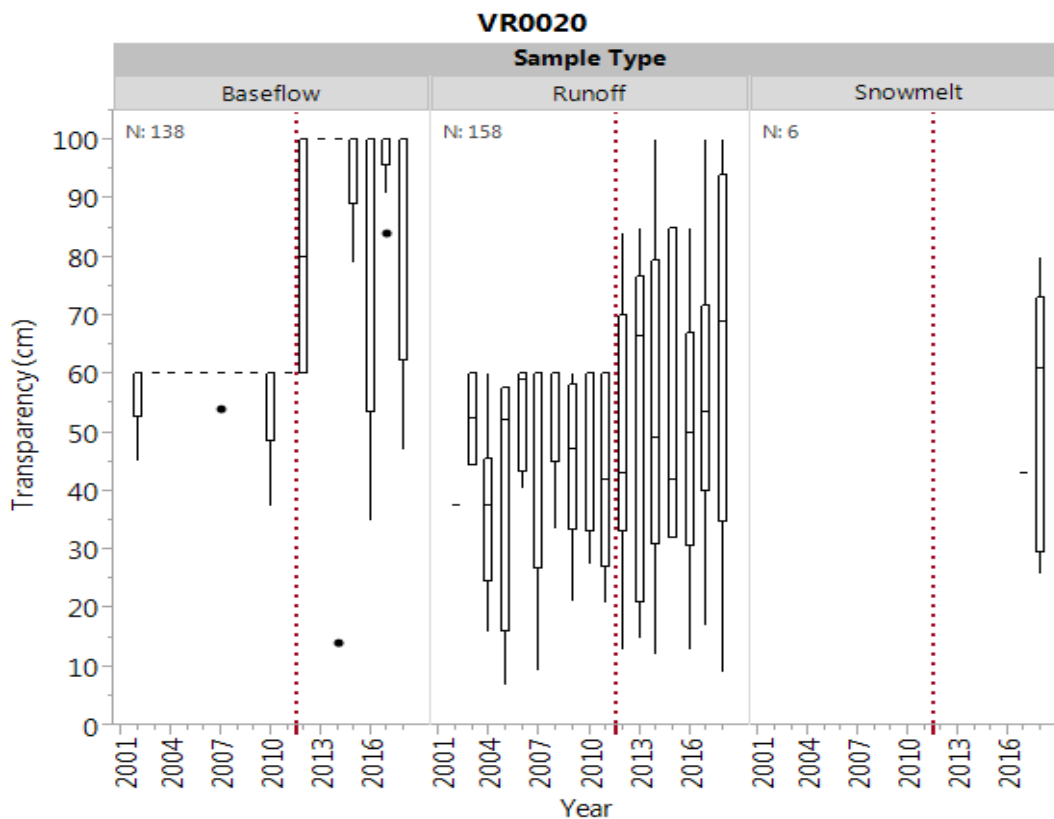
Figure 23i. Historical transparency by sample type for VR0020. Secchi tube (100cm length) use began in 2012 (red dotted line).

The historical data in Figure 23a-i shows a lot of year-to-year variability, closely related to rainfall amount and intensity. Overall, baseflow condition measurements show greater clarity than runoff conditions and snowmelt measurements tend to be relatively clear, though not as clear as baseflow condition measurements. The vertical red line in each of the historical figures indicates when the 60 cm transparency tubes were phased out and the 100 cm Secchi tubes were introduced in 2012.

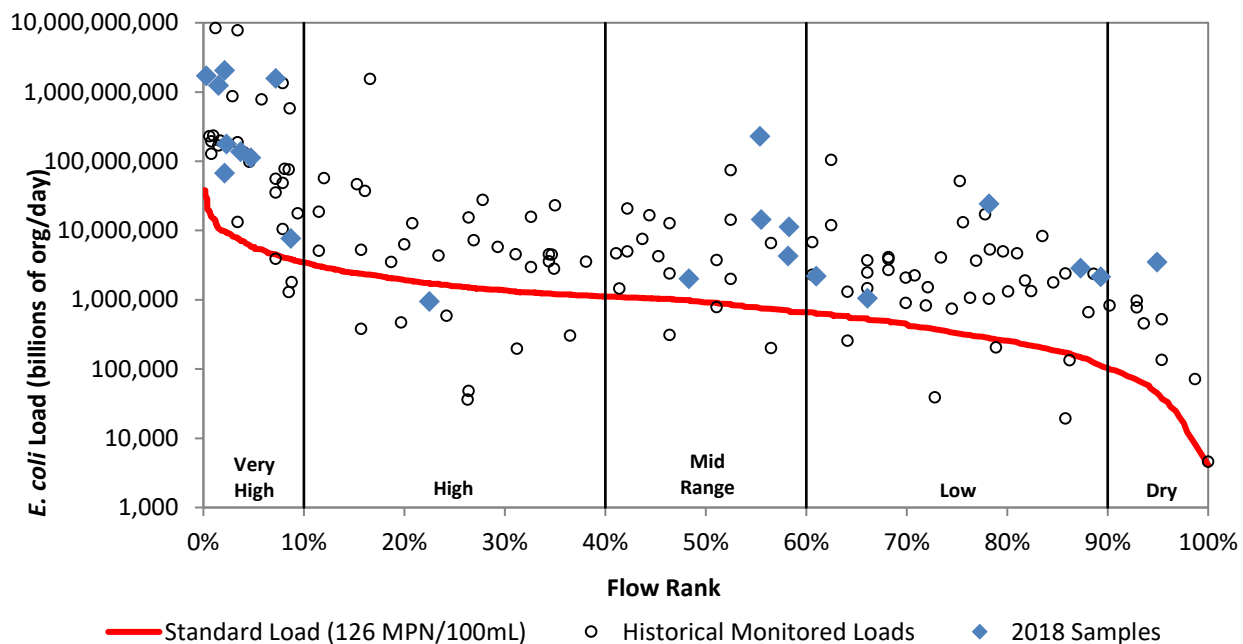
Figure 24a. Load duration curve for *E. coli* at VR24.

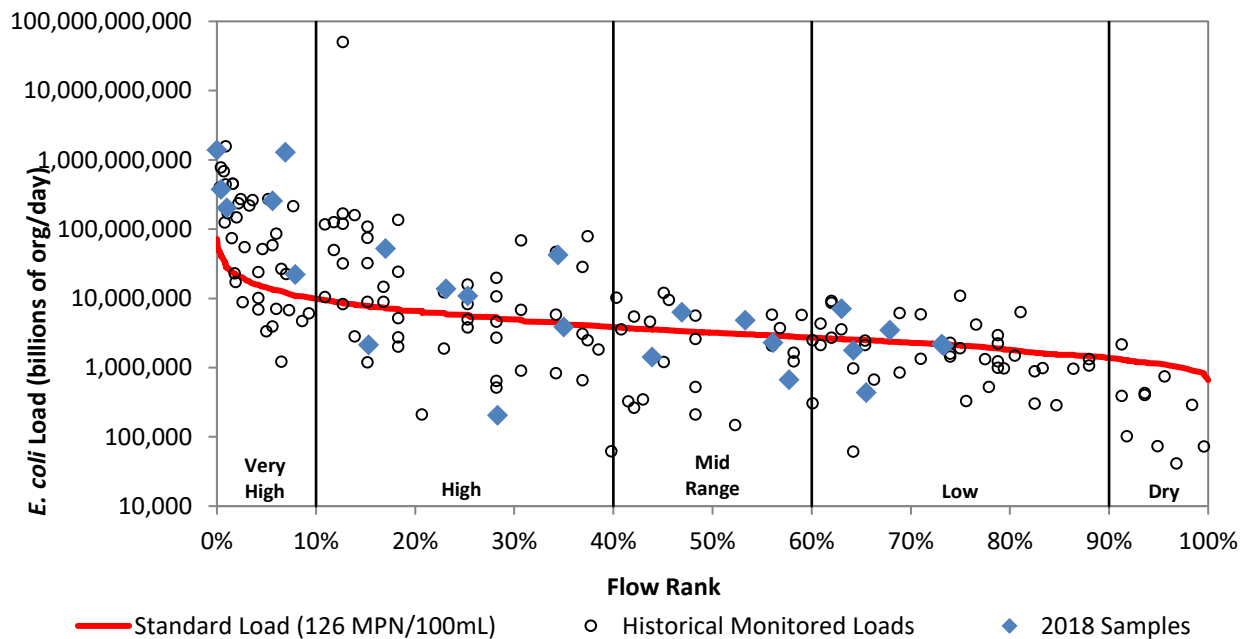
SC806 *E. coli* Load Duration Curve

Figure 24b. Load duration curve for *E. coli* at SC806.

E. coli loads exceeded the state standard (≤ 126 MPN/100mL) across all flow regimes at all sites (Figures 24a-i). Consistently elevated levels of *E. coli* are indicative of a chronic source of *E. coli* in the watershed that is contributing across all flow regimes, not just during very high or high flows.

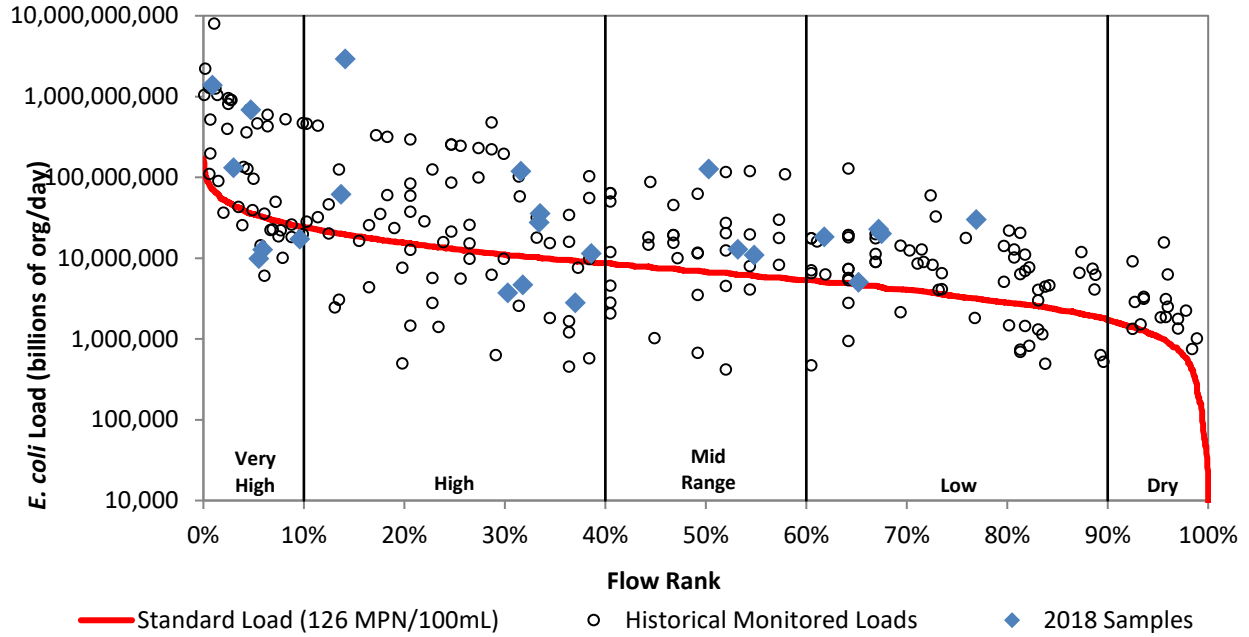
VR804 *E. coli* Load Duration Curve

Figure 24c. Load duration curve for *E. coli* at VR804.

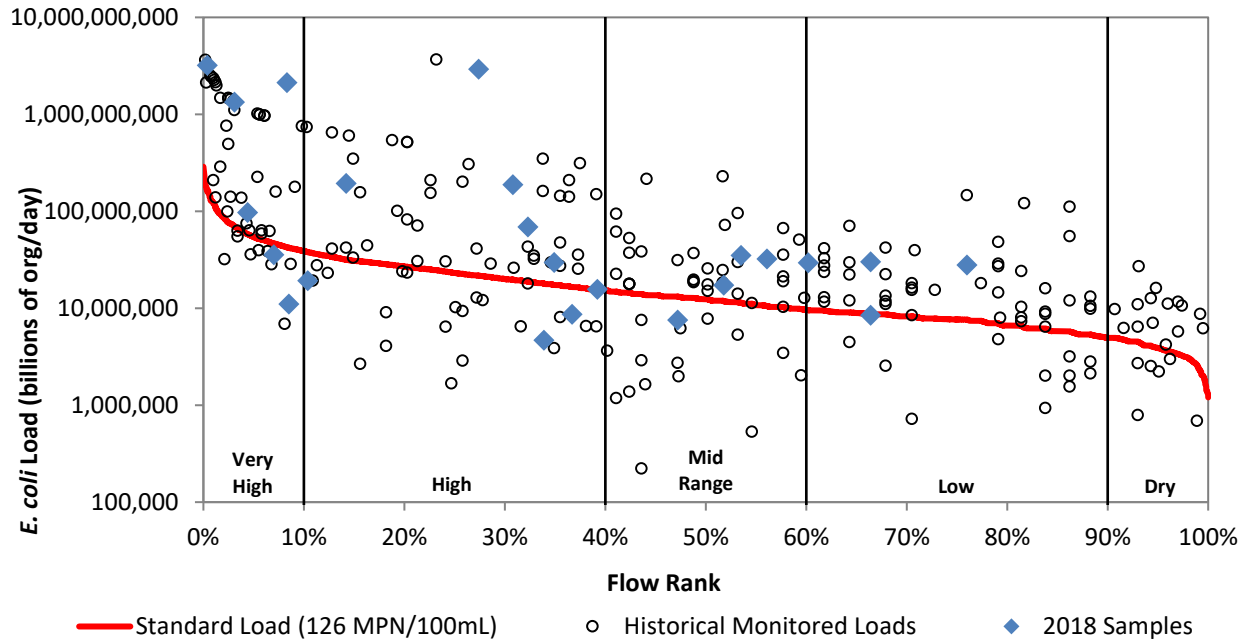
VR807 *E. coli* Load Duration Curve

Figure 24d. Load duration curve for *E. coli* at VR807.

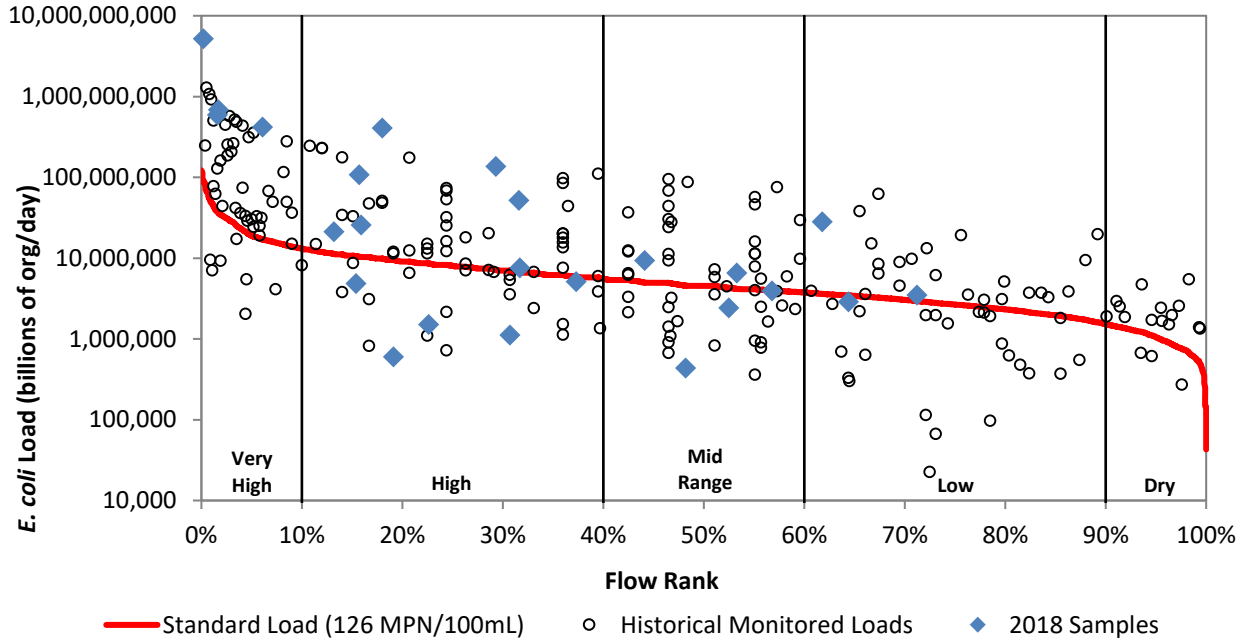
NC808 *E. coli* Load Duration Curve

Figure 24e. Load duration curve for *E. coli* at NC808.

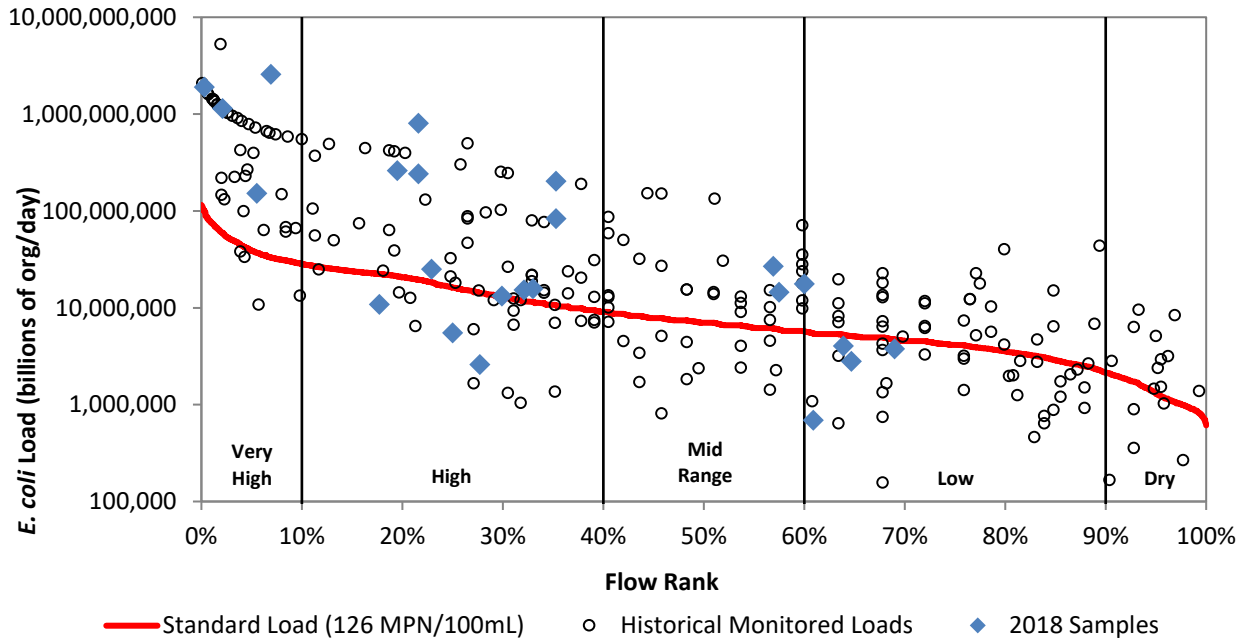
NC801 *E. coli* Load Duration Curve

Figure 24f. Load duration curve for *E. coli* at NC801.

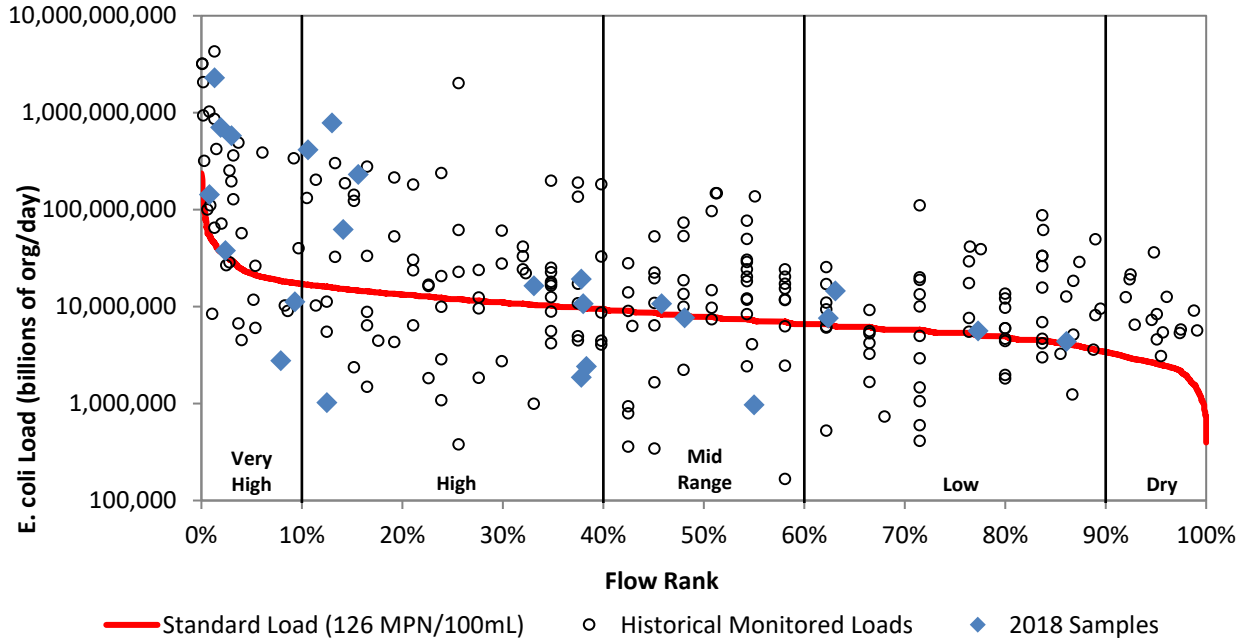
SB802 *E. coli* Load Duration Curve

Figure 24g. Load duration curve for *E. coli* at SB802.

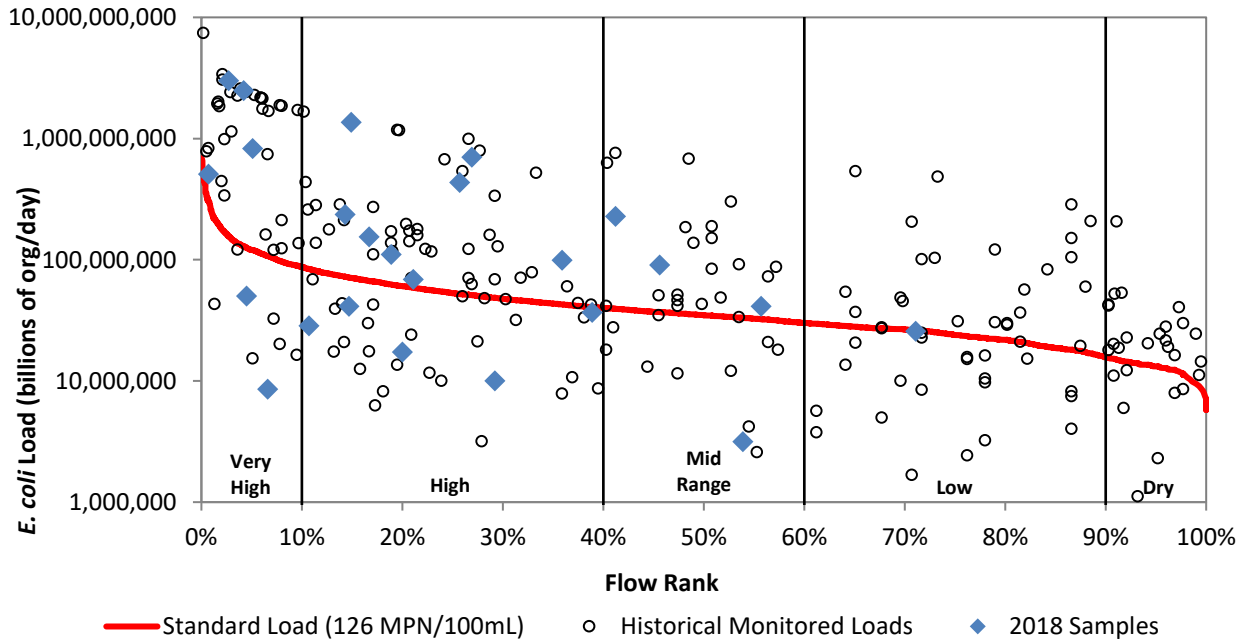
VR803 *E. coli* Load Duration Curve

Figure 24h. Load duration curve for *E. coli* at VR803.

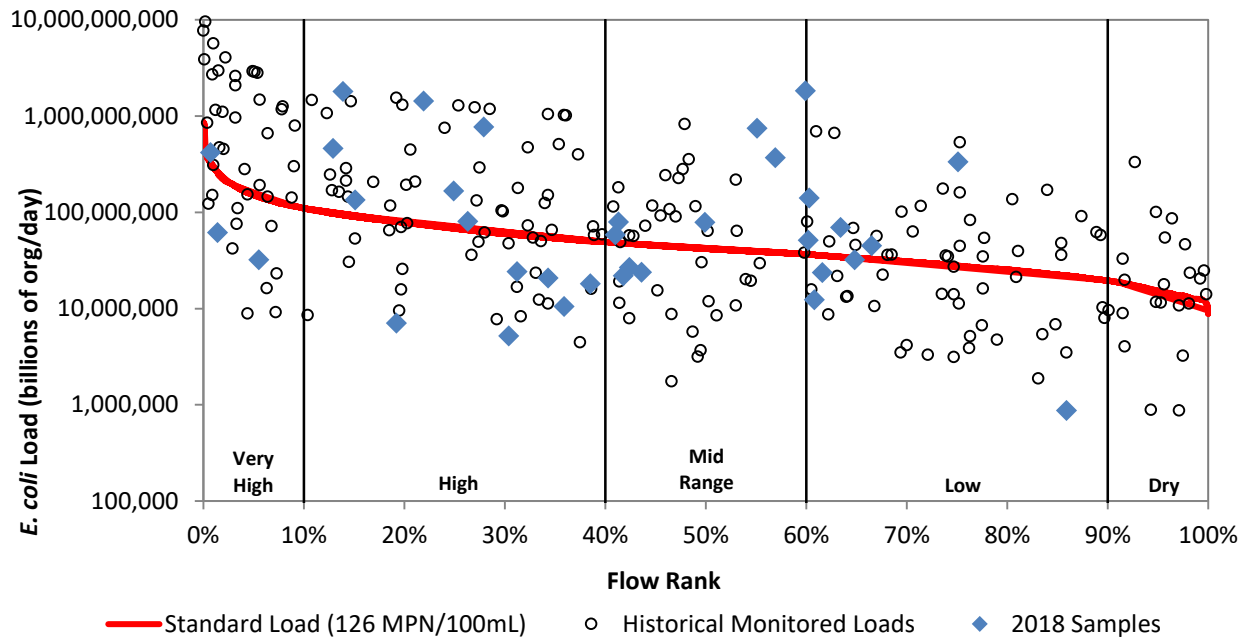
VR0020 *E. coli* Load Duration Curve

Figure 24i. Load duration curve for *E. coli* at VR0020.

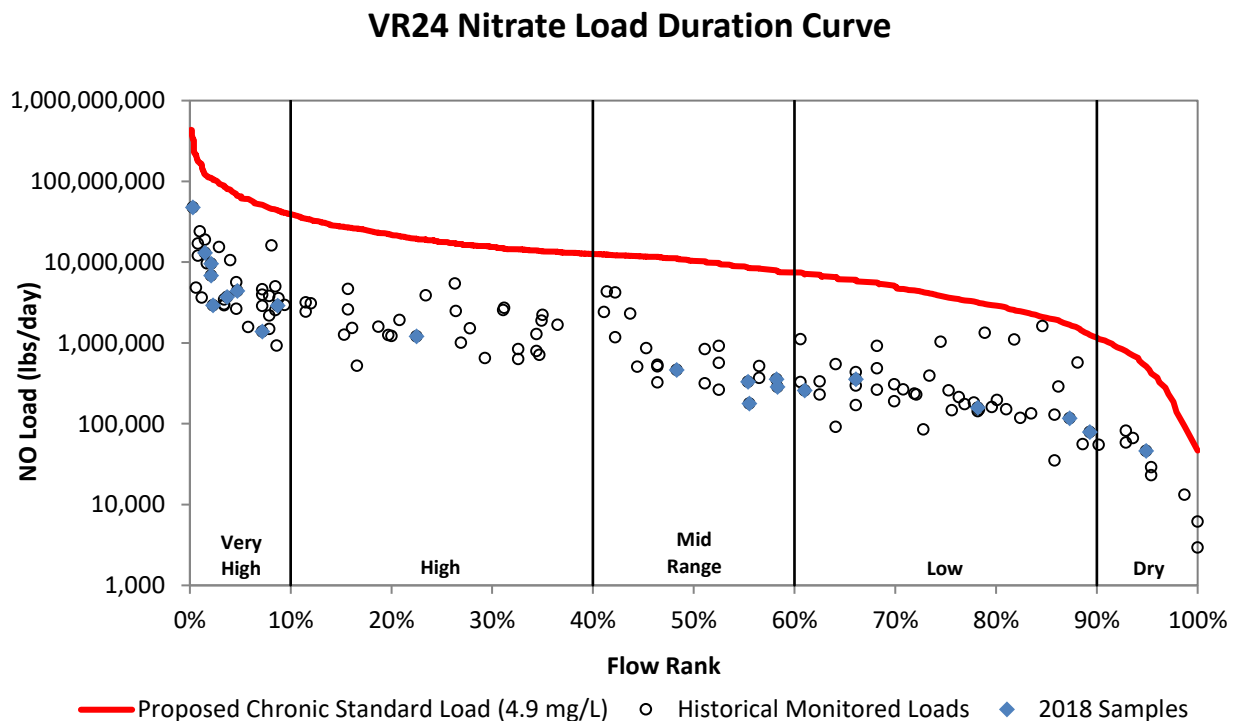
Figure 25a. Load duration curve for nitrate at VR24.

The proposed chronic standard for acute life toxicity (four day average concentration of 4.9 mg/L) for 2B streams was used to analyze loading capacity for VR24, VR803, and VR0020 (MPCA 2010). Single day loads at VR24 fell below the chronic standard (Figure 25a), but levels at VR803 and VR0020 were consistently at or near the standard load during very high, high, and mid-range regimes (Figure 25h and 25i). The nitrate loading at SB802 is a major contributor to elevated nitrate levels at downstream site VR803 and VR0020.

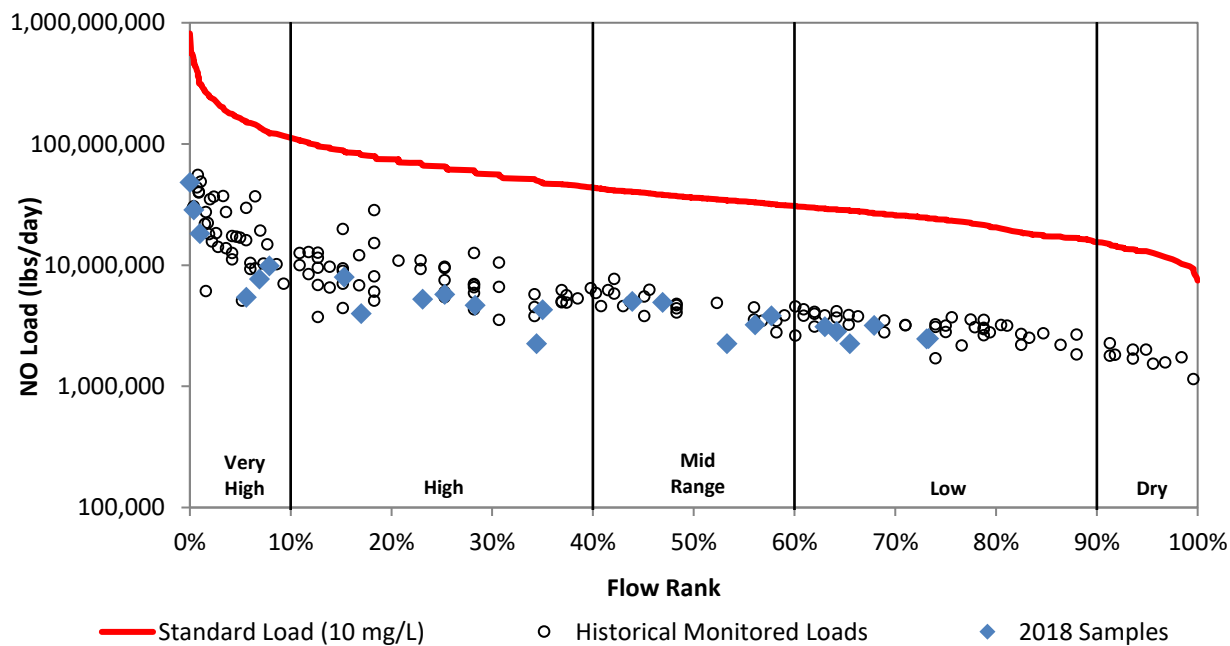
SC806 Nitrate Load Duration Curve

Figure 25b. Load duration curve for nitrate at SC806.

As expected, nitrate loads at coldwater streams were highest at SB802 (Figure 25g), though no monitoring site had exceedances of the drinking water standard at any flow regime in 2018 ($\leq 10\text{mg/L}$) (Figures 25a-i). Increased nitrate loads at SB802 could be attributed to the highly agricultural land use in the subwatershed, resulting from extensive use of drain tiles and/or increased fertilizer application resulting in nitrate leaching into shallow groundwater or directly discharged to the river through drain tiles.

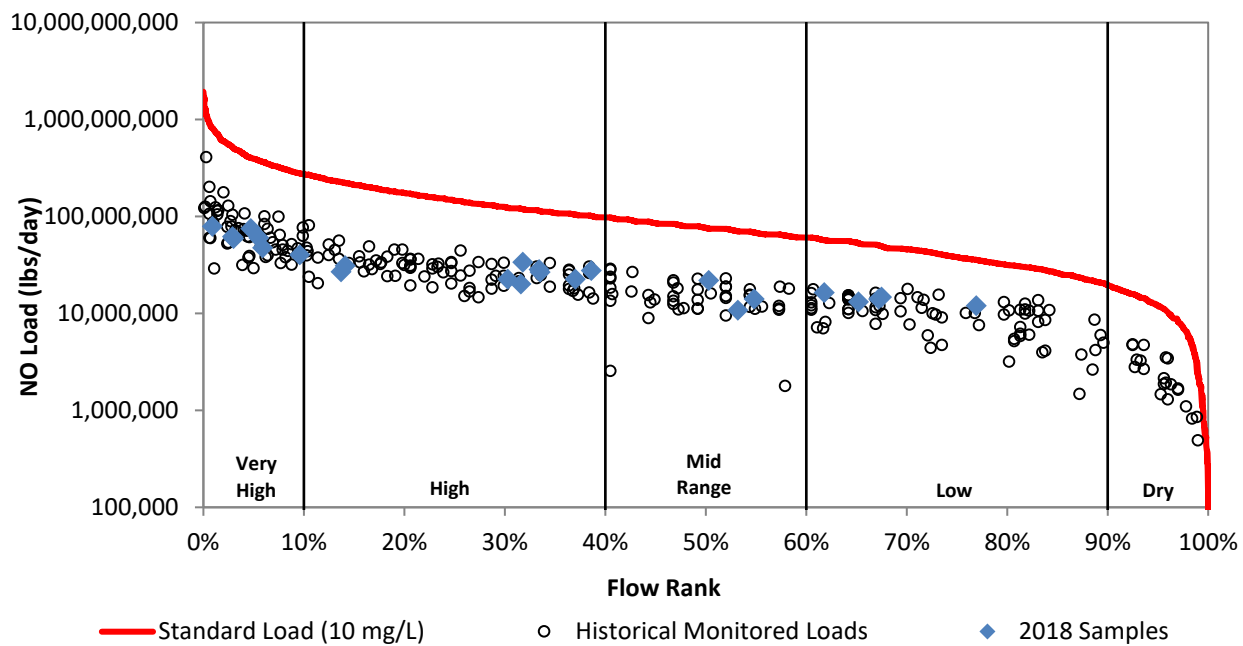
VR804 Nitrate Load Duration Curve

Figure 25c. Load duration curve for nitrate at VR804.

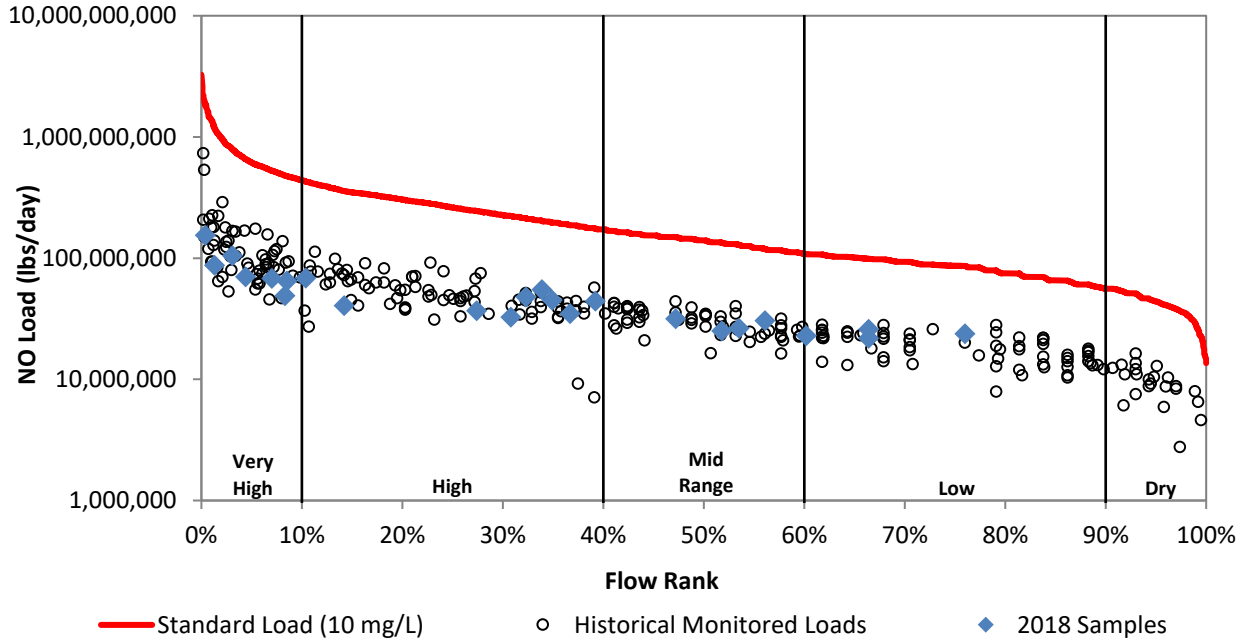
VR807 Nitrate Load Duration Curve

Figure 25d. Load duration curve for nitrate at VR807.

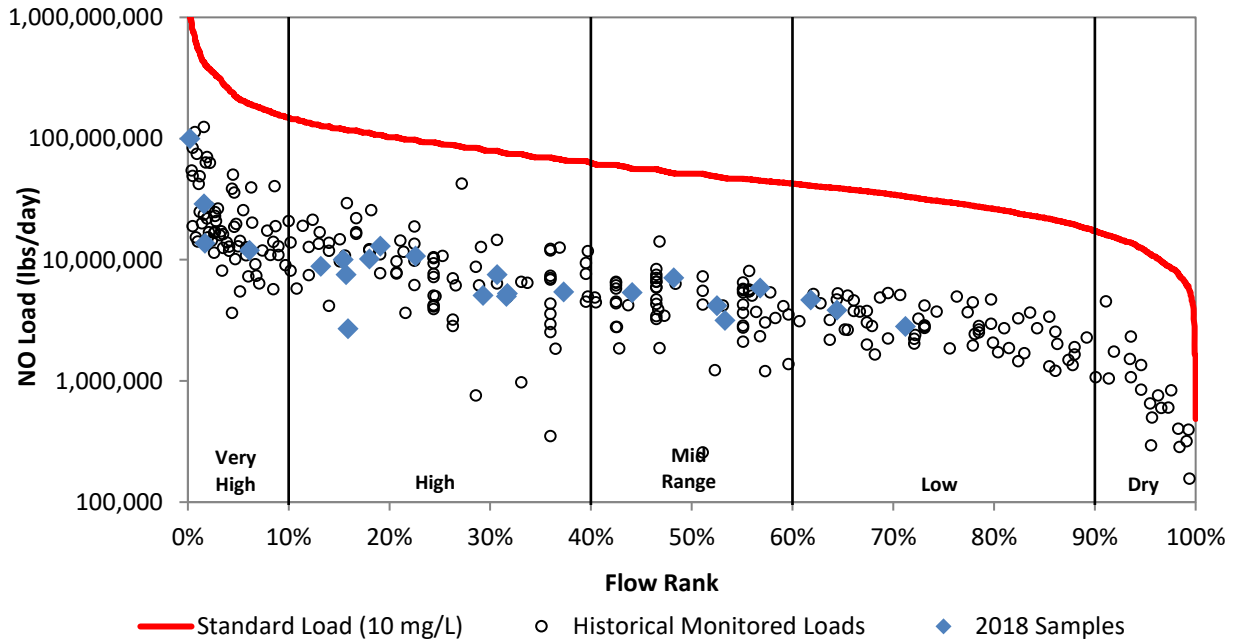
NC808 Nitrate Load Duration Curve

Figure 25e. Load duration curve for nitrate at NC808.

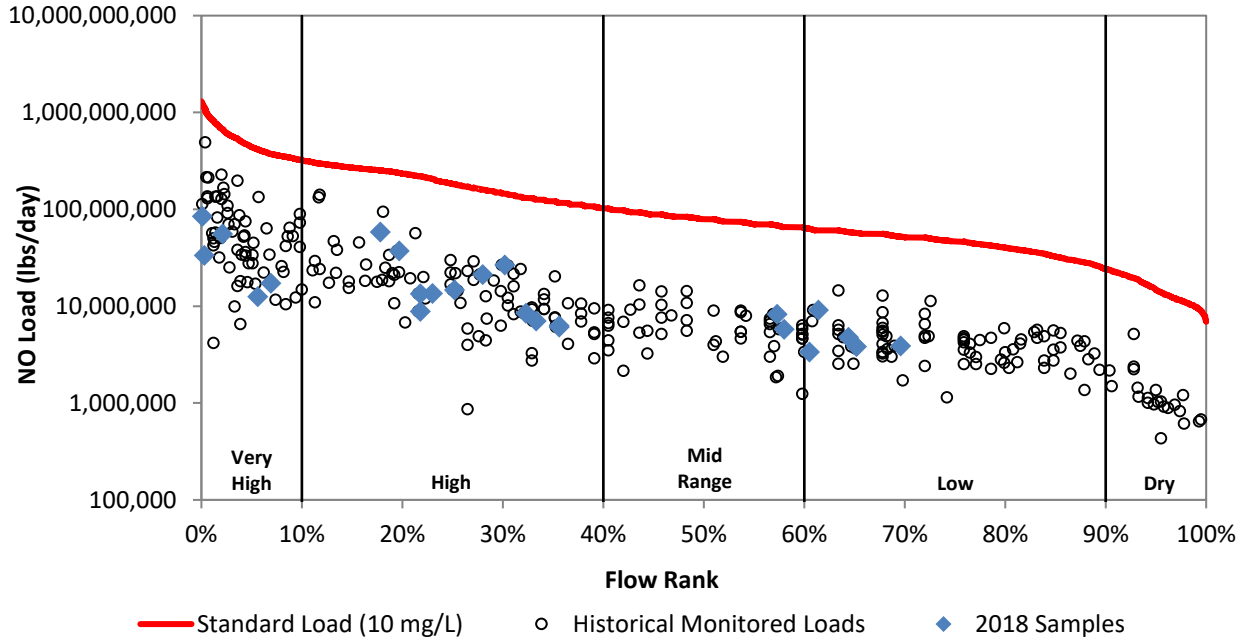
NC801 Nitrate Load Duration Curve

Figure 25f. Load duration curve for nitrate at NC801.

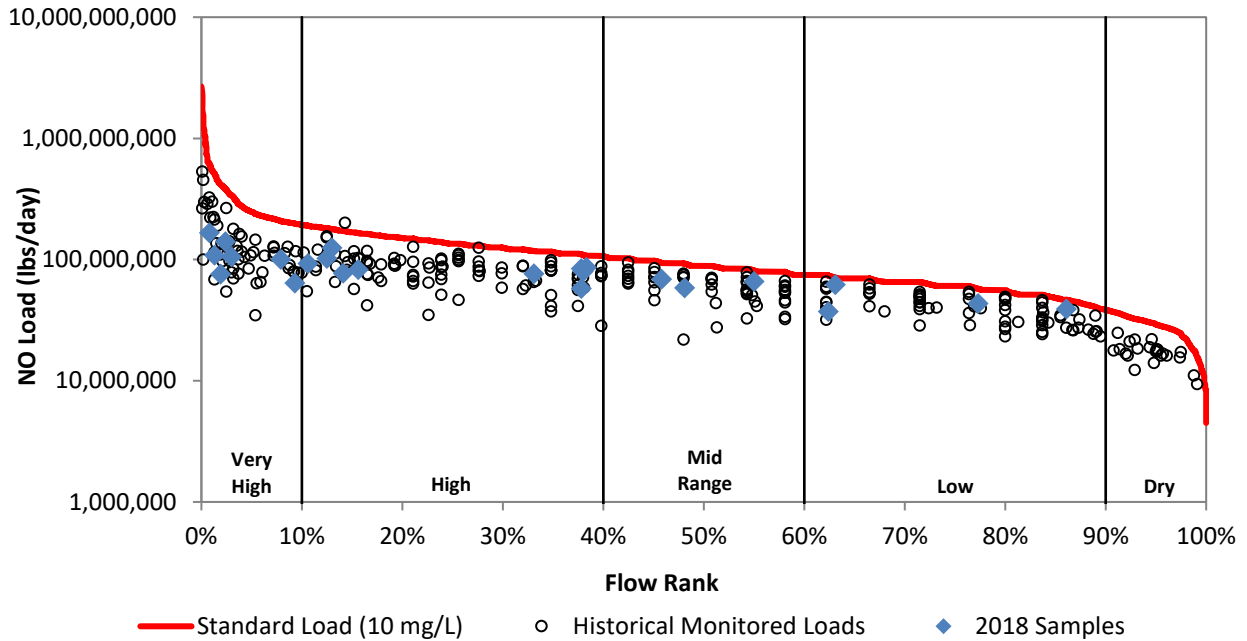
Figure 25g. Load duration curve for nitrate at SB802.

SB802 Nitrate Load Duration Curve

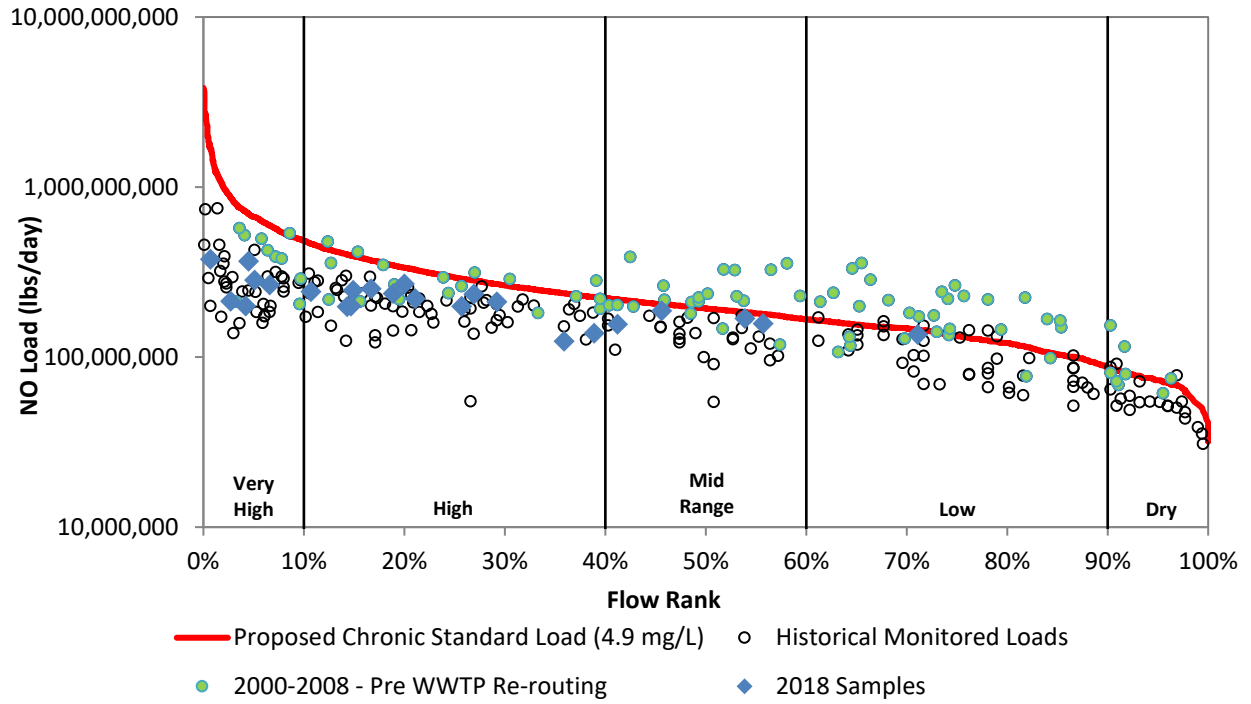
Figure 25h. Load duration curve for nitrate at VR803.

VR803 Nitrate Load Duration Curve

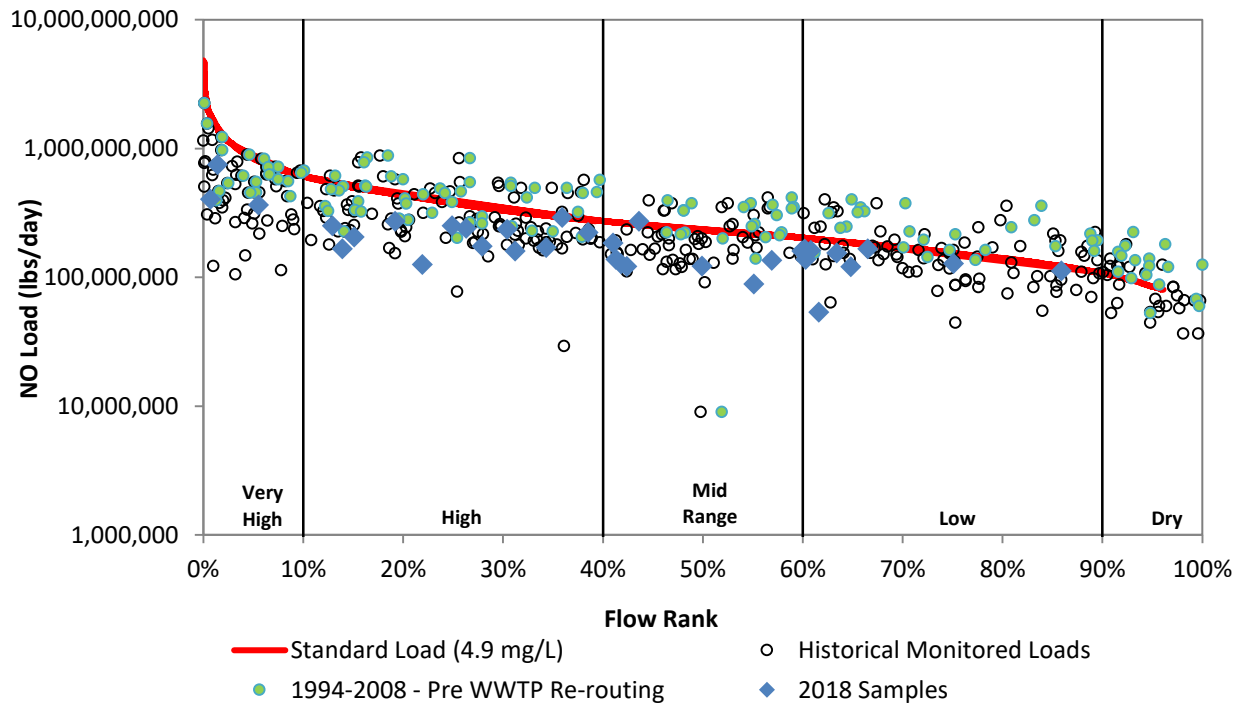
Figure 25i. Load duration curve for nitrate at VR0020.

VR0020 Nitrate Load Duration Curve

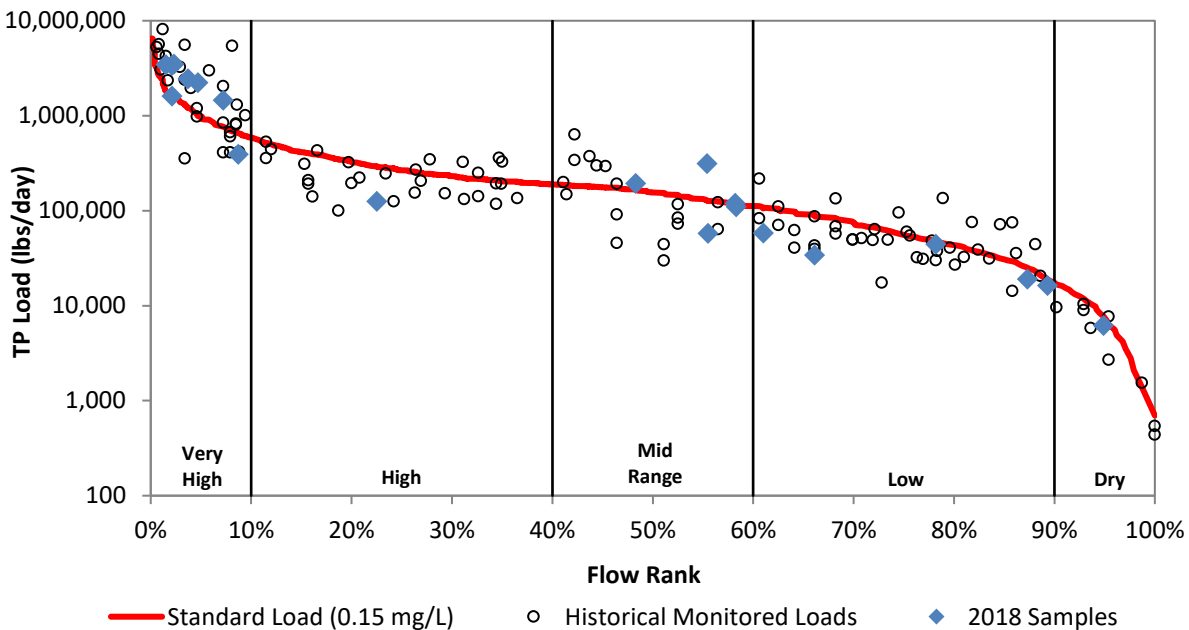
Figure 26a. Load duration curve for total phosphorus at VR24.

VR24 Total Phosphorus Load Duration Curve

The majority of exceedances for the total phosphorus standard load (0.15 mg/L) collected in 2018 occurred during high and very high flows (Figures 26a-i). A small percentage of samples were at or near the standard at mid-range and no exceedances occurred at low flows (VR24, VR804, VR803, VR0020), or in dry conditions.

Though Elko New Market WWTP was decommissioned and re-routed in 2012, total phosphorus levels remain at or near the standard during all flow regimes at VR24 (Figure 26a). The elevated concentrations could be a result of legacy phosphorus still present in the river and may continue to impact phosphorus levels for years to come.

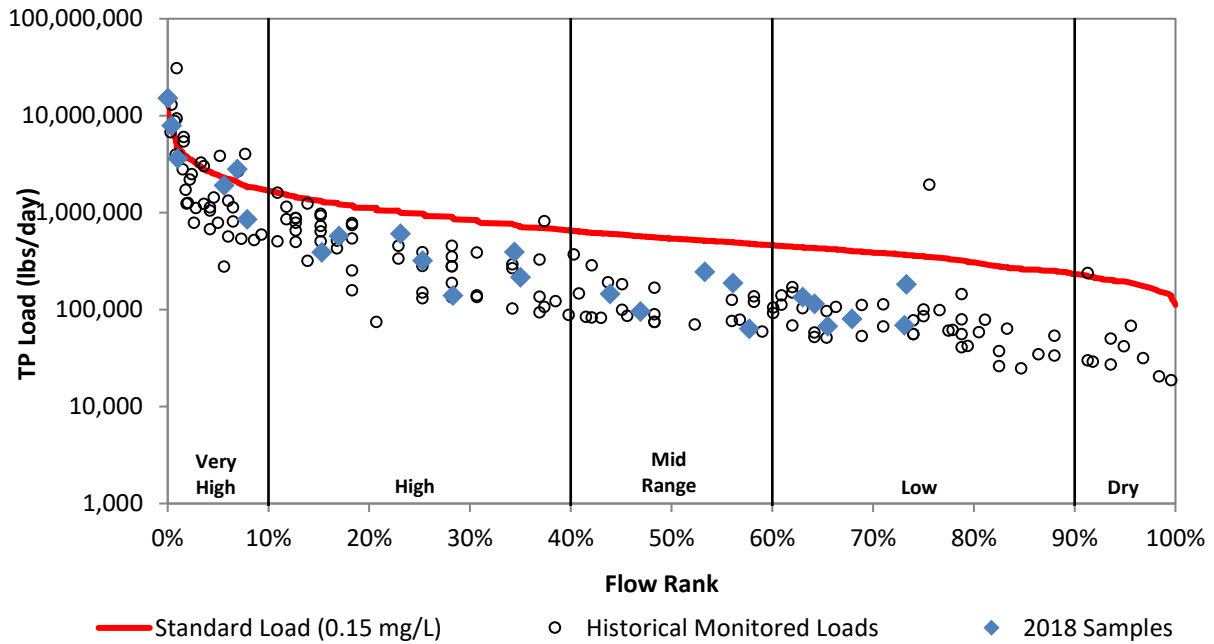
Figure 26b. Load duration curve for total phosphorus at SC806.

SC806 Total Phosphorus Load Duration Curve

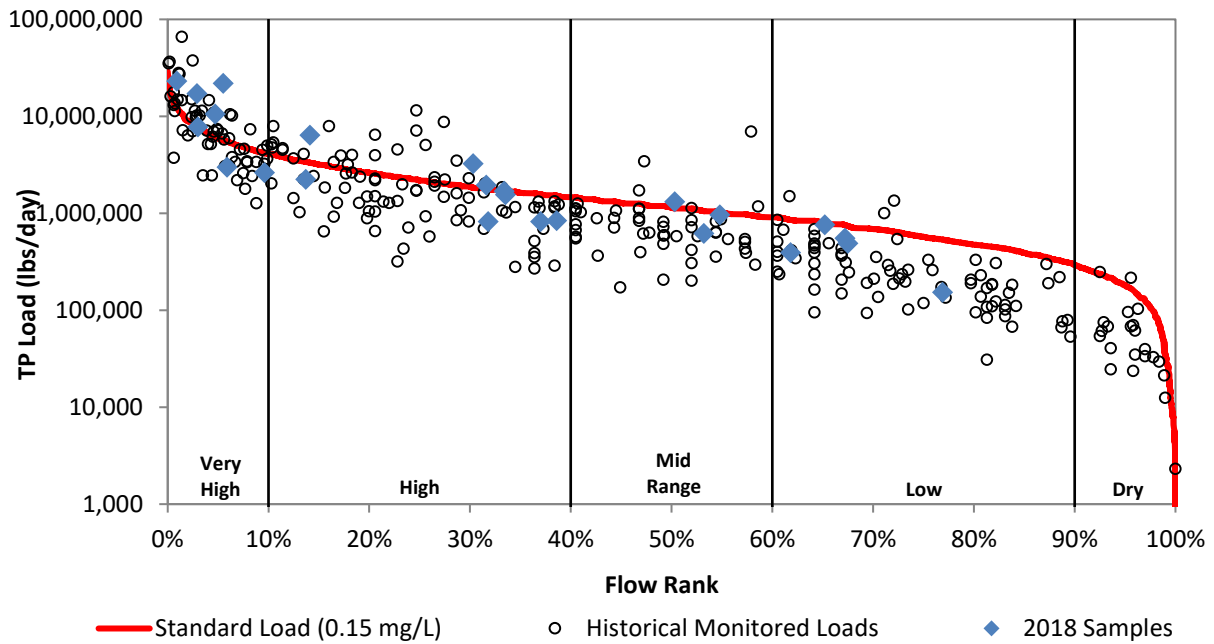
Figure 26c. Load duration curve for total phosphorus at VR804.

VR804 Total Phosphorus Load Duration Curve

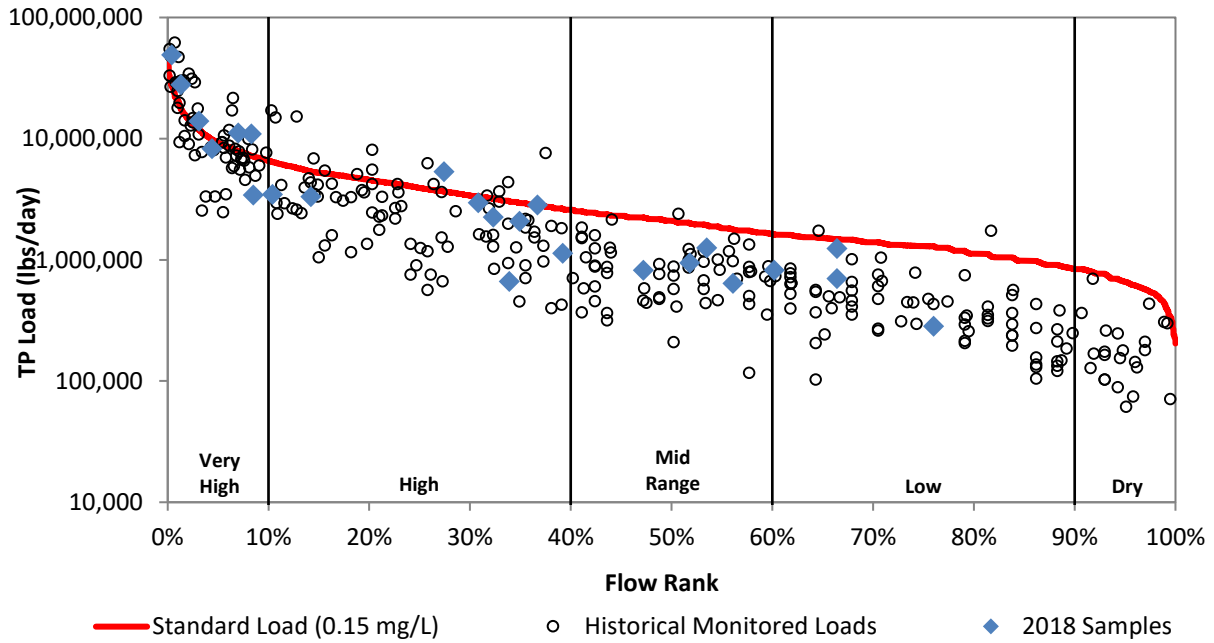
Figure 26d. Load duration curve for total phosphorus at VR807.

VR807 Total Phosphorus Load Duration Curve

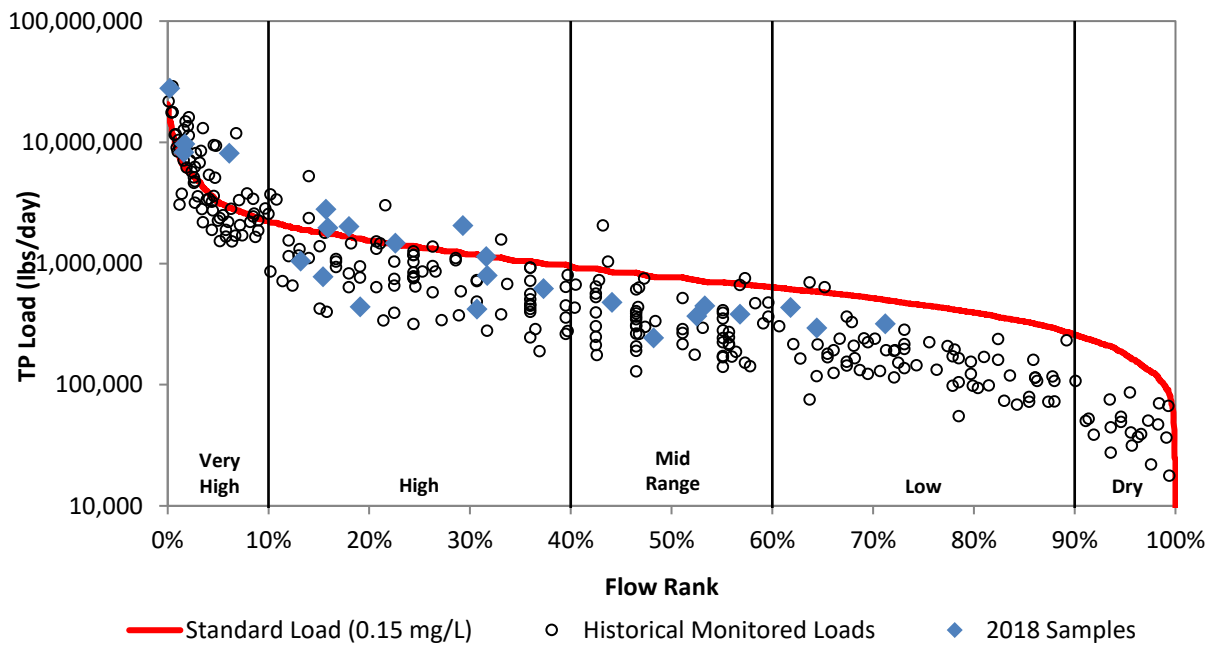
Figure 26e. Load duration curve for total phosphorus at NC808.

NC808 Total Phosphorus Load Duration Curve

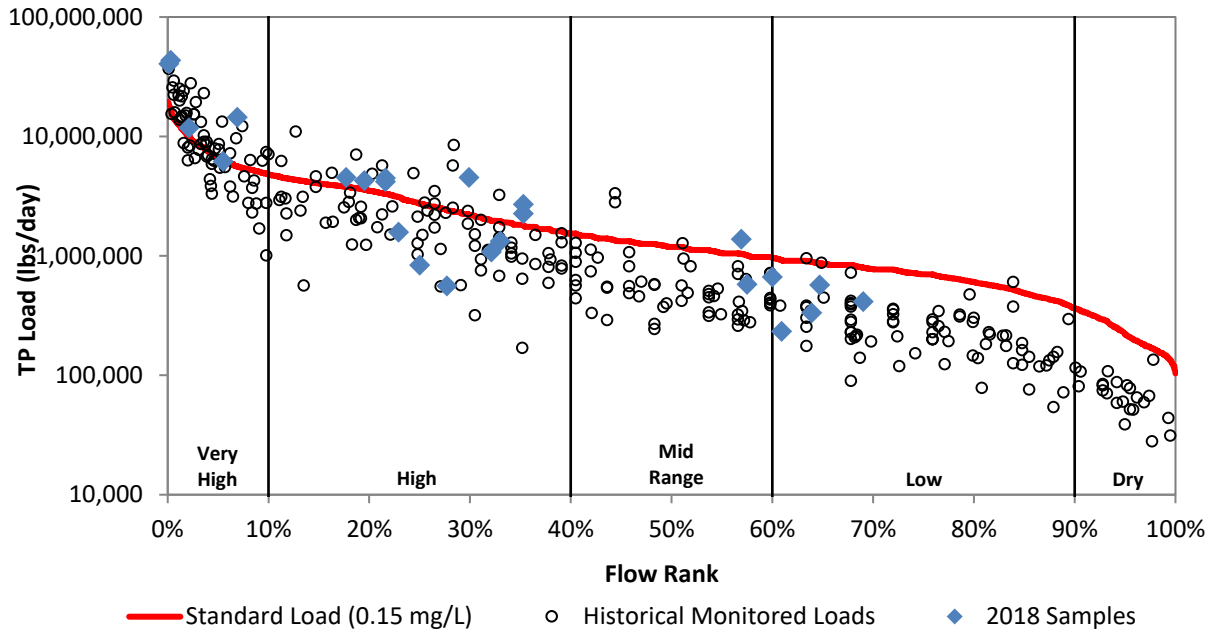
Figure 26f. Load duration curve for total phosphorus at NC801.

NC801 Total Phosphorus Load Duration Curve

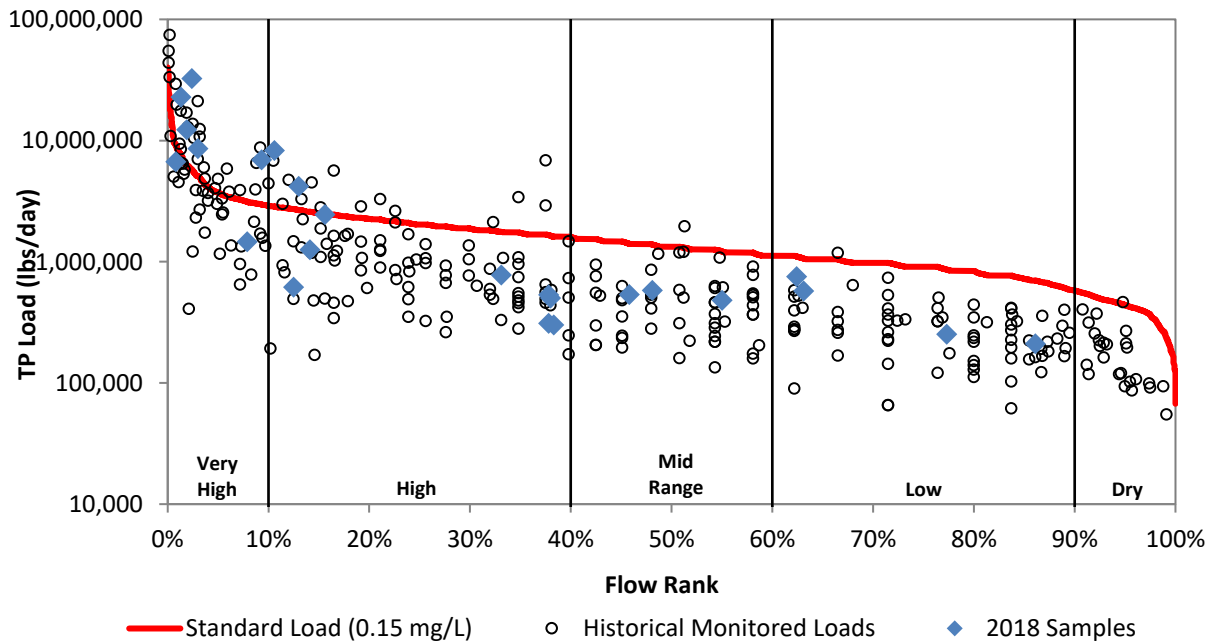
Figure 26g. Load duration curve for total phosphorus at SB802.

SB802 Total Phosphorus Load Duration Curve

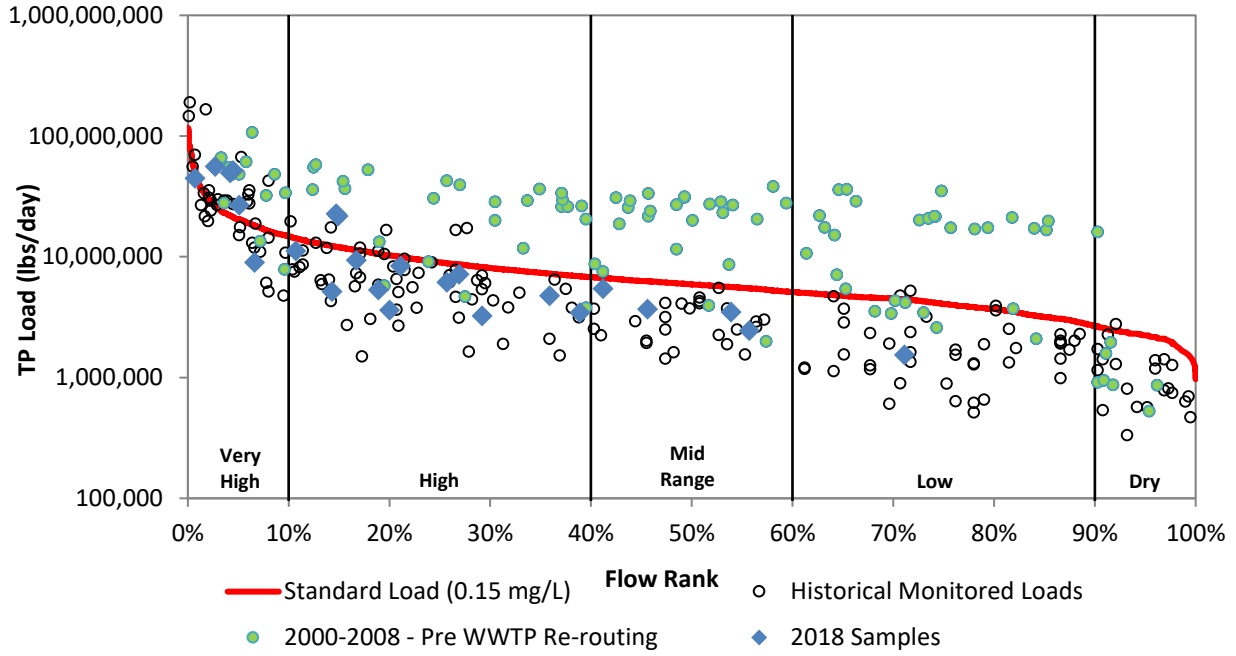
Figure 26h. Load duration curve for total phosphorus at VR803.

VR803 Total Phosphorus Load Duration Curve
