Vermillion River Monitoring Network 2018 Annual Report

*Prepared for the Vermillion River Watershed Joint Powers Organization
by the Dakota County Soil and Water Conservation District*

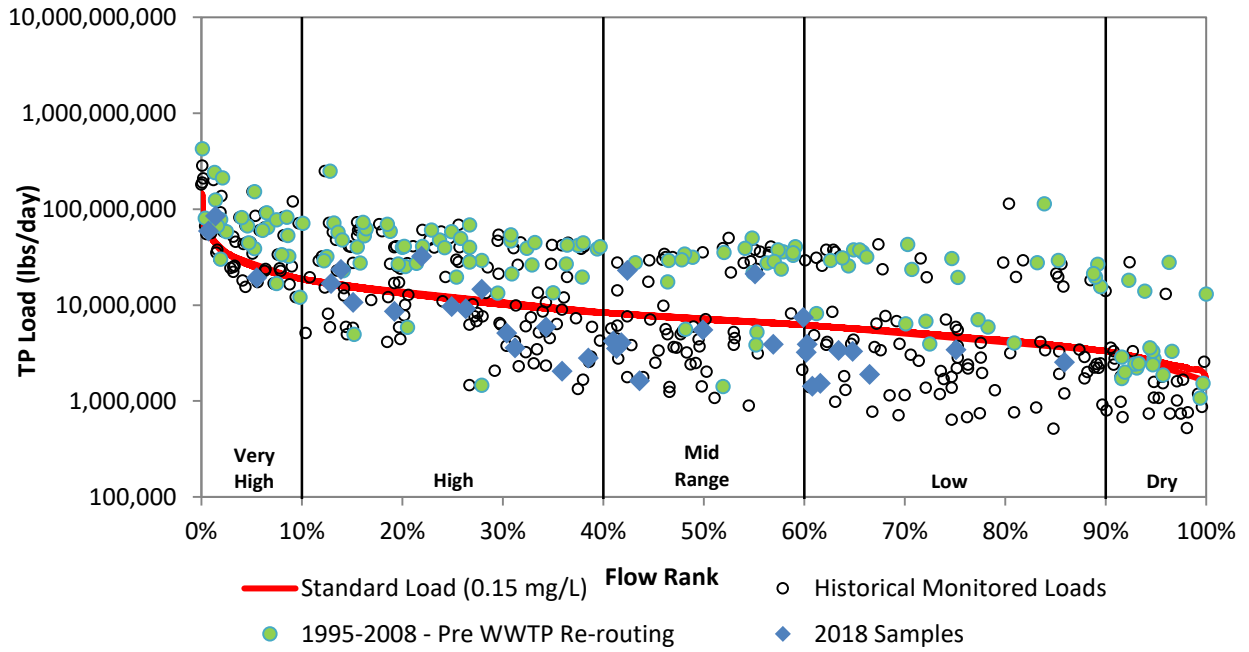
Figure 26i. Load duration curve for total phosphorus at VR0020.

VR0020 Total Phosphorus Load Duration Curve

The majority of exceedances for the total phosphorus standard load (0.15 mg/L) collected in 2018 occurred during high and very high flows (Figures 26a-i). A small percentage of samples were at or near the standard at mid-range and no exceedances occurred at low flows (VR24, VR804, VR803, VR0020), or in dry conditions.

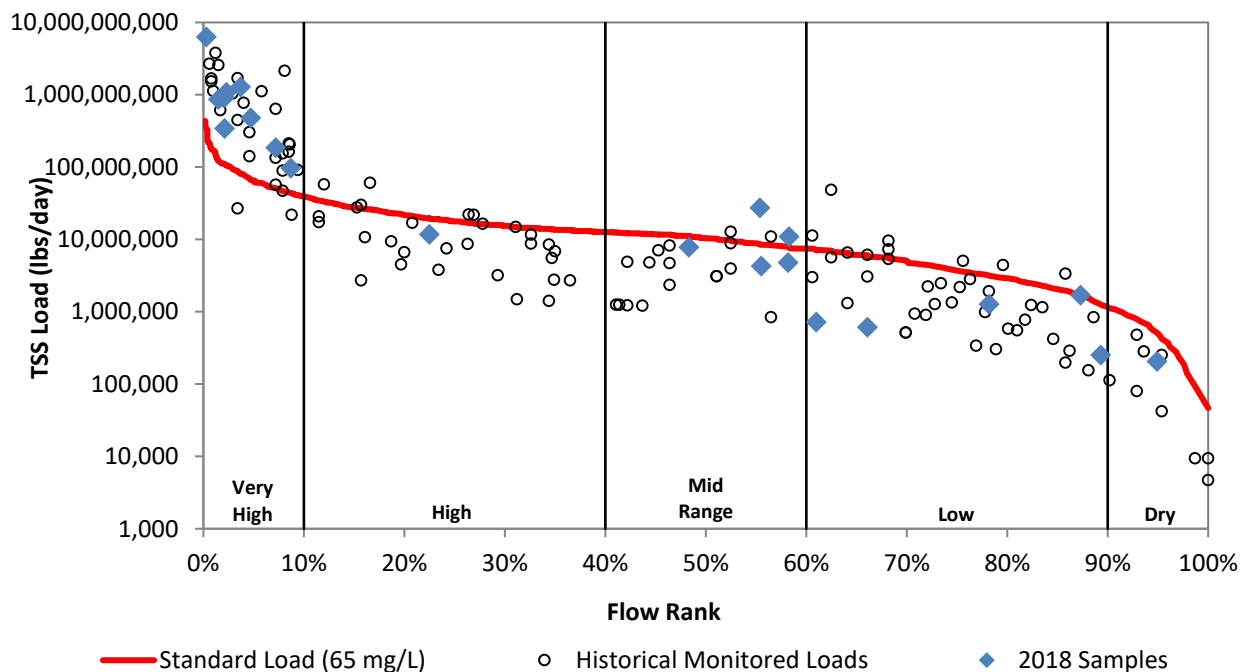
Figure 27a. Load duration curve for total suspended solids at VR24.

VR24 Total Suspended Solids Load Duration Curve

Most exceedances of the standard load for TSS in 2018 occurred during high and very high flows (a few were seen during mid-range conditions as well). Higher levels of TSS are expected during those flow regimes due to increases in runoff from impervious surfaces and agricultural fields during rain events, as well as bank erosion as water levels and flow rates increase.

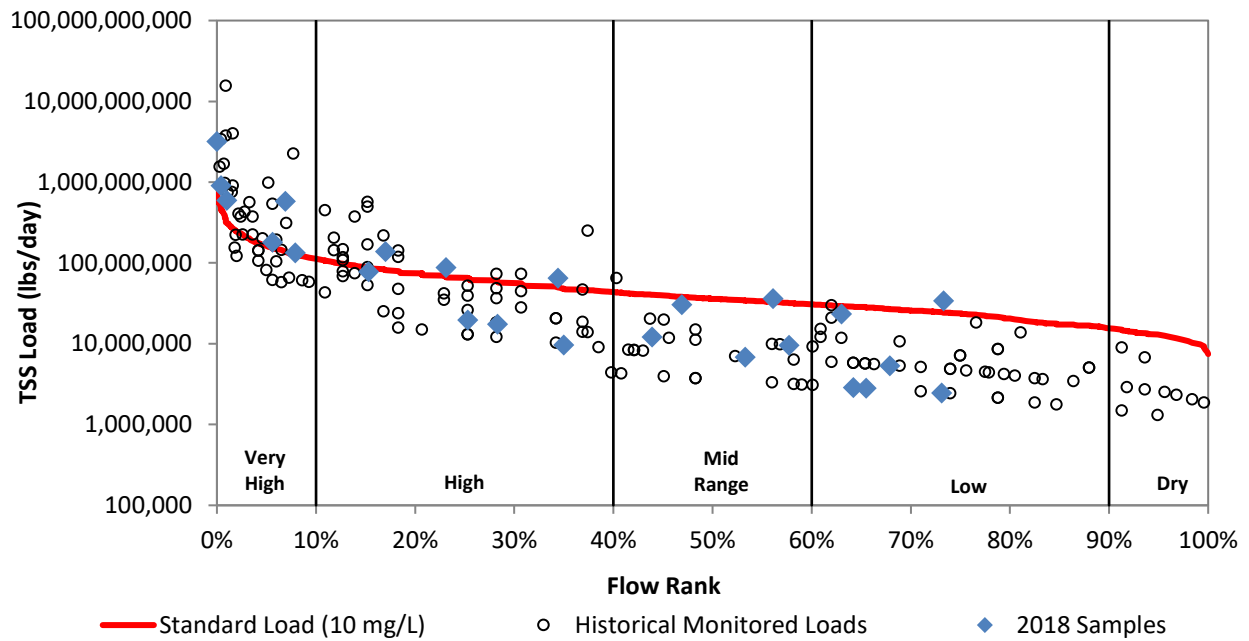
Figure 27b. Load duration curve for total suspended solids at SC806.

SC806 Total Suspended Solids Load Duration Curve

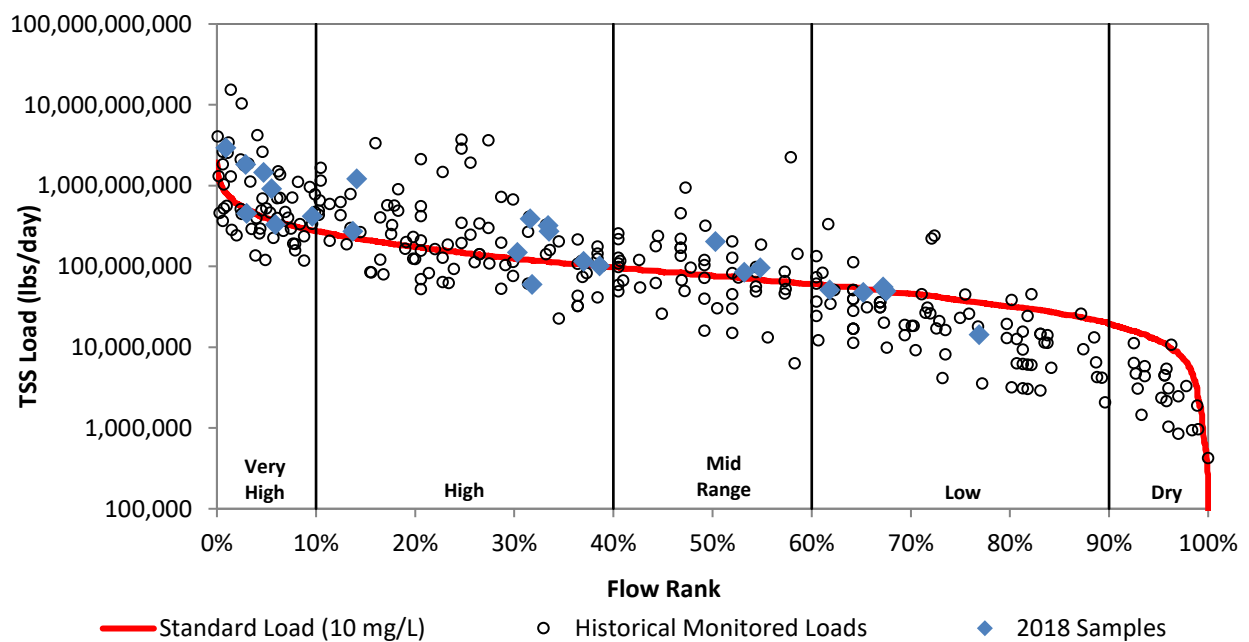
Figure 27c. Load duration curve for total suspended solids at VR804.

VR804 Total Suspended Solids Load Duration Curve

Both VR804 (Figure 27c) and SB802 (Figure 27g), highly agricultural subwatersheds where exposed soils could contribute to elevated TSS levels, also had exceedances in the mid-range and low flow regimes. Much like in 2017, exceedances in the mid-range and low flow regimes were also seen at VR807 (Figure 27d) which could be caused by higher TSS levels at VR804, the monitoring site immediately upstream. Unlike previous years, the three sites in more with more urban subwatersheds (SC806 (Figure 27b), NC801 (Figure 27f), NC808 (Figure 27e)) also had exceedances during mid-range and low flow conditions. Influxes of pollutants associated with urban stormwater (dirt, sand, oil, etc) following rain events are most likely the cause.

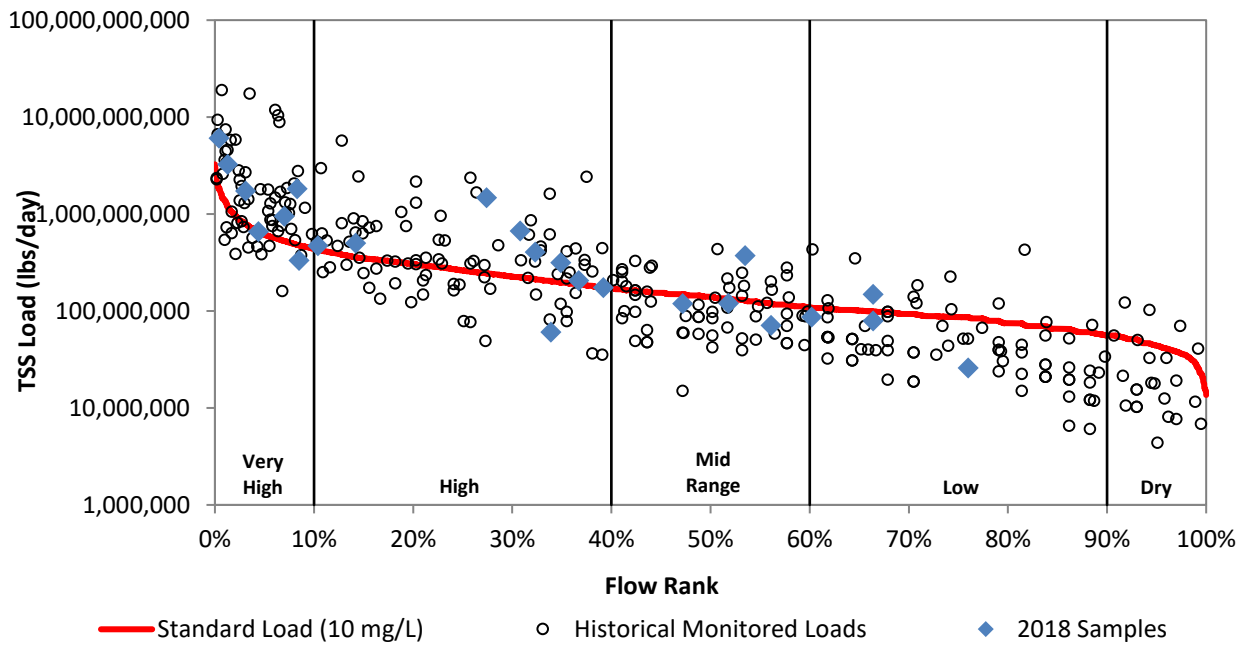
Figure 27d. Load duration curve for total suspended solids at VR807.

VR807 Total Suspended Solids Load Duration Curve

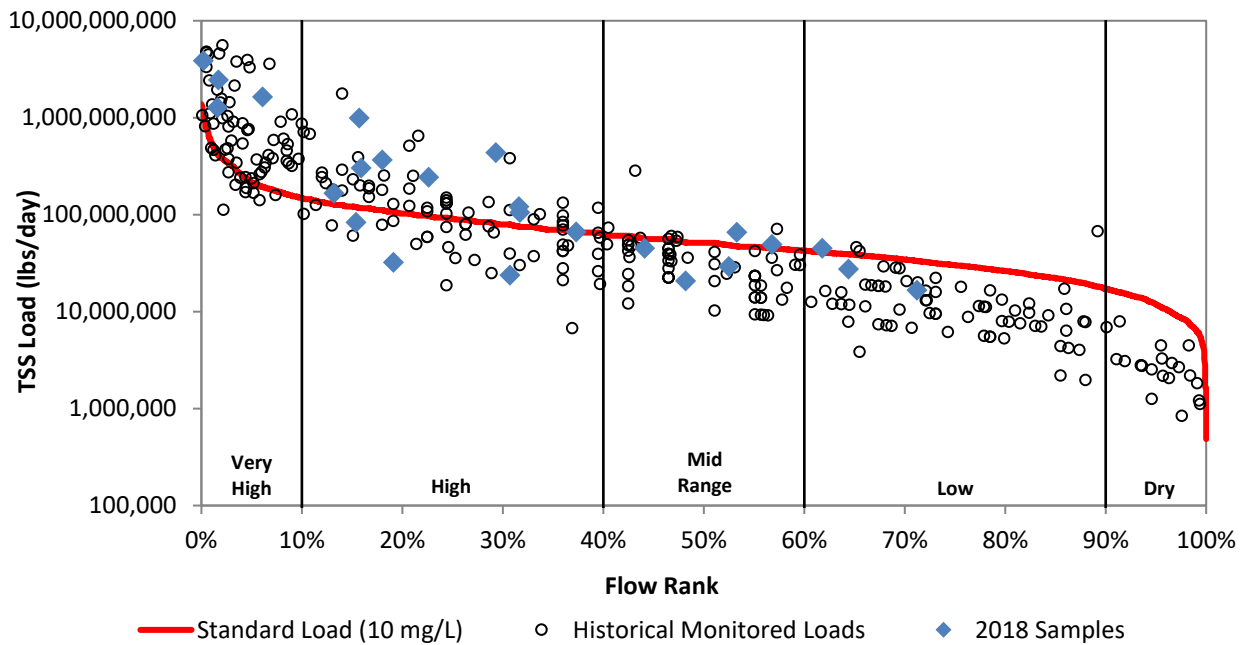
Figure 27e. Load duration curve for total suspended solids at NC808.

NC808 Total Suspended Solids Load Duration Curve

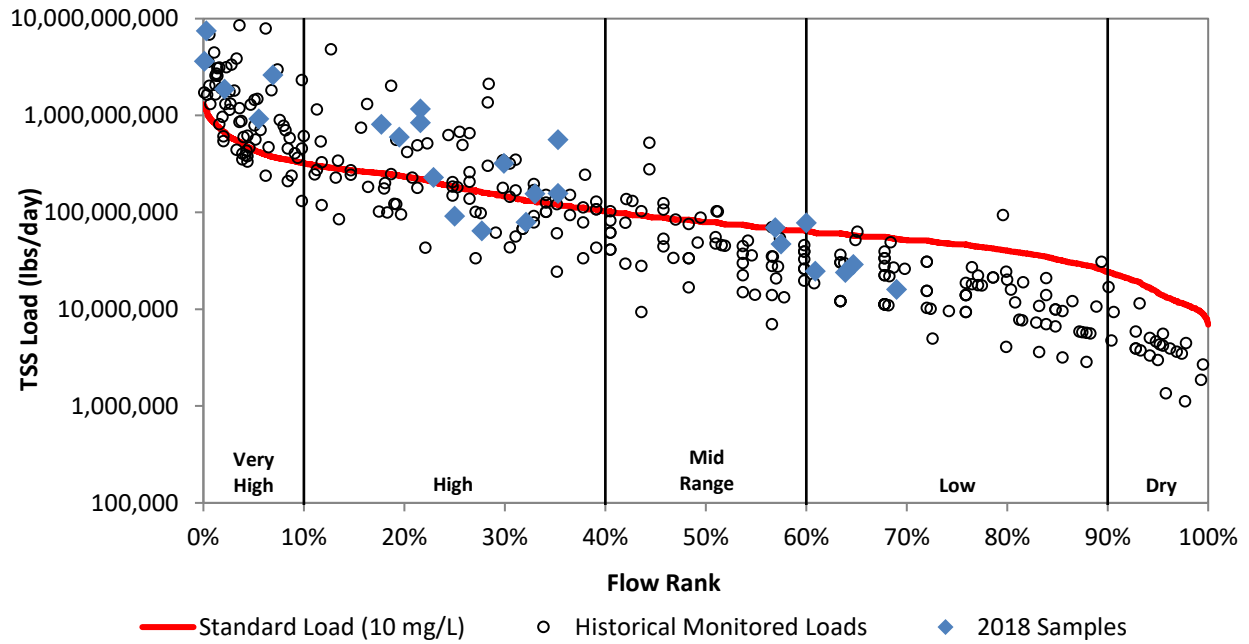
Figure 27f. Load duration curve for total suspended solids at NC801.

NC801 Total Suspended Solids Load Duration Curve

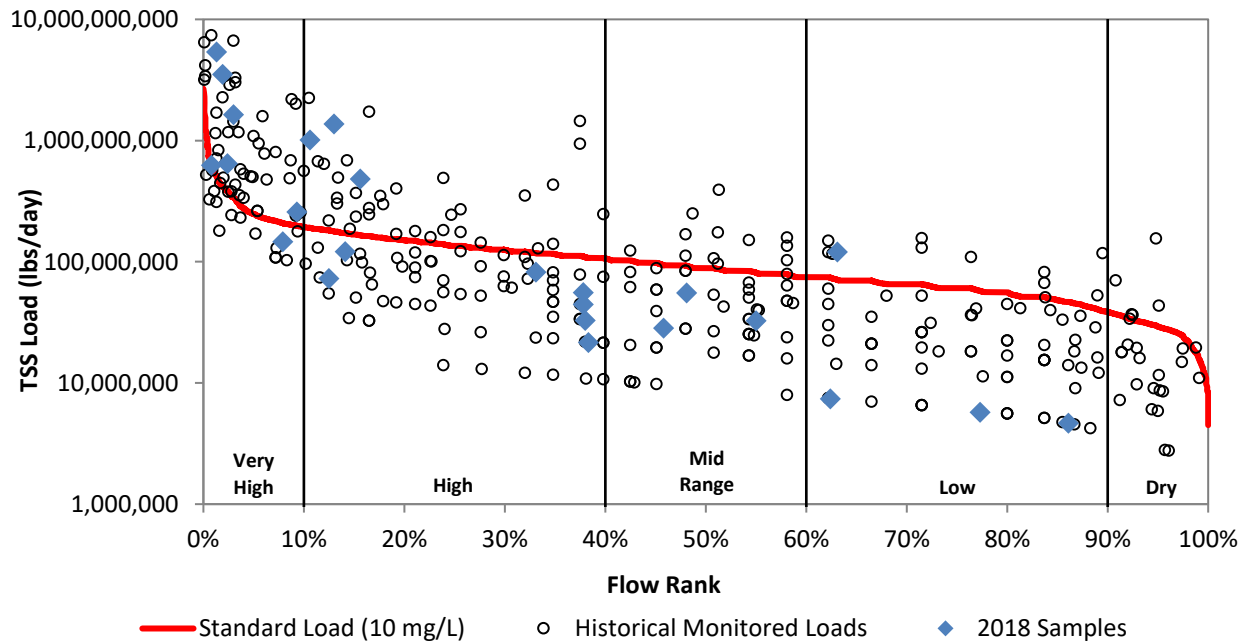
Figure 27g. Load duration curve for total suspended solids at SB802.

SB802 Total Suspended Solids Load Duration Curve

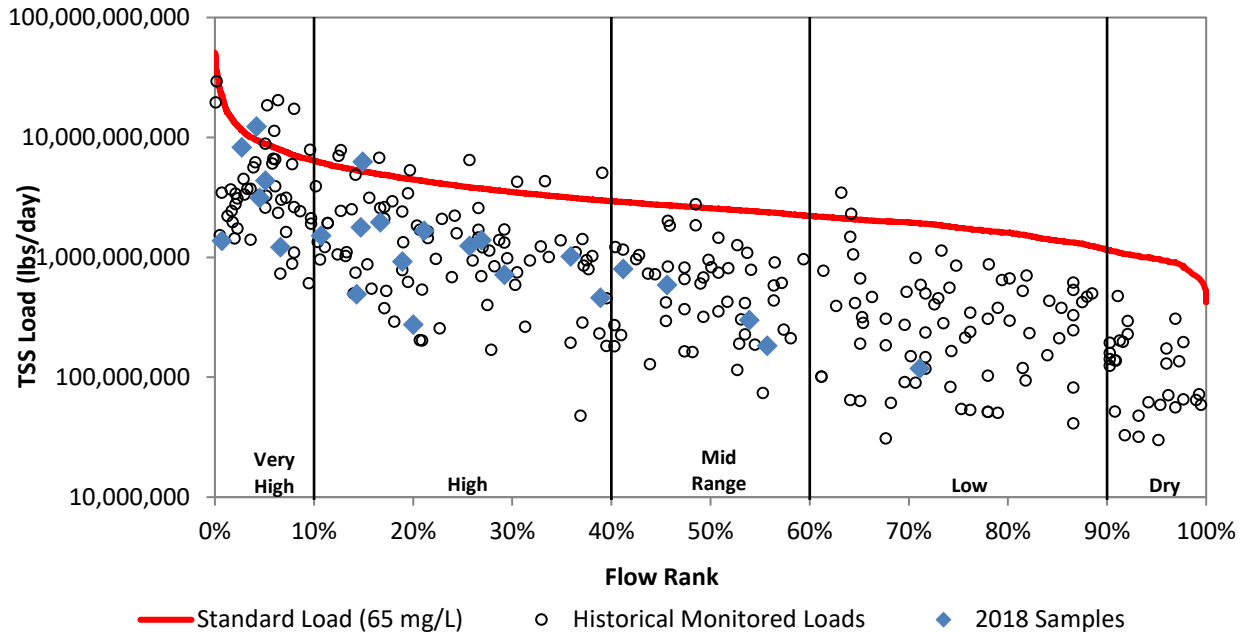
Figure 27h. Load duration curve for total suspended solids at VR803.

VR803 Total Suspended Solids Load Duration Curve

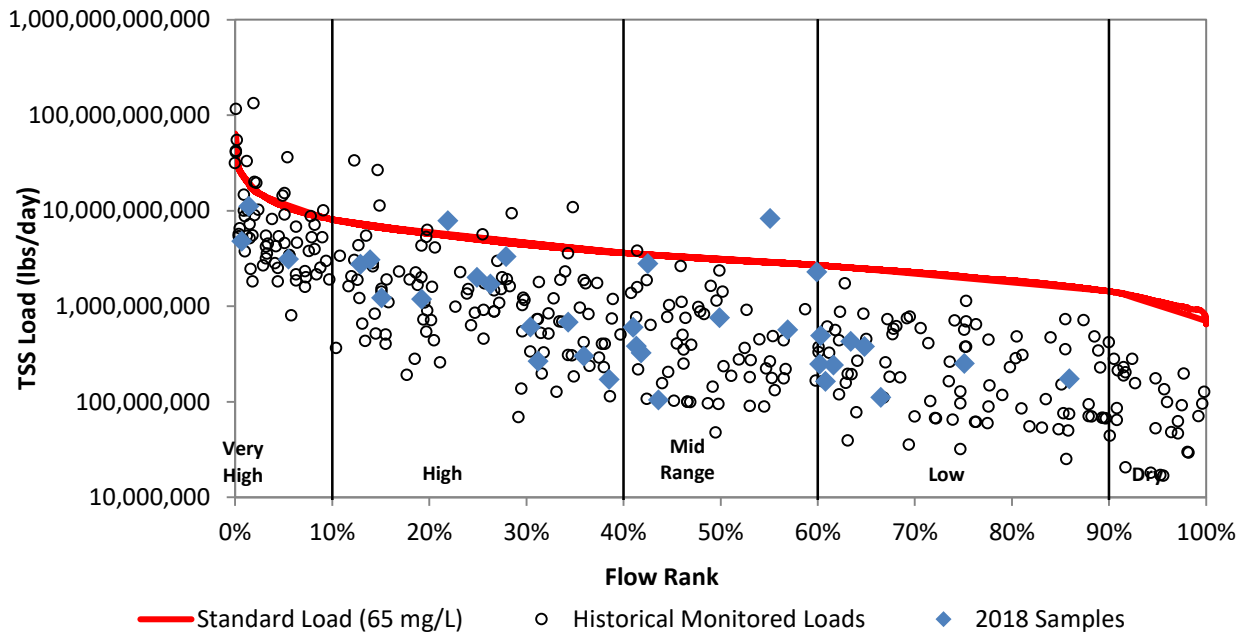
Figure 27i. Load duration curve for total suspended solids at VR0020.

VR0020 Total Suspended Solids Load Duration Curve

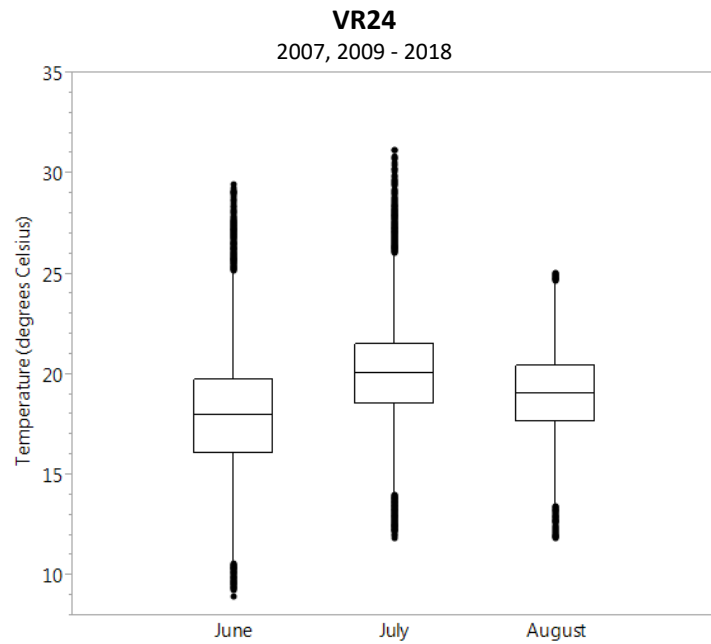
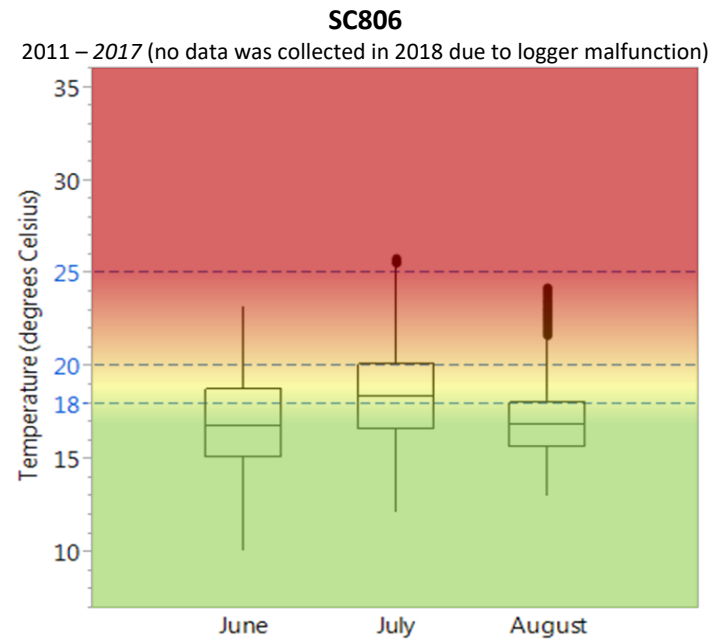
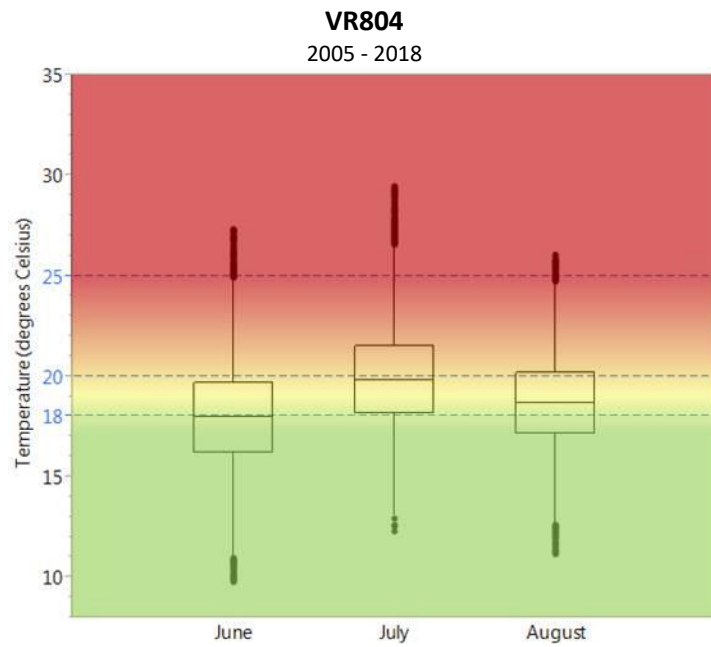
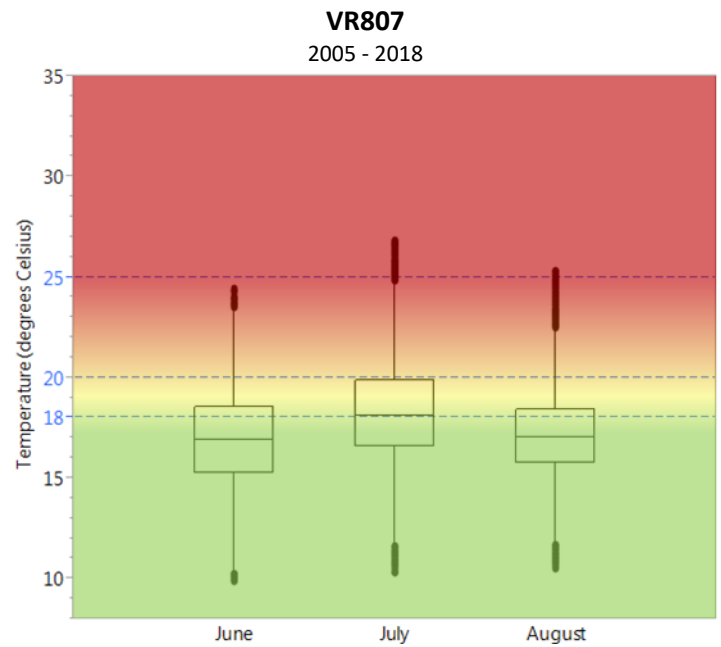
Continuous temperature data, measured in 15 minute intervals, has been collected annually starting in 2005 for many of the sentinel monitoring stations in the Vermillion River monitoring network. Figure 28 shows the median, 25th and 75th percentiles, and outliers for each site during the summer months (June through August). Stations VR24, VR803, and VR0020 are in warm water (2B) reaches; figures for these stations do not contain trout temperature limits as they do not apply.

Figure 28. Continuous temperature data for each permanent monitoring station during the summer months from 2005-2018 (when available). Temperature ranges apply to adult Brown Trout. Optimal <18°C, tolerance 18-20°C, resistance 20-22°C, and complete mortality at 25°C (Coutant (1975), Gardner & Leetham (1914), Bell (2006))

Optimum: The 'optimum' temperature is that in which growth is optimized; fish will often preferentially move to the optimum temperature. For adult brown trout, the optimal temperature is less than 18°C (shown green in Figure 28).

Tolerance: Beyond the optimum range is the tolerance range. The tolerance range for adult brown trout is 18-20°C (shown yellow in Figure 28) and can be more clearly defined as the upper limit of the temperature beyond which 50% of the population survives an indefinitely long exposure. The tolerance range is generally avoided, but can be endured, and often is, for short periods of time for various reasons such as foraging for food.

Resistance: The upper limit of the resistance range is bounded by the critical thermal maximum at 20-22°C (shown orange in Figure 28) (Coutant, 1975). Prolonged exposure to temperatures in the resistance range often leads to high mortality rate, which is consistent with observations by Gardner and Leetham (1914) in which high mortality above 20°C and complete mortality above 25°C (red) was described.

According to Figure 28, temperature maximums were measured in the resistance range (orange; > 20°C) at all class 2A streams during all summer months with the highest median water temperatures observed in July. The June median was within the optimum (green; < 18°C) range for all 2A waters, though the June median temperature for station VR804 was just below the optimum/tolerant threshold.

The August median temperature at SC806 and SB802 was lower than at other stream reaches. These lower temperatures may be attributed to cool groundwater feeding the stream during low flow conditions, either naturally from springs and seeps or artificially from tile drainage. Station SC806 has high conductivity values under low-flow conditions, consistent with the ion signature which is indicative of groundwater discharge to the reach, and there is little contribution from other tributaries. Station SB802 is representative of a subwatershed which has a lot of acres in agricultural production and presumably many acres of tile drained land. The nitrate concentrations near station SB802 further suggest a high degree of tile drainage (Watkins, et al., 2011). The tile, while a contributing factor towards some pollutant issues, appears to be an additional source of cold water to the South Branch Vermillion River, besides the groundwater inputs to the river.

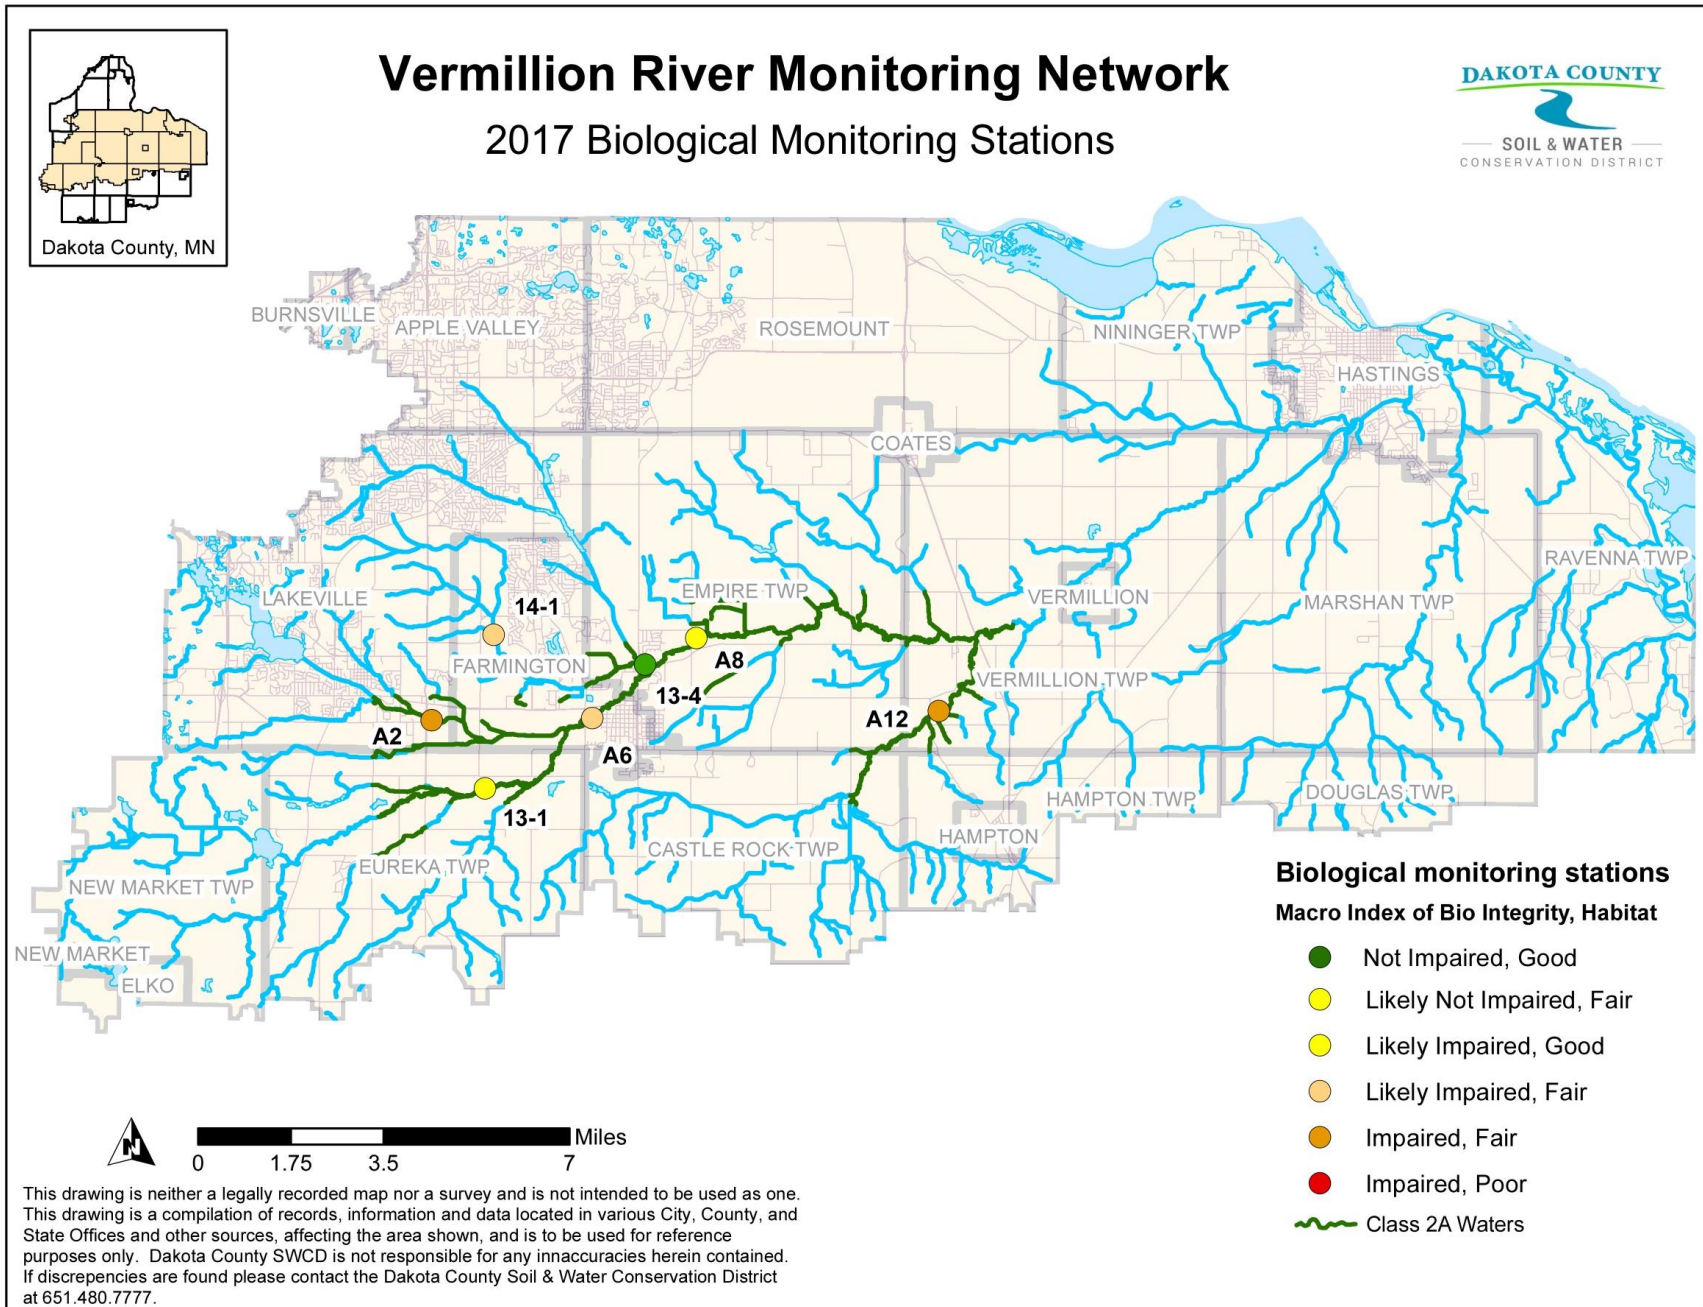
Figure 29 shows the biological monitoring network stations with a color ramp to easily visualize the quality of the macroinvertebrate community and habitat based on indices that are described later in this section. Only the sites that were actively monitored in 2018 are shown on the map. For more detailed information, including data and a map for biomonitoring sites which have been discontinued, refer to the following narrative sections and the Appendix.

Figure 29. Vermillion River Monitoring Network biological monitoring stations for habitat and macroinvertebrates in 2018.

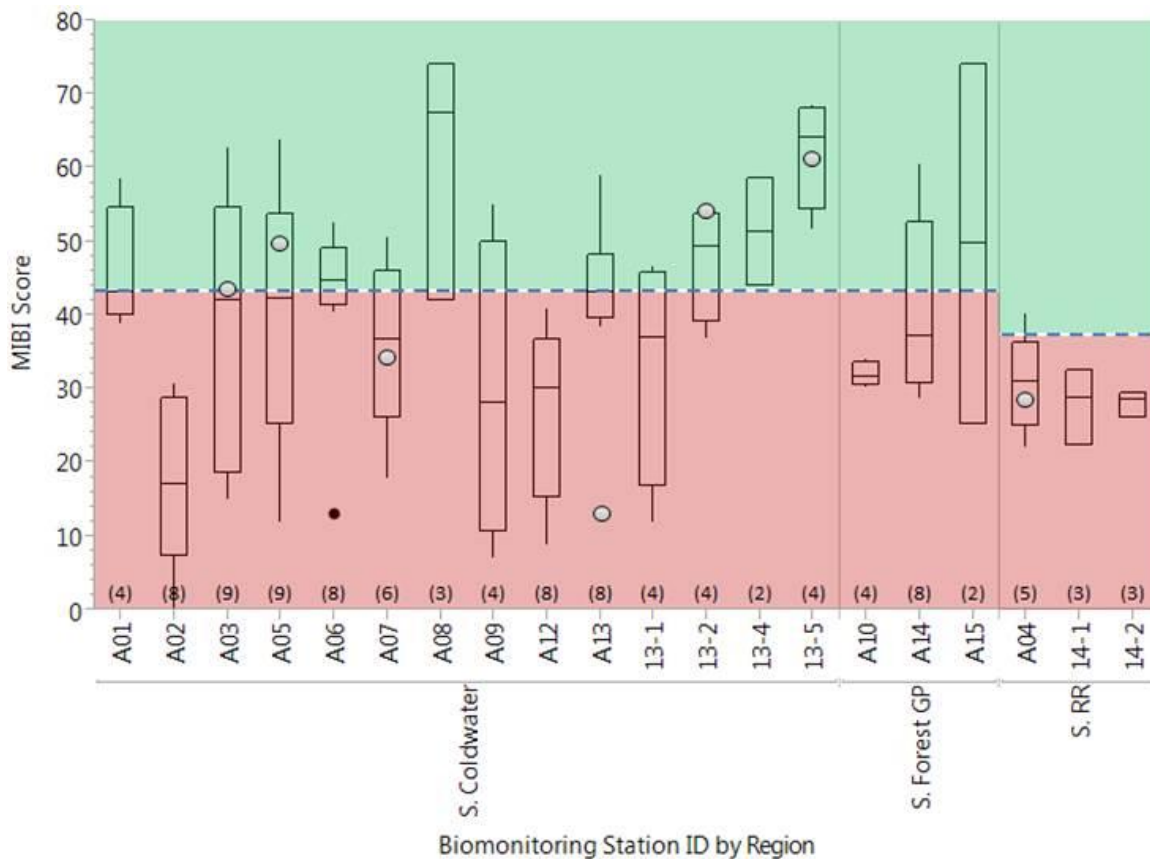
Figure 30. Macroinvertebrate Index of Biological Integrity (MIBI) score by region. Number of samples collected from 2009-2018 is shown in parenthesis (see Appendix for more details). The impairment threshold is indicated by a dashed blue line. Sites with scores above the threshold value (green area), are likely not to be considered 'impaired'. Sites with scores below the threshold value (red area), are likely to be considered 'impaired'. Sites monitored in 2018 have a black circle indicating the MIBI score.

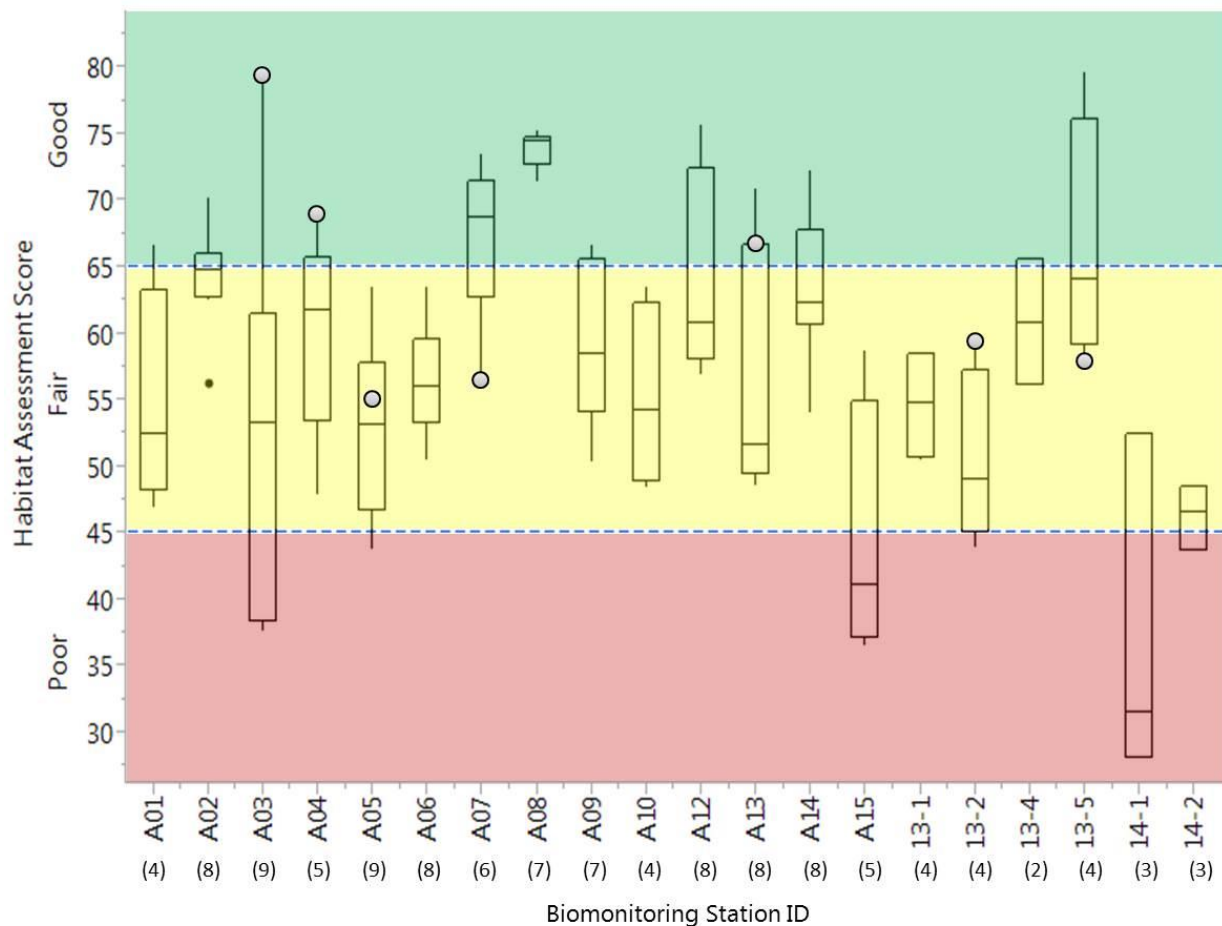
Figure 31. Habitat assessment scores for biomonitoring stations. Habitat scores for 2018 are indicated by grey circle. Dashed blue lines indicate limits for Good (≥ 66), Fair (45-65), and Poor (≤ 44) categories. Number of samples collected from 2009-2018 is shown in parenthesis (see Appendix for more details).

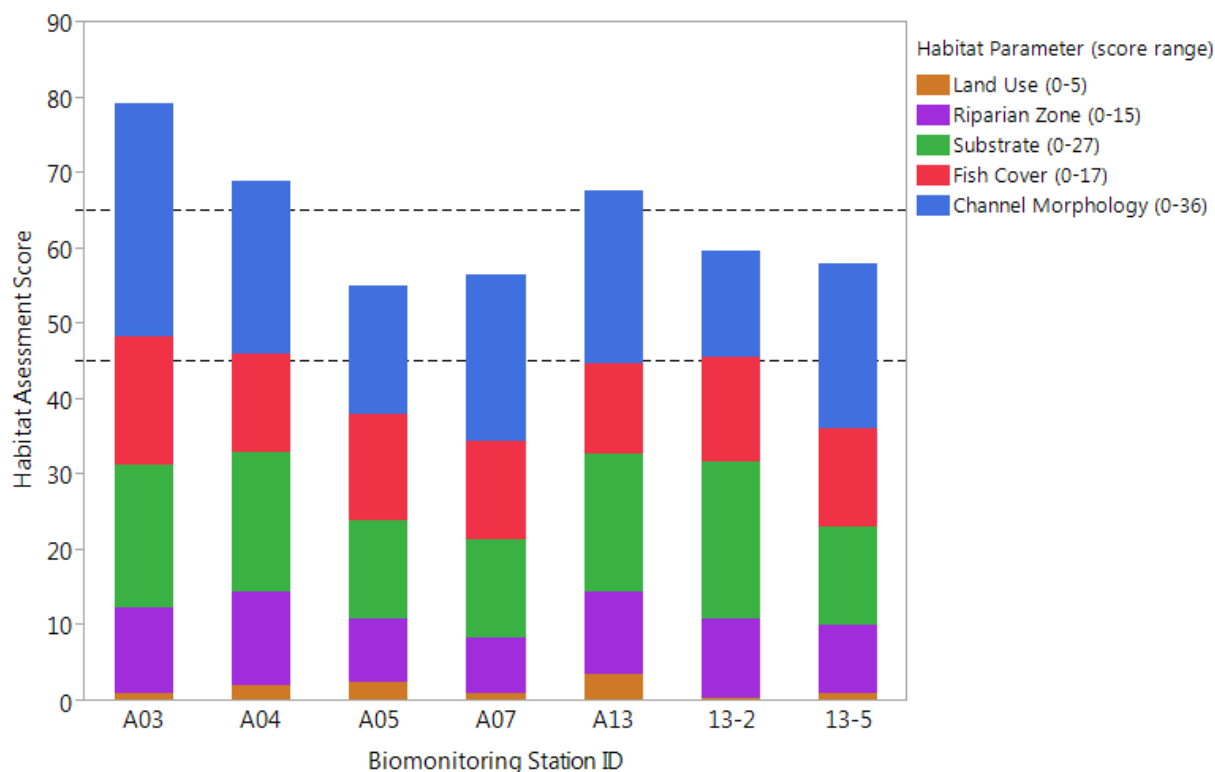
Figure 32. Habitat assessment score by habitat parameter for each biomonitoring station in 2018. Dashed black lines indicate limits for Good (≥ 66), Fair (45-65), and Poor (≤ 44) categories based on the total habitat assessment score (total score of 100).
