Vermillion River Monitoring Network

2020 Annual Report

*Prepared for the Vermillion River Watershed Joint Powers Organization
by the Dakota County Soil and Water Conservation District*

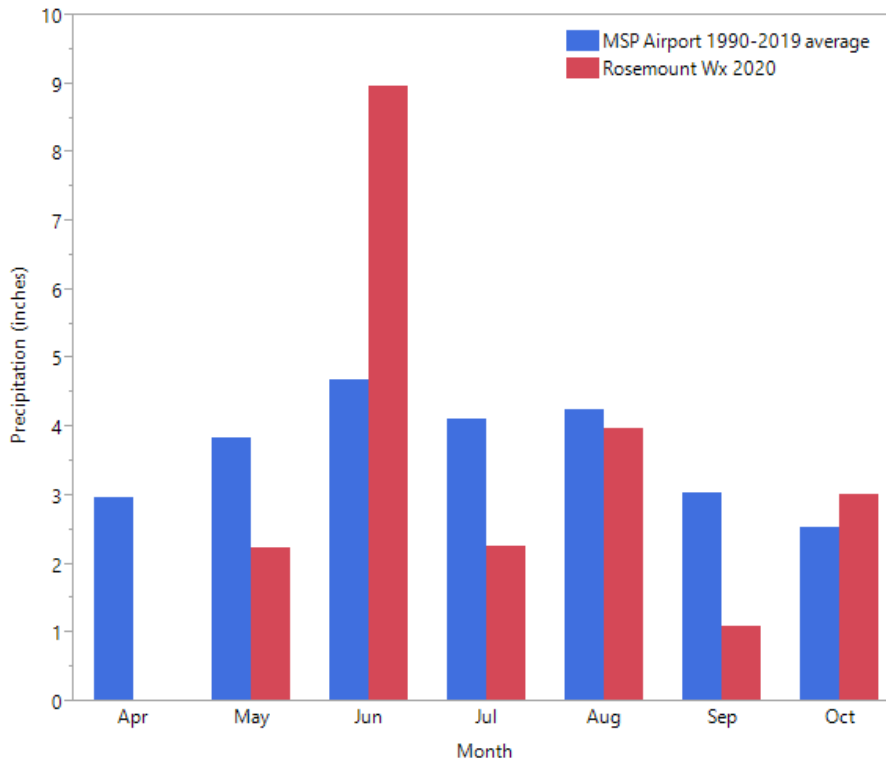
Figure 4. 30-year monthly average (1990-2019) precipitation at Minneapolis-St. Paul airport and 2020 monthly precipitation measured at the Rosemount weather station from April through October.

Large rainfall events were few and far between resulting in most samples being collected during baseflow or low water level conditions. The 30-year average (1990-2019) for the April-October period at the MSP Airport was 25.464 inches while the total April through October 2020 precipitation data was 23.82 inches.

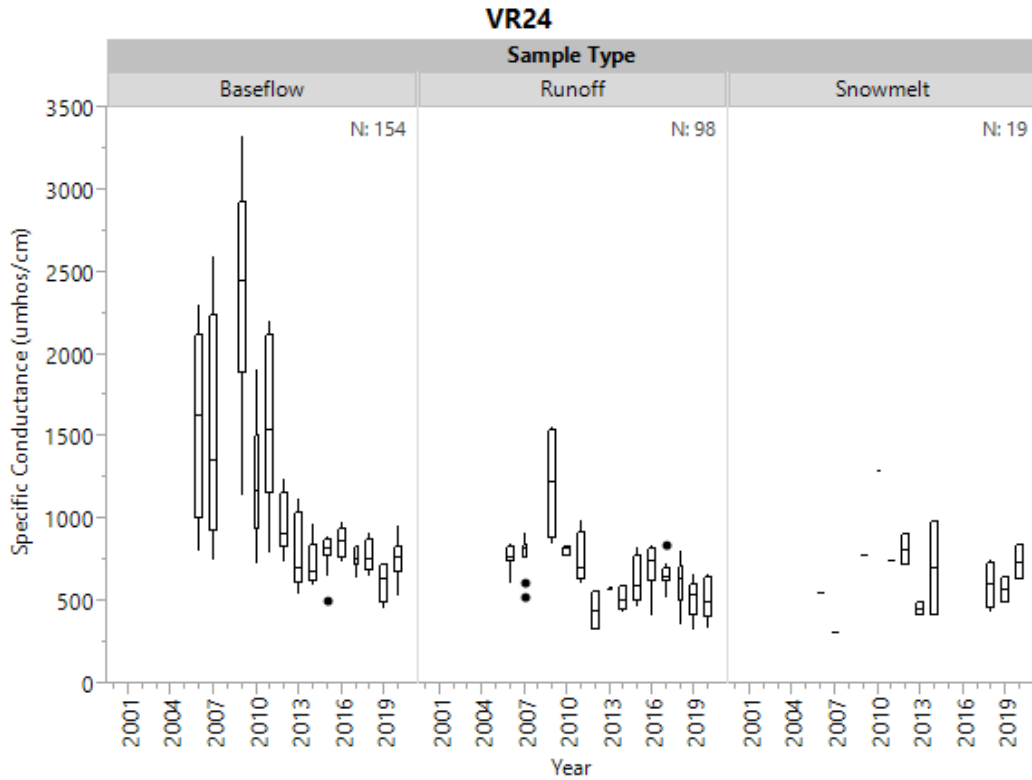
Historically, VR24 has much higher conductivity values compared to other stations in the network (take note of scale, Figures 9a-i). Conductivity tends to be higher downstream of WWTPs; a pattern that can be seen at VR24 and VR803 until the mid-2000s (Ort, 2008). Following the WWTP upstream of VR24 being redirected to the Empire WWTP in 2012, a decrease in conductivity has been observed and is expected to continue to decrease in the future. Additionally, a portion of the land use upstream of VR24 is sod farming, where the land is drained via tile and ditches as well as irrigated with groundwater, which may have contributed to elevated conductivity values. After the Empire WWTP was rerouted to the Mississippi River, the conductivity measured at VR803 showed a noticeable decrease in both the baseflow and runoff values.

Figure 8a. Historical specific conductance by sample type at VR24.
 **Note the scale difference between VR24 and other monitoring sites.

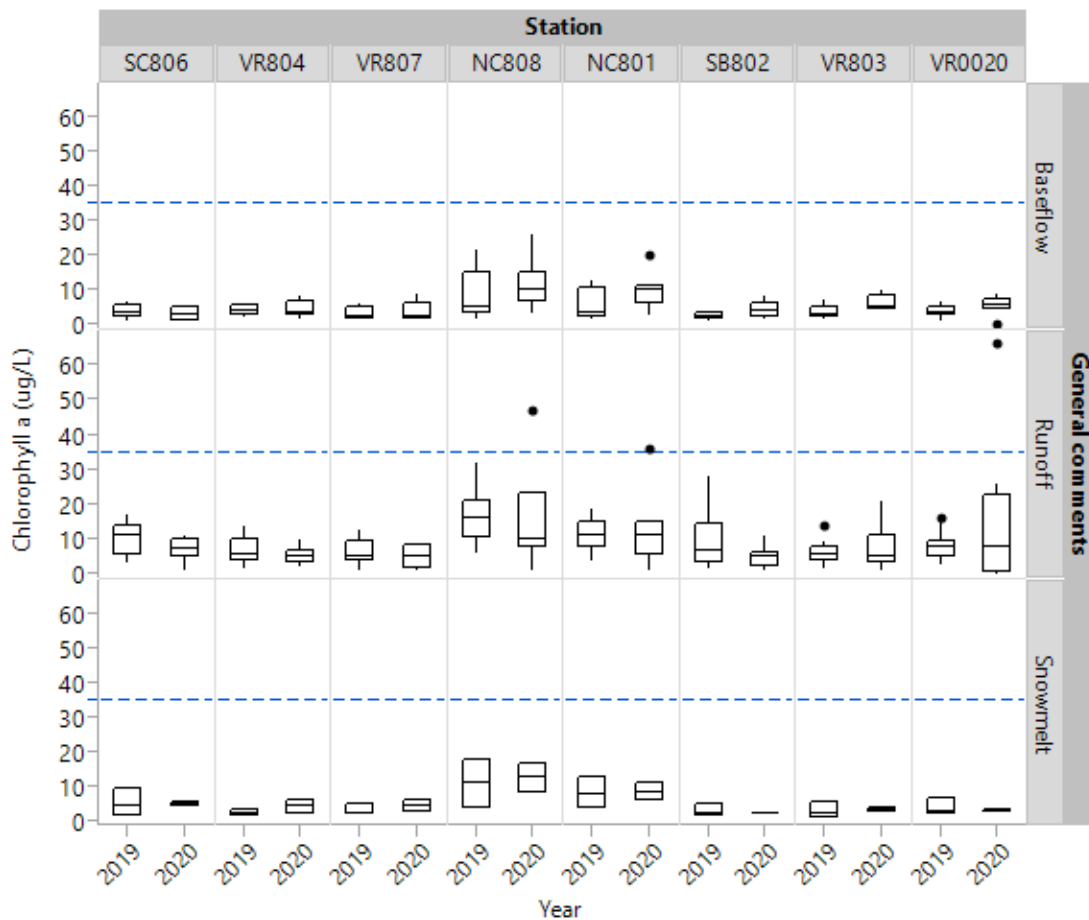
In 2019 and 2020, the sample median for all sites was below the state standard of ≤ 35 mg/L during all monitoring efforts (Figure 12). Some individual sampling events exceeded the standard during runoff conditions.

Figure 12. Chlorophyll *a* for each station during all sample types for 2019 and 2020.
