Seidls Lake

2021 Water Monitoring Report

Lake Summary

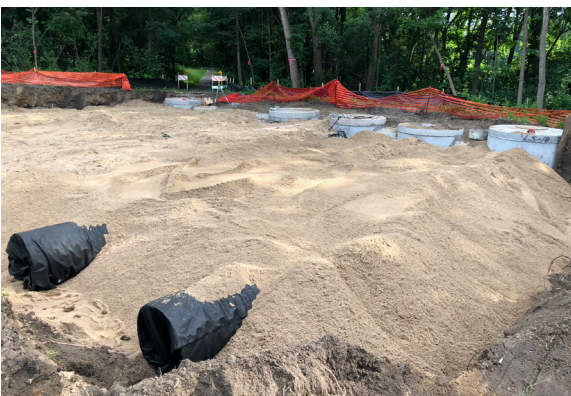
The LMRWMO partnered with the City of South St. Paul to install large underground pipe chambers (shown below) in 2018 to clean and infiltrate stormwater before it enters Seidls Lake.
